New Excavations at VIII.7.1-15, Pompeii: A brief synthesis of results from the 2005 season

Gary Devore and Steven J.R. Ellis

In July and August of 2005, the Pompeii Archaeological Research Project: *Porta Stabia* (PARP:PS) completed its first season of excavations at VIII.7.1-15, Pompeii. PARP:PS is a collaborative project under the direction of Steven Ellis (University of Michigan) and Gary Devore (Stanford University). The project has planned a total of six seasons of excavations with the aim of understanding the structural and occupational history of the *insula*, from its earliest origins through to 79 CE. With a program of selective excavation, structural analysis, and geophysical survey, PARP:PS aims to produce a complete archaeological analysis and assessment of the shops, workshops, inns, and houses at VIII.7.1-15 (figs. 1-2). We are particularly interested in the development of the structural and spatial relationship between public and private space in the Roman city.

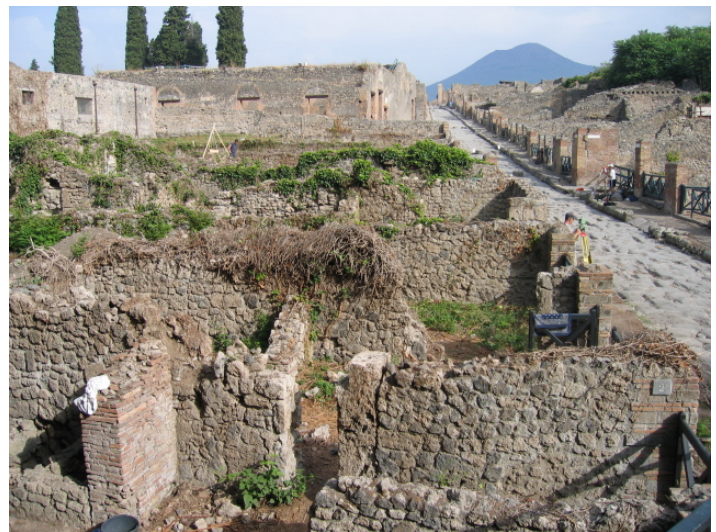
Fig. 1. Overview of VIII.7.1-15 with the Via Stabiana

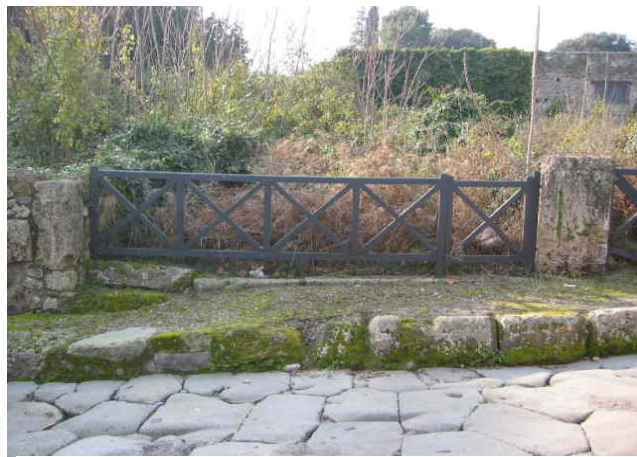
Fig. 4. The shop at VIII.7.9-10, prior to investigations

A large trench was opened in the front room (Room a) of VIII.7.9-10 (figs. 3-4). This trench occupied the southern half of the room and extended from the threshold to the southern doorway leading to the rear rooms of the property. Investigations were later extended in two small window trenches toward the northern wall of the room. Our motivation in opening Trench 3000 in this location was to pursue an overall understanding of the spatial arrangement of the *insula* in our first season. Confusion had always surrounded the number of street-side doorways into this particular property – and therefore of the entire *insula* – since some published plans show this retail front as having two separate entrances, while others have it with just a single entrance. Additionally, the location of this trench would help us to determine the property division between this shop-front at 9-10 with its neighbours to the north at 11-15, and those to the south at 7-8. Lastly, our aims included the recovery of the topographic and geological sequence of this part of the city. Outcrops of lava are visible today in the immediate vicinity directly opposite property 9-10, for example, at I.2.6, and along the perpendicular street between *insulae* I.1 and I.2. Any discovery of the same prehistoric flow of lava in VIII.7.1-15 would allow us to begin charting the entire developmental sequence of this corner of the city, from the first urban use of the land, through to the latest activities that led up to the 79 CE destruction. The same prehistoric flow of lava was indeed found within Trench 3000 and its discovery is of considerable significance to both our understanding of the natural topography of the area, and our identification of the earliest cultural sequences built atop it.

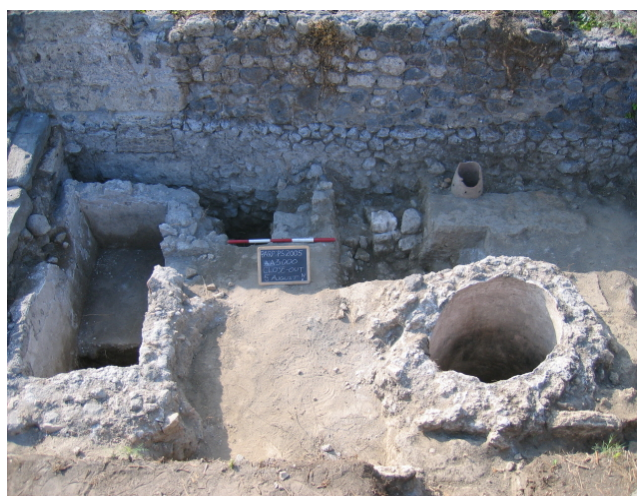
Fig. 5. Circular tank feature at right

The earliest urban features included two tank-like structures, each built directly onto, and in parts into, the natural deposit of lava. One of these tanks, circular in shape and located in the centre of the room, was characterised by a wide mouth with hydraulic plaster lining a masonry structure (fig. 5). The other tank was rectangular and located along the inside of the front threshold to the property (fig. 6). It was equally constructed with masonry rubble and lined with hydraulic plaster. At the end of their effective operation, each tank was filled with rubble, and the floor level raised for the following phase of activities (incorporating the same sequence of rubble fill as with the tanks).

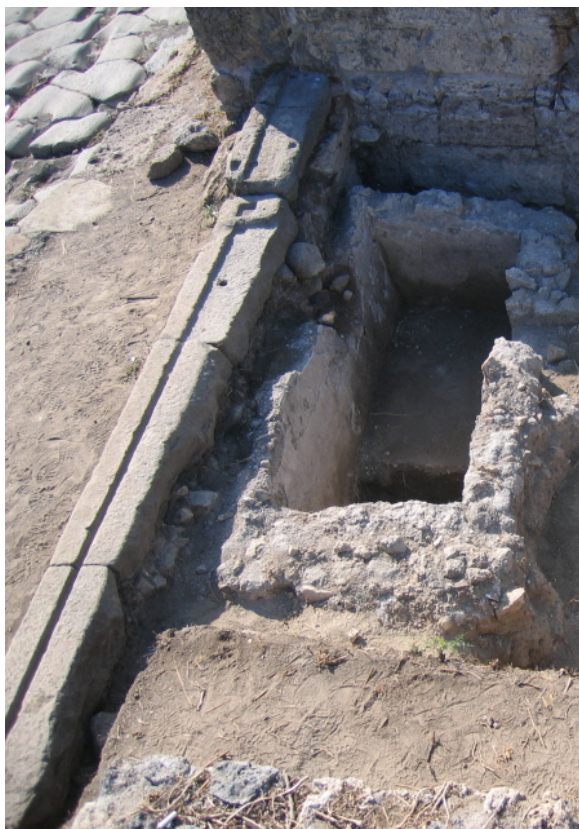
Fig. 6 Large rectangular tank inside the threshold. Note the two separate entrances to the property: a wide retail opening together with a narrower entrance (at top of photo) to a possible flight of stairs

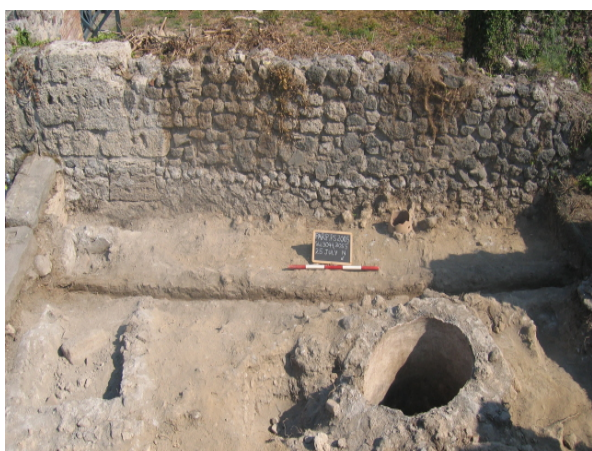
Fig. 8. Drain cutting west to east through the room

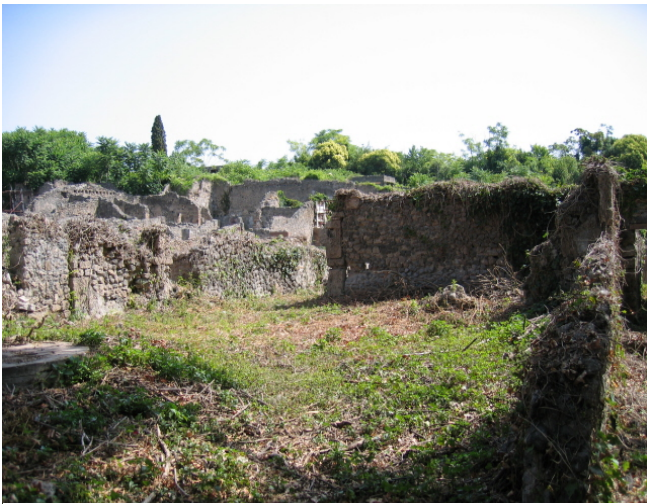
Fig. 9. Triclinium and cooking area prior to excavation

The removal of the modern and humus layers revealed a *triclinium* in a very poor state of preservation (figs. 9-10). None of its decorative treatment (visible in the archival photos) survived, and much of the eastern arm of the structure had fallen into a cistern that had collapsed below, during or shortly after the 79 CE eruption). The creation of the modern toilet facilities in the *quadriporticus* had caused further severe damage to this area with the associated cesspit and an overflow pit destroying all of the deposits associated with the remainder of this space. The extent of this damage inhibited the results of excavations around the *triclinium*.

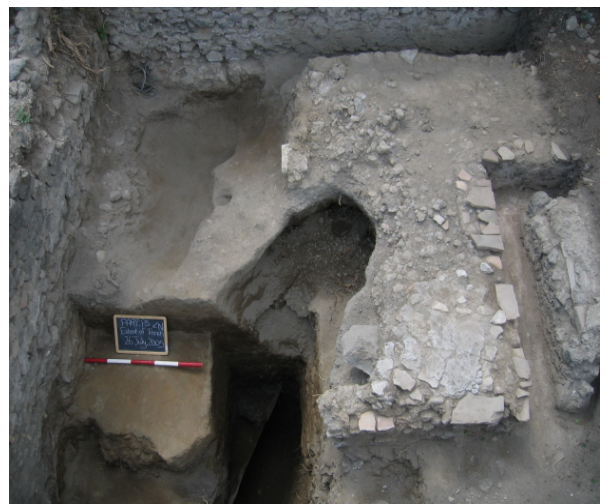
Fig. 10. Eastern half of triclinium in ruinous condition

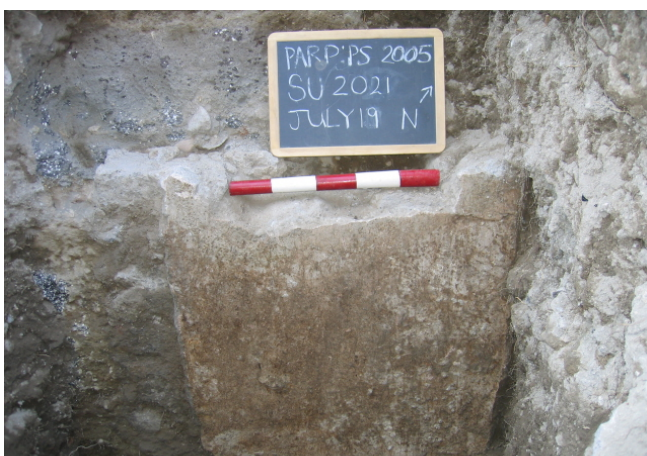
Fig. 11. Only the north wall of the tank survives

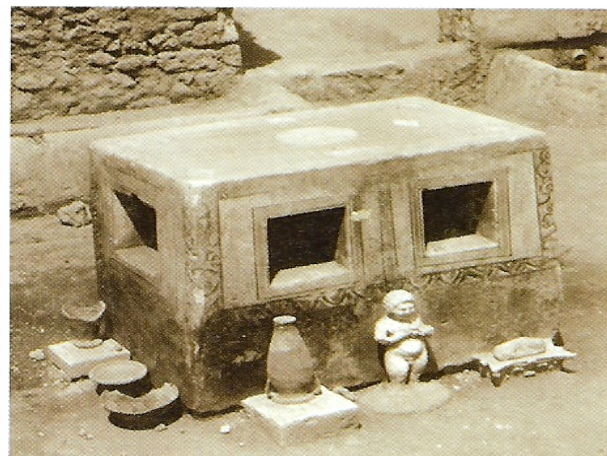
Fig. 12. Masonry table to the north of the triclinium. This feature is totally destroyed (After Stefani 2005: 102)

storage facility that once occupied the centre of the room, as illustrated in the photographic archive, is today entirely lost (fig. 12).

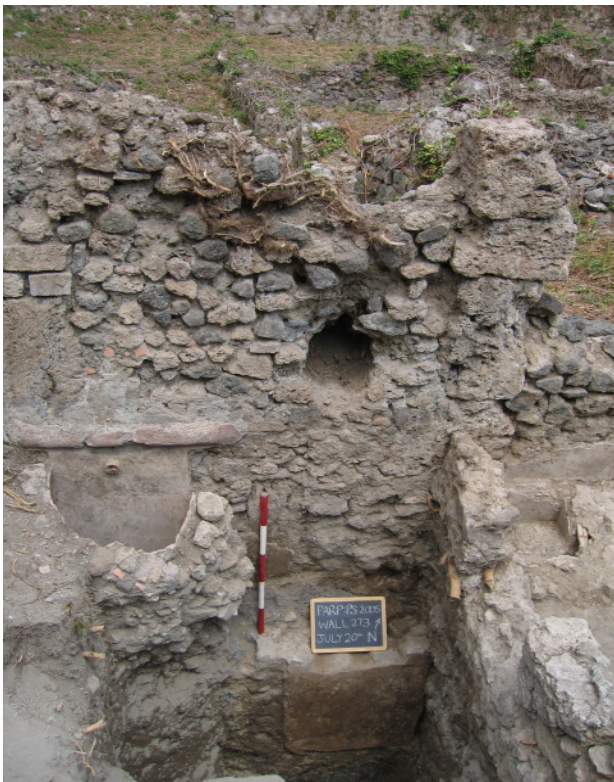
Fig. 13. Semi-circular basin at left of image, with small settling tank at far right

A small semi-circular basin projected from the north wall, opposite the *triclinium* (fig. 13). The basin was also of the final phase, and collected water from a spout that protruded from the wall. A lip of decorative plaster projected above the spout, in which two iron nails remain visible. These nails perhaps supported some type of decorative feature, and it is easy to imagine, for example, a theatrical mask hanging over the spout so that water poured through its open mouth and into the basin. The basin was not equipped with any form of drainage in its bottom, but instead it is likely that it operated as a settling tank and that overflow drained from its upper level directly along the north wall in an eastward direction and through the *in situ* pipe in the low partition wall. This pipe fed another small basin, which itself gave onto the mouth of a very well preserved cistern (fig. 14). Given the frequent seismic activity at Pompeii, it is very rare to find a completely intact cistern in such excellent condition. Its size (approximately 2m deep, 1.5m wide, and 7m long) indicates that a considerable supply of water was held here and that some provision was made to keep the water fresh with a series of settling tanks. Indeed the cistern appears to have had, at some stage, a second entrance for water cut into its southern end, although it was blocked in antiquity. Repairs had been carried out on the cistern in antiquity with smears and patches of lime mortar applied over several cracks (fig. 15).

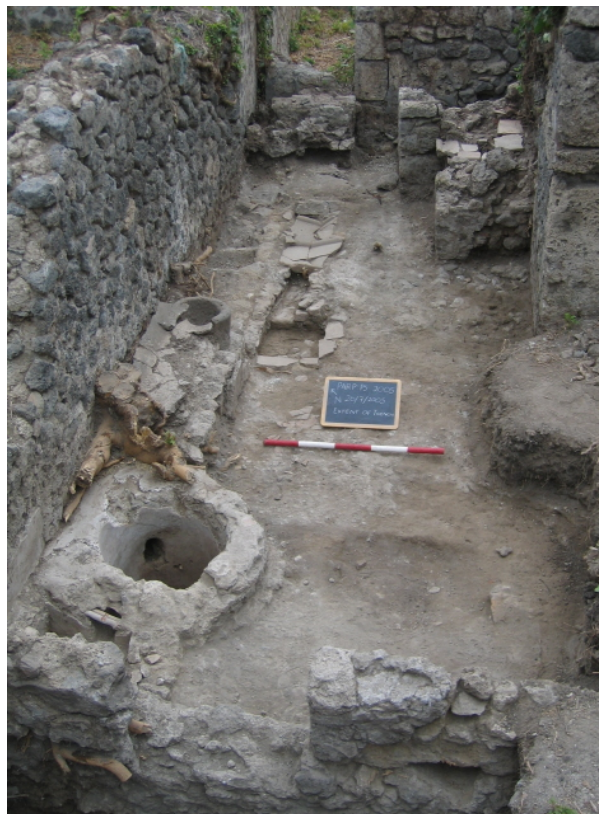
Fig. 14. Cistern head with kitchen facilities behind

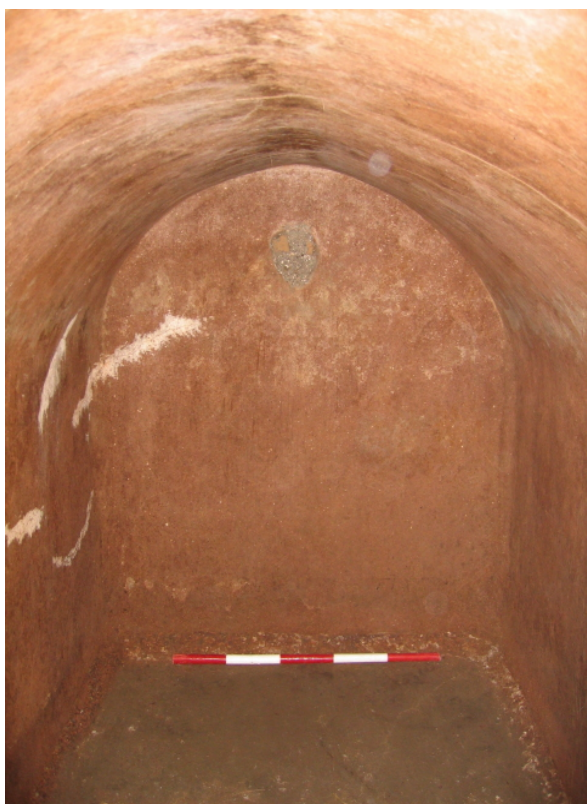
Fig. 15. Southern end of the cistern. Note the patching on the wall at left

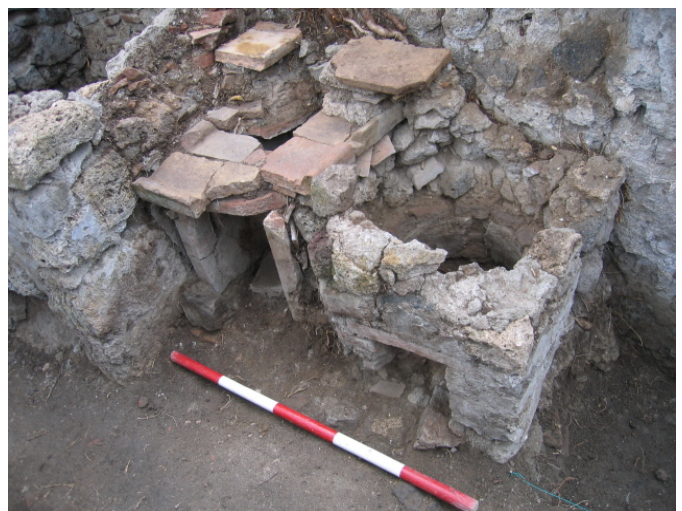
Fig. 16. Cooking feature with waste facility at rear

A food preparation area and cooking hearth were located further to the east of the cistern, along with a waste disposal chute (fig. 16). However, given the time expended by our team on the *triclinium* area during the early weeks of the campaign, these features await investigation in future seasons.

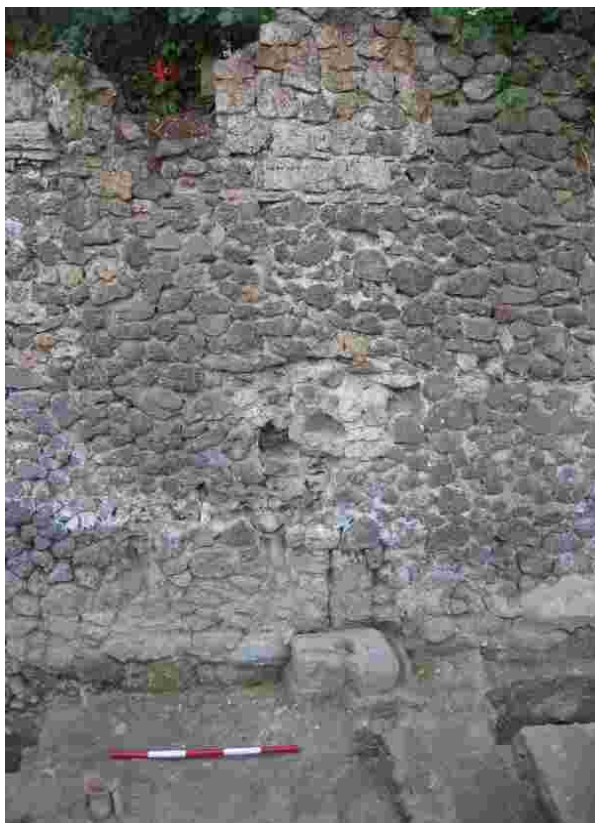
Fig. 18. The southern property wall

Although many plans of this part of the city show what appears to be an open doorway or window in this southern property wall, we found there was no indication of such an aperture, and this is probably an often repeated error or misrepresentation of the doorway that once led from the *Via Stabiana* to the fortifications of the city wall. Modern disturbances and vegetation prevented us from securing a solid date for the construction of this important wall, the southern boundary of the *insula*, but its western section will be investigated next season and an undisturbed section of the wall's foundation can probably be recovered.

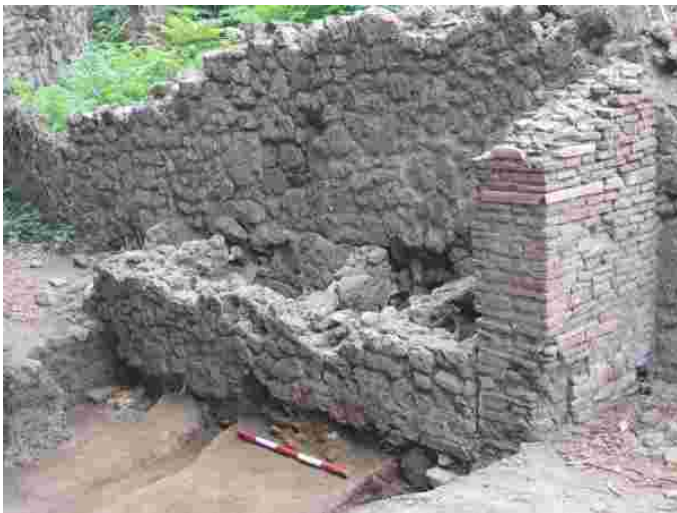
Fig. 19. The industrial tanks

Three tanks and a *dolium* base were found installed against the northern wall of the front room of this property (fig. 19). Several previous plans of the area had not recorded this evidence of ancient industrial activity, so we carried out careful documentation and controlled excavation. It was not possible to discern what industrial activity had actually taken place here, since the tanks and *dolium* base were very close to the modern surface and heavily damaged by modern vegetation and neglect, but samples of some hydraulic plaster still in situ will be analysed to see if any chemical residue can be recovered.

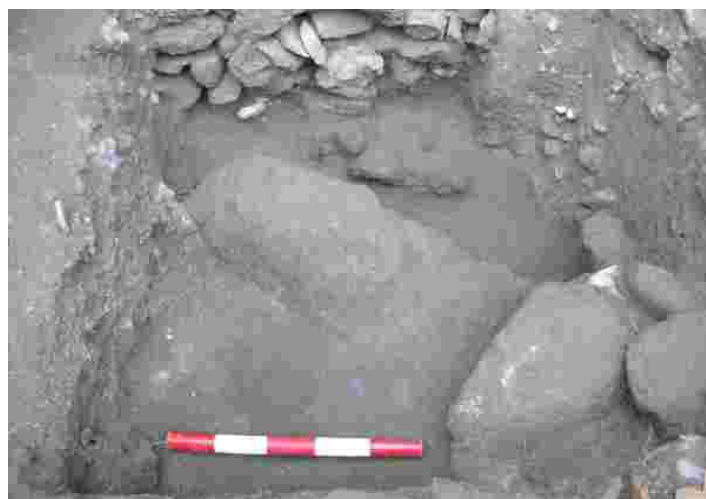
Fig. 20. Hard-packed earthen foundations

Several phases of the area's developmental sequence were defined. The earliest was glimpsed only with the remains of a small stone wall with hard-packed earthen foundations (fig. 20). It ran diagonally from north-west to south-east, but was completely disassociated from any other features in the area, as well as the latest alignment of the *Via Stabiana* and the general layout of the *insula*.

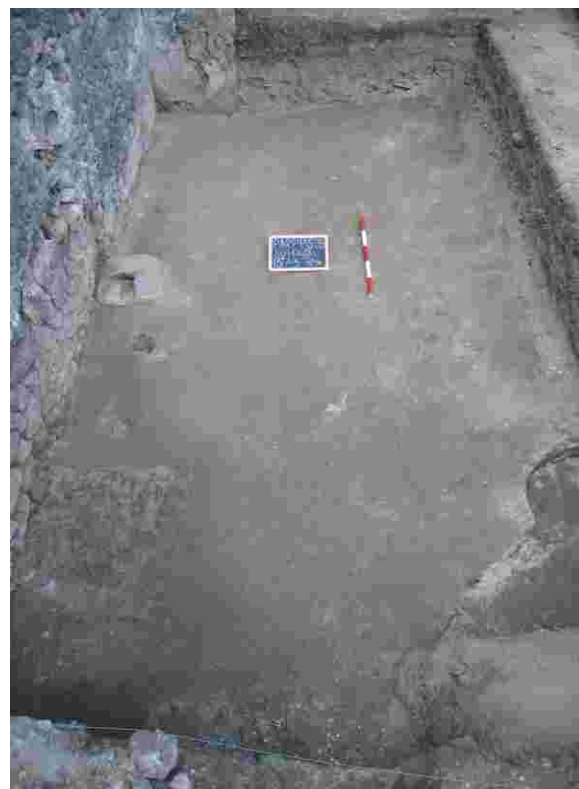
Fig. 22. Earthen surface of the large open space of Trench 1000

The small rooms were eventually knocked down, creating one large open space. The earthen floor level and threshold into the area were raised, and a ramp made of large lava stones was installed in the front of the property (fig. 22). This was probably the arrangement of the area at the time of the 79 CE eruption. This also seems to have been the time when the tanks and *dolium* base were installed, and industrial activity was carried out. August Mau³ originally identified this area as a stable accessible by horse and cart, with the tanks as water troughs. While the ramp undoubtedly enabled wheeled traffic to enter, the tanks do not look anything like water troughs visible elsewhere in the city. In addition, the tanks were built onto small elevated ramps, which would have made it difficult for any four-legged pack animal to manoeuvre close enough for a drink. These tanks were more

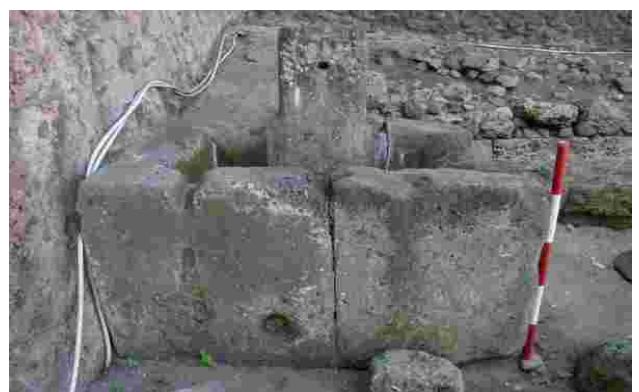
Fig. 25. The fountain from the front

To our knowledge a detailed plan of the features immediately inside the *Porta Stabia* had never been completed, so we cleared modern debris and accumulated sediment from a roughly triangular area near the gate (figs. 23-24). This cleaning and some small stratigraphic exploration enabled us to discern what appears to be two distinct phases in this area. The earliest had a public fountain in operation alongside of the *Via Stabiana* and next to the city fortifications while this entire area was originally completely open to the west (fig. 25). The fortifications (and an assumed rampart) were thus accessible from inside the city.

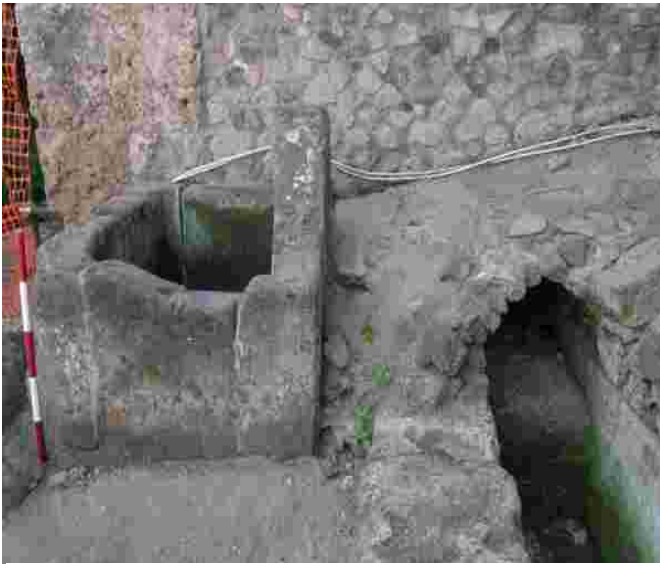
Fig. 26. The fountain from the side showing wear patterns

The fountain seems to have been accessible from three of its four sides in this first phase (fig. 26). Deep wear patterns on the top of the fountain walls suggest that those wishing to fill vessels with water from the fountain's mouth could lean over the northern, eastern, and western walls, and many people doing so over a prolonged period (with the additional

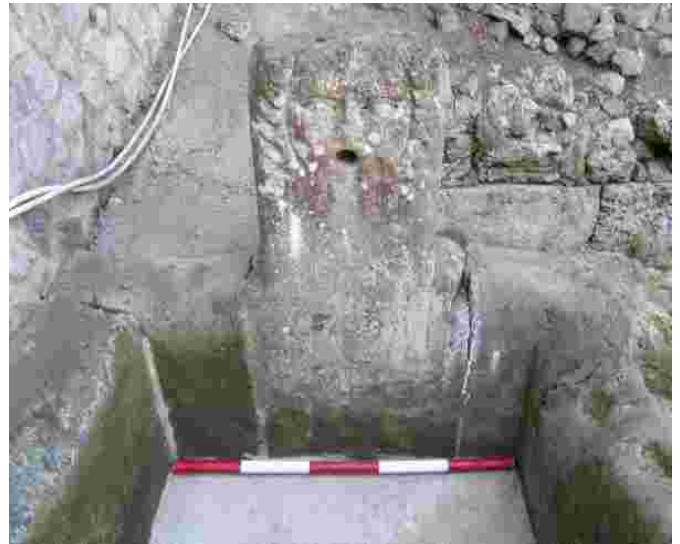
Fig. 27. Detail photo of wear on the rear wall of the fountain

factor of the water) produced the wearing visible at the top of the stones (fig. 27). This ubiquitous activity, visible at virtually every fountain in Pompeii, here became a valuable piece of phasing information.

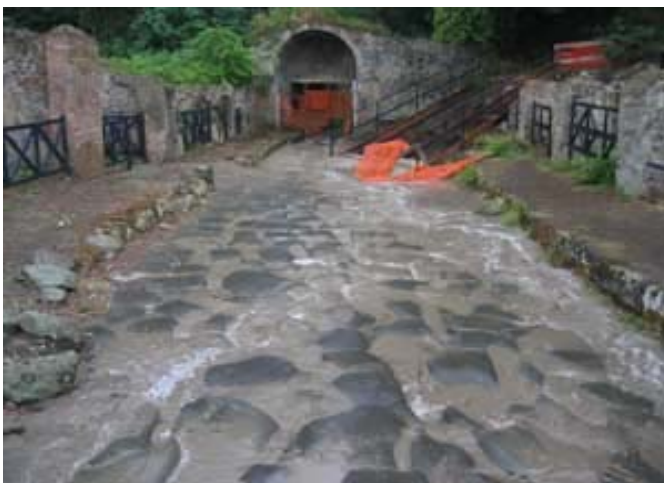
Fig. 28. The rainstorm, with water directed toward the drain

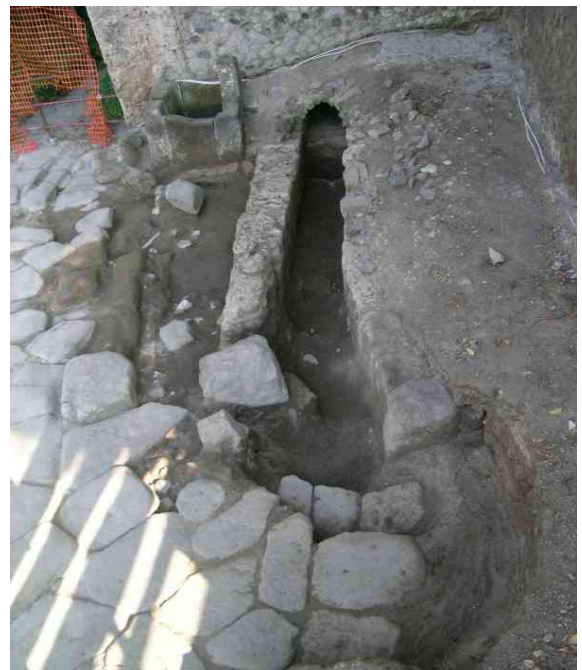
Fig. 29. Detail of drain arrangement

The drain was constructed of large upright stones of Sarno limestone set closely together to provide the drain's walls (fig. 29). These were once covered with plaster, the remains of which were still visible on the drain's smooth stone base. A continuous arched covering of lava stones once extended along the entire length of the exposed drain in this area, although only a small section of this survives today. Because of disturbance, it was not clear this year how water and waste were fed into the channel. Wall stones at the north end of the drain had been removed and paving stones were overturned, possibly in modern times. One small flight of stairs made of the same volcanic lava stones as the *Via Stabiana* led into the drain channel at its junction with the street, but the absence of water wear on the stones, and the general disturbed character of that section did not confirm that this was part of the drainage system, or if it was possibly an earlier course of the street paving seen in this disturbed area. A more detailed stratigraphic exploration of the sidewalks here and along the length of the *insula* in future years may provide more answers about the drains sequence and how it was associated with both the public *Via Stabiana* and the private properties of VIII.7.
