## Towards an understanding of the shape of space at VIII.7.1-15, Pompeii: preliminary results from the 2006 season

Steven J.R. Ellis and Gary Devore

In its second season of excavations, the Pompeii Archaeological Research Project: *Porta Stabia* (PARP:PS) had a primary goal of establishing a clearer understanding of the structural and social shape of the *insula*. To this end, five trenches were strategically located to help define certain properties, and to recognise the spatial relationships within and between such buildings. Trenches 5000 and 6000 were opened in property VIII.7.1-2; trench 7000 was located in VIII.7.9-10; trench 8000 was opened in VIII.7.14-15; trench 9000 was opened in VIII.7.12; and trench 10000 was opened within the *Porta Stabia* (figs. 1-2).

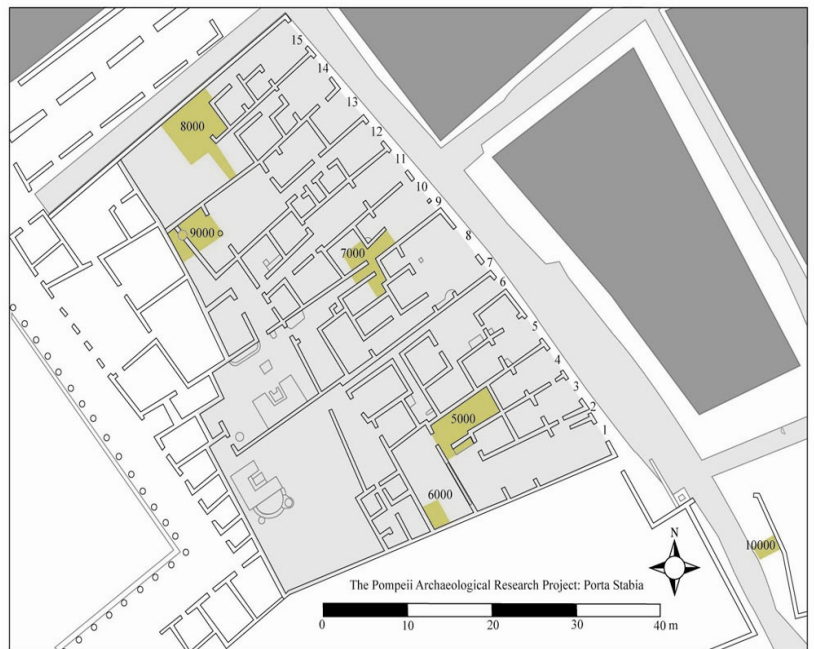
Fig. 1. Location of trenches in the 2006 season.

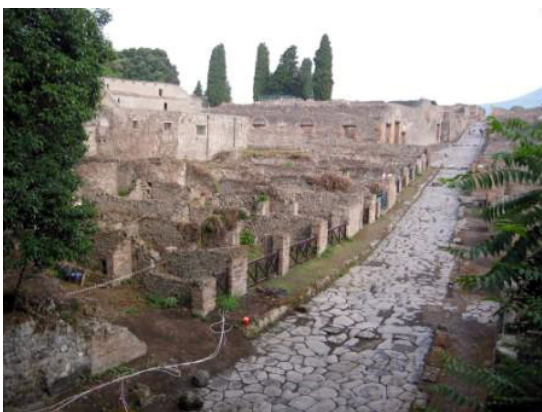
Fig. 2. Overview of VIII.7.1-15 from the *Porta Stabia*.

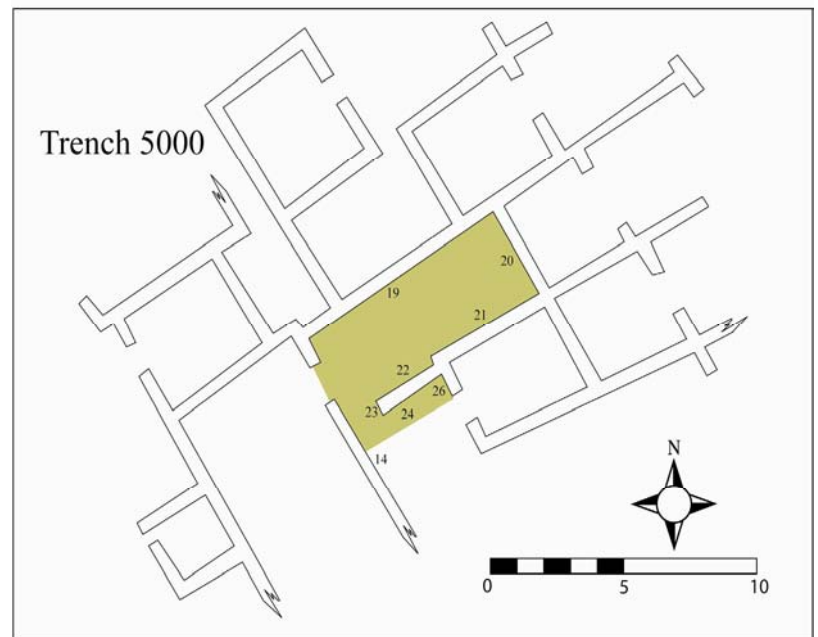
Fig. 3. Plan of Trench 5000.

Trench 5000 was located in the northernmost room of VIII.7.1-2 and occupied its entire surface area (fig. 3)<sup>1</sup>. The location of this trench was chosen to delineate the spatial arrangement and northern extent of the property since the southernmost extent of the property had been investigated in the 2005 season (Trench 1000, Devore and Ellis 2005). Additionally, we were concerned with learning more about the function of the (seemingly late) masonry structure skirting the north wall (WF 19) and its possible functional relationship with the industrial fixtures located for the final phase of the property in Trench 1000 (*ibid* 2005, 6)<sup>2</sup>.

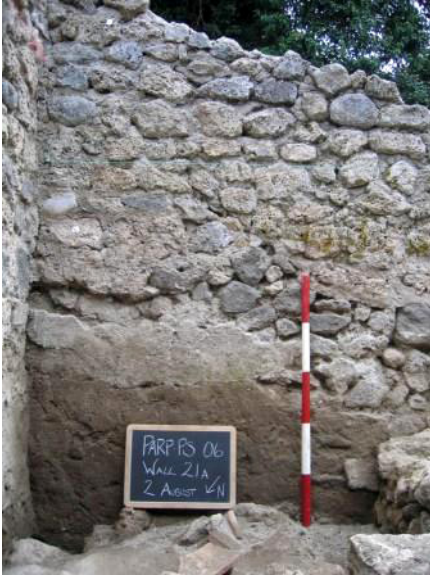
Fig. 4. Wall Face 21. Note the surviving relatively smooth surface.

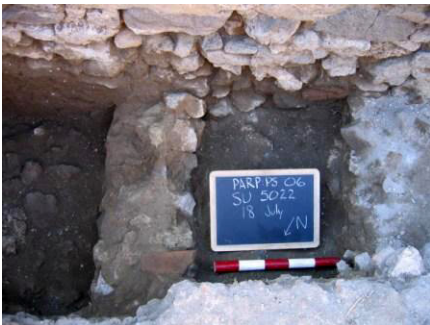
Fig. 5. Remains of the north-south aligned wall (Wall Faces 1022/1023/1024).

A further north-south aligned wall (WFs 1022-1024), also visible in this phase, may have been residual from an earlier phase, possibly from the contemporary insertion of buried walls from Phase 1 (fig. 5). Interpretation of this feature is therefore limited to the acknowledgement of its existence in this phase (but not its construction), and its destruction in Phase 3.

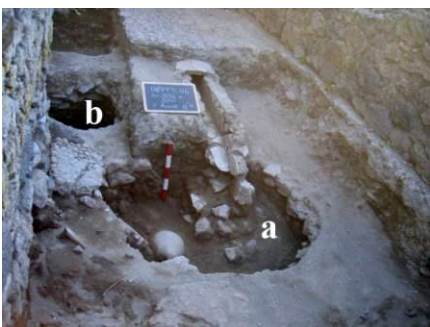
Fig. 6. The two circular features (a and b) of Trench 5000.

Two circular stone-lined features were the most remarkable features in this phase (fig. 6, a). The first was located on the south side of the centre of the room and is thought to have been used for drainage. The western side of this feature had a curved aperture and sloped down beneath the ground at a steep angle in a north-westerly direction.

The second circular stone-lined feature, however, was not fully curved on all sides (fig. 6, b). On the western and southern sides, the edges were built in straight lines. The southern side abutted the vertical face of WF 22 to incorporate it into the structure. There was no evidence of plaster lining or other such detail that would elucidate the nature of this feature's use.

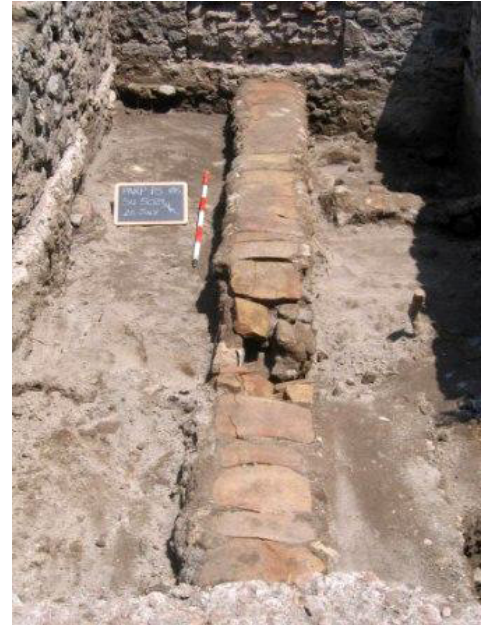
Fig. 7. Drain running from west (near end of photo) to east through Trench 5000.

A drain was constructed down the centre of the room from east to west in this phase, although no functional shift seemingly occurred in this area at this time (fig. 7). Some sort of industrial activity seems to have taken place here in this phase. Sequentially, the earlier *opus signinum* surface was destroyed, remnants of which appear to have been thrown into the fill on the south side of the area. Simultaneously, the northern edge of the buried wall (WF 1023) from Phase 1 was cut, and the original construction event of WF 20 was partially removed and cut through to accommodate the course of the drain, which continued to the street where an exit point is still visible (fig. 8). Once the drain was constructed, the second construction phase of WF 20 was built creating a doorway on the east side of this space (fig 9). The associated surface in this phase was another *opus signinum* floor.

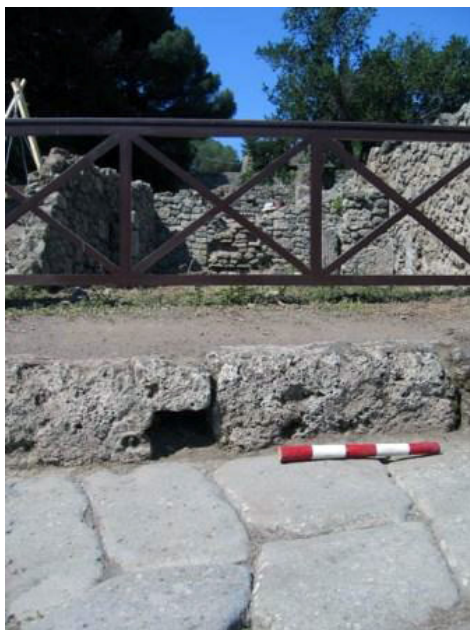
Fig. 8. Likely outflow of the drain from Trench 5000 into the Via Stabiana.

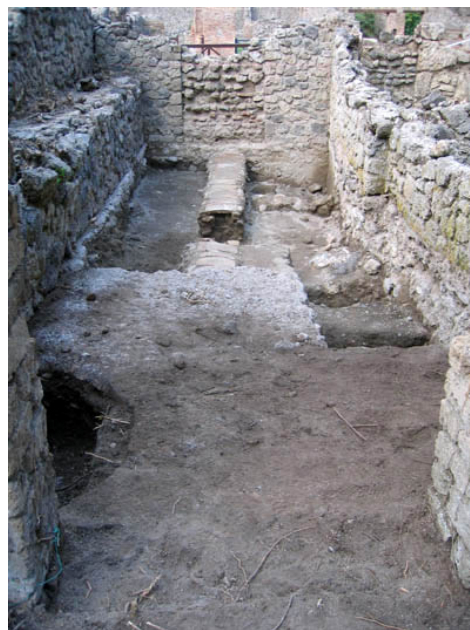
Fig. 9. Note the blocking of the doorway at the eastern end of the room (from Phase 4).

The *opus signinum* surface of the previous phase was retained in this phase, but it witnessed minor changes in the spatial configuration of the area, with a high probability of functional continuity. For example, the drain still appears to have been in use at this time. The doorway that existed in WF 20 was blocked, changing the configuration of access so that the sole entry point was from the west end of the room (fig. 9).

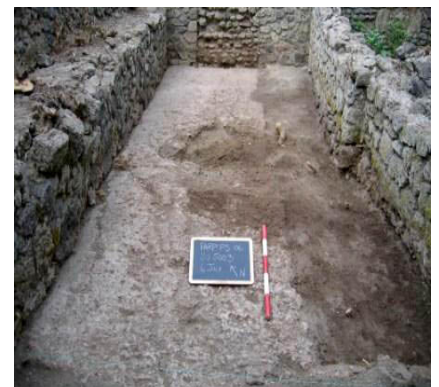
Fig. 10. *Opus signinum* floor that was laid against a possible wooden feature along the south side of the room. Note the masonry bench along the north (left) side of the room.

The new *opus signinum* surface did not cover the full extent of the trench, but was laid against several features that were removed in the following (final) phase (fig. 10). In the south of the room, the surface was laid against a rectangular feature of unknown nature. As there are no remnants of a masonry structure or any evidence of scarring on the walls, it is thought to have been a wooden structure, such as a bench – possibly the precursor to the masonry bench constructed in the final ancient phase of this area.

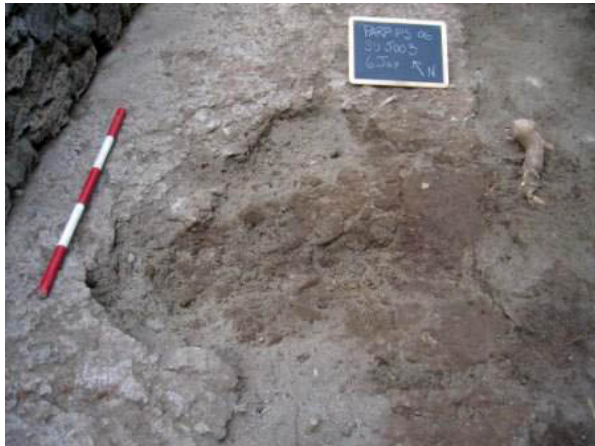
Fig. 11. Collapse of the *opus signinum* floor into the circular feature.

In modern times, the stone-lined feature in the centre of the trench collapsed, slumping into the circular feature along with the latest floor surface (fig. 11).

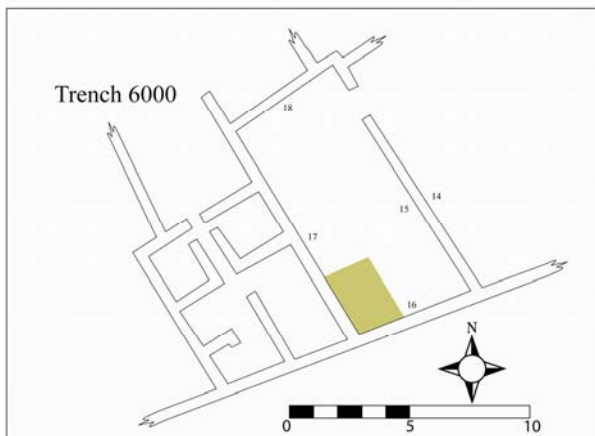
Fig. 12. Plan of Trench 6000.

This trench was sunk in the south-west corner of the rear room of VIII.7.1-2 in order to elucidate the southern and westernmost limits of the property (fig. 12)<sup>3</sup>. The area is bounded, and defined, by WF 16 to the south (along the city defences) and WF 17 to the west (the back wall of the property). The stratigraphic sequences revealed primarily late deposits and activities, even though the deepest limits of the trench reached the natural stratigraphic sequence of palaeolithic soils that usually overlay the Pompeian natural lava outcrop (seen in other sequences across the *insula*).

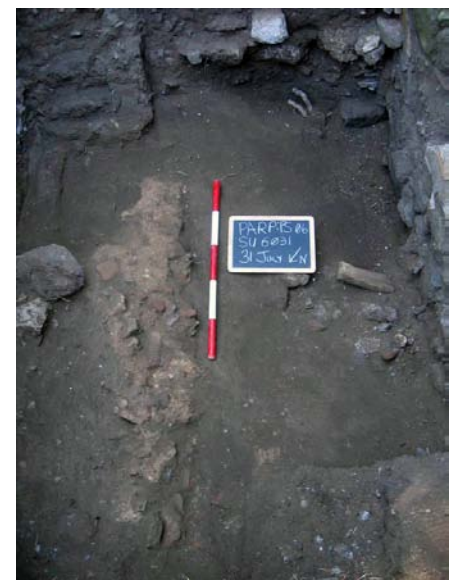
Fig. 13. Scant remains of a possible wall.

The earliest evidence for cultural activity came from a yellow mortar deposit with large inclusions of brick and stone that most likely represented an early wall fragment on a north-south alignment (fig. 13). To the east of this was what appears to be an associated packed surface of similar matrix.

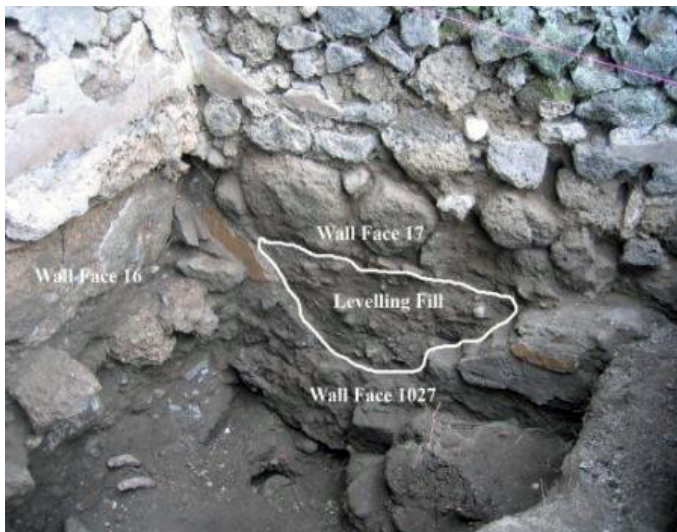
Fig. 14. Early wall (Wall Face 1027) on a north-south alignment. Note its destruction and subsequent levelling fill for the following sequence of construction.

A north-south aligned wall (WF 1027) was built in the west of the trench, possibly indicating an early property boundary that would eventually lose its significance (fig. 14). The foundations for this wall revealed two clusters of coins, twelve in total (fig. 15). Each cluster was encased in soil and, as a consequence, preliminary statements of coin identification are not currently possible, but will be of tremendous importance in dating this phase.

This area was significantly re-organized in the third phase. The substantial wall of Phase 2 (WF 1027) was destroyed and a huge levelling deposit laid down over and around the wreckage, upon which the construction events of this phase were built (fig. 14). This fill level was not bound by the existing architectural remains, but overlaid the remnants of the earlier north-south wall, the rear property wall upon which the later north-south wall (WF 17) was constructed (on a slightly different alignment to the earlier version).

An east-west wall (WF 16) was also built at this time on top of the same levelling deposit (fig. 14). The construction of this wall incorporated fragments of the Phase 2 north-south wall (WF 1027), such as a re-used Sarno block as an orthostat for the east side of a possible doorway (see below). This block contained the same plaster as the earlier wall.

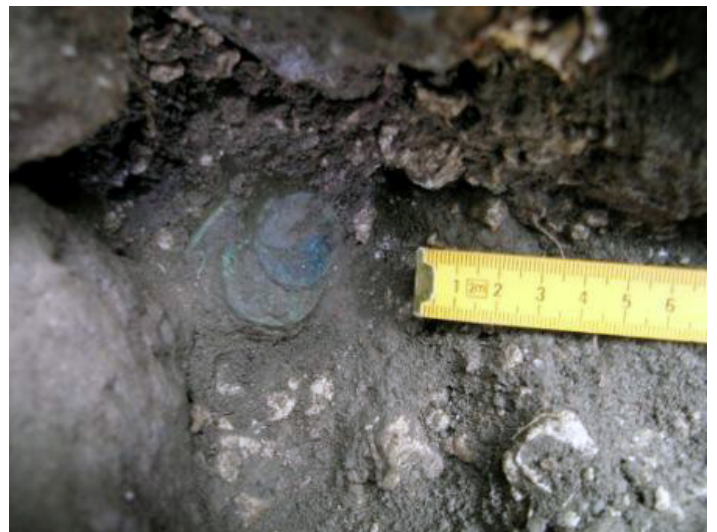
Fig. 15. Some of the coins found in the foundation of Wall Face 1027.

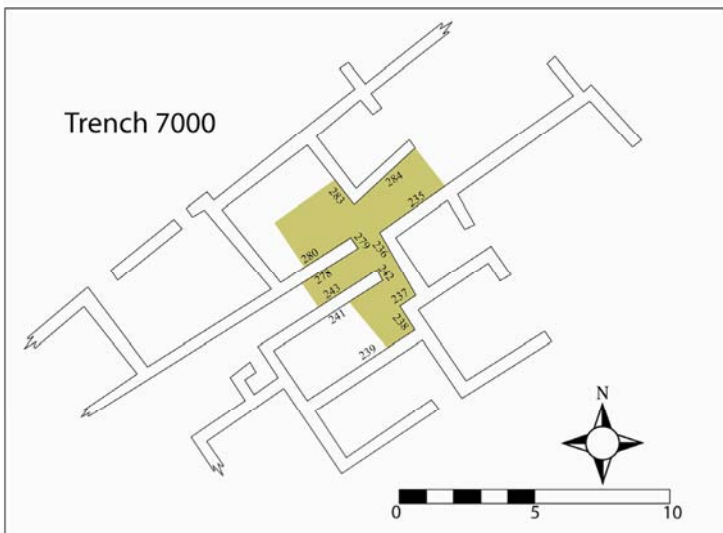
Fig. 16. Plan of Trench 7000.

Trench 7000 investigated several walls we considered very important for understanding the construction history of the entire *insula* (fig. 16)<sup>6</sup>. In particular, WF 235/280, the boundary wall between properties 9/10 and 8, seems to have been pivotal to the spatial order of the area. Not only did this wall separate the two properties, at least in plan, it also appeared to have divided the entire *insula* into halves (see fig. 1). Moreover, the construction of the eastern rooms of the *Quadriporticus* appears to have respected this division; the northwestern limits to the *insula* were bound by a wall (WF 333/339/459) that ran southward in an unbroken and straight line from the northernmost confines until it reached our division wall. As the *Quadriporticus* wall proceeded further southward, it shifted its linear alignment several times, as if having to respect pre-existing features or spaces. We therefore located Trench 7000 in the hallway and surrounding area of the break between WF 235/280 in order to investigate and date this important dividing wall, and to test the hypothesis that it had originally been one long wall (hence, 235/280) that was punched through to create access to the rear *triclinium* area behind property 7/8.

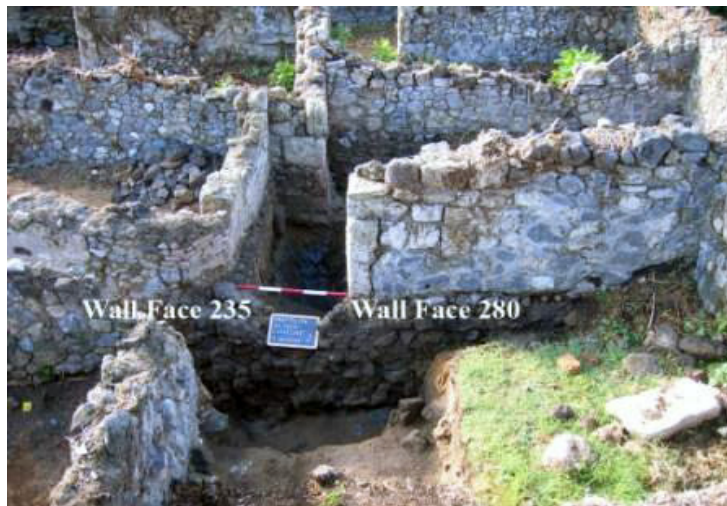
Fig. 17. The unified construction of Wall Faces 235 and 280. The doorway was created in the fourth phase.

As expected, the uppermost layers of the trench were very ephemeral and heavily disturbed from the modern vegetation in the area, but we soon came down on to evidence that WFs 235 and 280 were in fact originally unified. Their foundations were still intact, and revealed that they had clearly been built as a single process (fig. 17). This wall was built directly atop the lava that forms the natural topography in this area of the city, and represents the earliest known phase of urban activity in this neighborhood. What is more, this wall remained in use from its earliest phase until 79 CE (so far the only wall found to do so).

The more fundamental architectural and spatial developments, however, occurred in the fourth phase. A doorway was created in WF 235/280, linking properties 8 and 9/10 for the first time (fig. 17). The property at 9/10 could now enjoy access to the rear parts of property 8, and their unification was further attested by arrangements made for common drainage. A new drain was laid on a similar course to the earlier version from Phases 2-3 (fig. 20). Although somewhat smaller, this later version equally ran along the southern side of WF 235/280 until just before WF 236. It then turned north and ran through the new doorway that punched through WF 235/280. The upper portion of WF 235 was rebuilt and rounded off to further open up the doorway, widening access through the passageway (WF 236a); the rebuilding of this wall incorporated the same material used in the building of the drain, providing strong evidence that they belonged to the same phase. The new drain now ran to the north for a short distance before turning east toward the street where it emptied. The drain broke through the Phase 1 north-south wall (WF 1069) that had been keyed into the division wall (WF 235/280), probably rendering it obsolete.

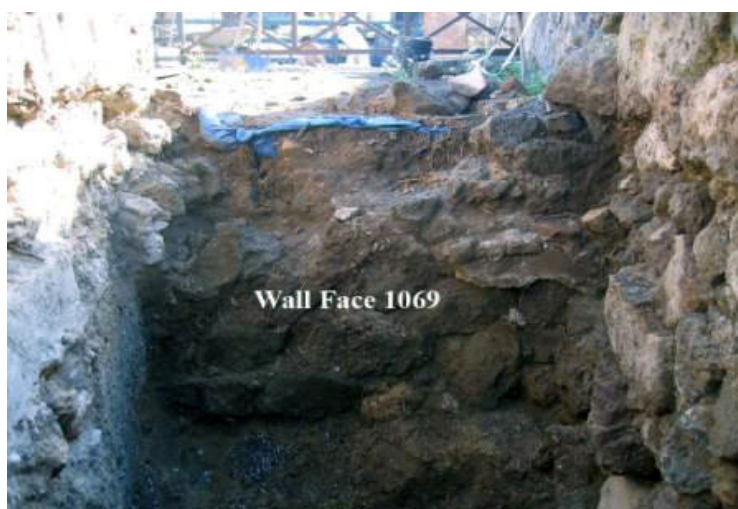
Fig. 18. Wall Face 1069 projecting north from the division wall, at right (Wall Face 235).

the trench, and keyed into the north face of the division wall (WF 235), offered the only evidence for the arrangement of space associated with this earliest phase (fig. 18). It seems that the foundation of WF 241/243, to the south of and parallel to the boundary WF 235/280, might have been built at the same time since it was equally built onto the lava, although almost a meter lower, due to the falling away of the natural topography here. No floor surfaces survive from this phase.

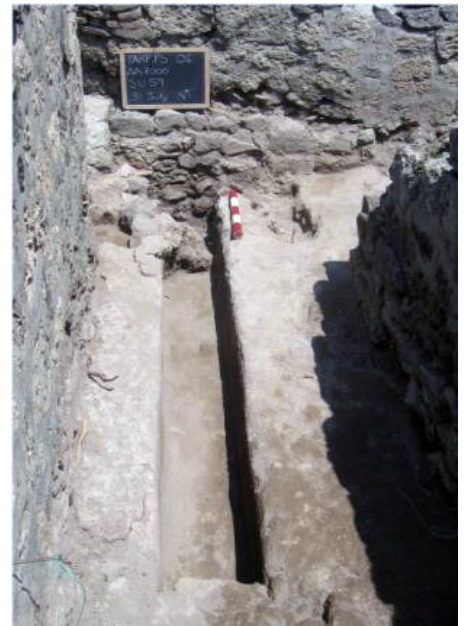
Fig. 19. Phase 2 drain heading toward the *Via Stabiana* before being cut by the construction of Wall Face 236 in Phase 3.

In the second phase, a sizable drain was cut into a sequence of simple earthen surfaces (fig. 19). It also incorporated the foundation of WF 235/280 as one of its sides. Lined with plaster, the drain ran presumably from the rear of the *insula* toward the street, passing under, and perhaps limited to, property 8. It was only located through excavations in this area, and the construction of WF 236 in the following phase later destroyed its course, rendering it ineffective. There is currently no outlet visible within the *Via Stabiana* curbstones for this early drain.

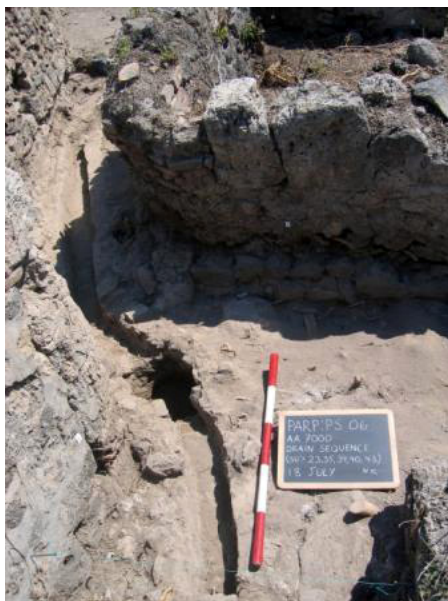
Fig. 20. Phase 4 drain heading north-east and bending through the newly opened doorway. Note the circular catchment built into the drain.

The drain must have originated in the kitchen to the west, which itself was associated with a *triclinium* (both features are from Trench 2000, excavated in 2005; see Devore and Ellis 2005, 3-5). A fascinating feature of this drain was a circular catchment built as part of its original construction, directly in the middle of the new doorway. Its bottom was 20 cm lower than the level of the drain. The larger items of material and waste from the kitchen would travel through the drain and settle at the bottom of the catchment. A circular stone lid with a handle closed the feature and could be removed for emptying the material (fig. 21). The system appears to be a rather unique arrangement at Pompeii.

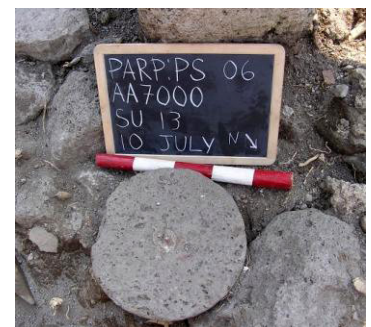
Fig. 21. Stone lid with handle to enable access to the catchment in the drain (scale = 50cm).

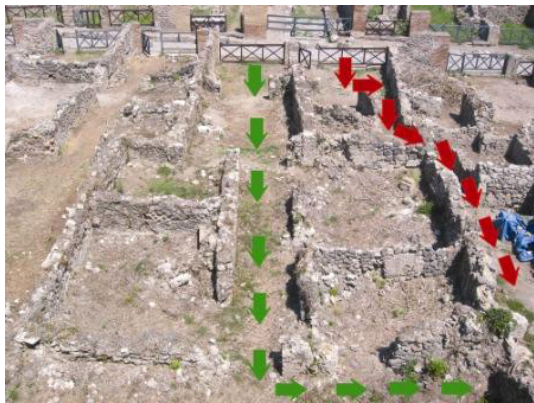
Fig. 22. Access from doorway 11 through to the *triclinium* (green arrows).

Since the little doorway in WF 235/280 led through a short hallway to the cooking and toilet area near the *triclinium*, we postulate that this area was a service corridor. The more public approach to the *triclinium* would have been through doorway 11, traversing several dining spaces before turning left to approach the *triclinium* space head-on (through what is now a modern blocked doorway; fig. 22). What is interesting about these arrangements is that it is the property at 9/10/11 that was seemingly growing southward, taking over the rear space from the property at 7/8 which had no spatial connection with the *triclinium* space at the ground floor level.

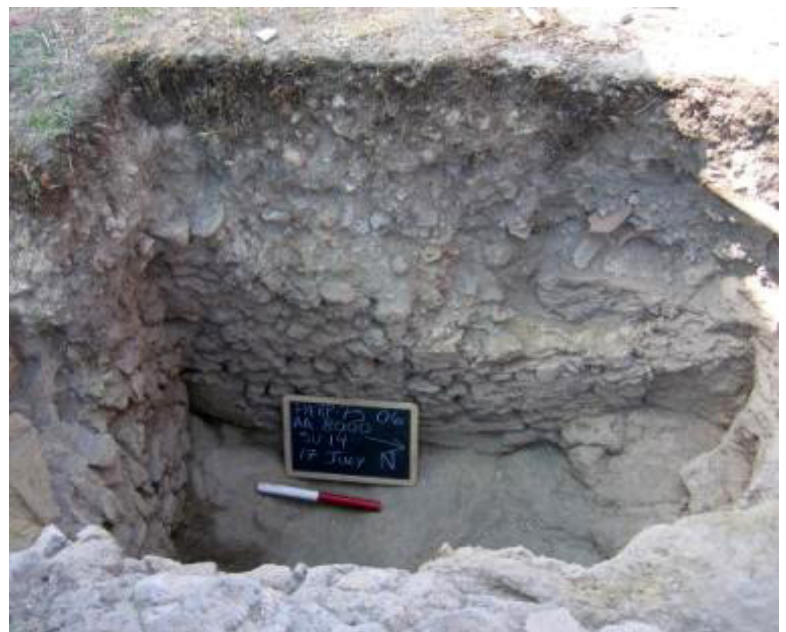
Fig. 24. Remains of the earliest wall in Trench 8000. Note its construction directly on top of the lava.

A crudely constructed *opus incertum* wall, WFs 1040/1041, L-shaped, and running south from the northern limit of the trench for 2 meters before turning east for 0.84 meters, was built directly on top of the lava spur that represents bedrock in this part of the city (fig. 24; *ibid* 2005, 2). This volcanic layer was revealed in three places, between 12.8 meters and 13.2 meters above sea level, and thereby provided a good indication of the natural topography for this northern limit of the *insula*. Of the wall itself, only the eastern and northern faces (WFs 1040 and 1041, respectively) of the L-shaped feature were brought to light, its

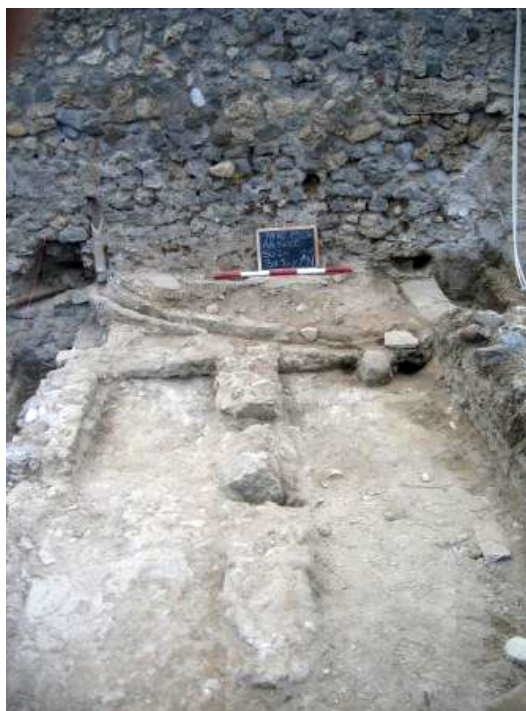
Fig. 26. The small narrow rooms created in the fourth phase.

(fig. 26). The inside space was characterized by a lime-mortar floor which filled the space west of WF 491, and spread northward as far as WF 460. Its western limits were defined by a newly constructed wall (WFs 1047/1048/1049) that incorporated the earlier wall (WFs 1046/1071/1056) for its foundations. This new wall also terminated precisely where its predecessor had, suggesting the persistence of this doorway or passage. Instead of continuing through this opening, the mortared floor terminated at this point. The southern extent of this surface was cut before it could meet with WF 492. The cut was made for the construction of a toilet and waste removal feature in the south-east corner of our area, abutting WFs 491 and 492 (fig. 27).

Two more new walls (WFs 1050-1054-1055 and 1051-1052-1053) served to organize this space yet more, with the creation of two long and narrow rectangular rooms (fig. 26). The creation of these two rooms allowed for a passageway between their northern limits and the property/*insula* boundary (WF 460). This passageway likely provided access to an outdoor area west of the narrow rooms with their concrete surface. A beaten earth surface defines this outdoor space. This space was also defined by an east-west wall (WFs 1043/1044/1045) built between the western limit of the two rooms (from WF 1047) as far west as WF 1037, which continued to act as a major partition of space (fig. 25).

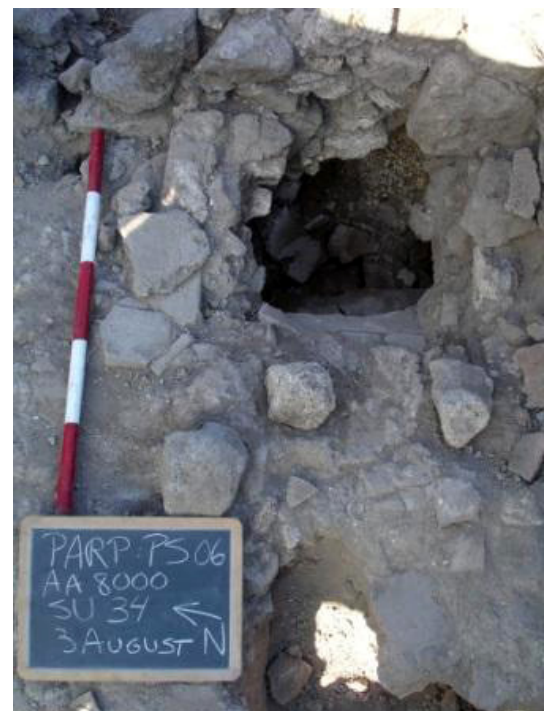
Fig. 27. Toilet and waste feature in the south-east corner of the room.

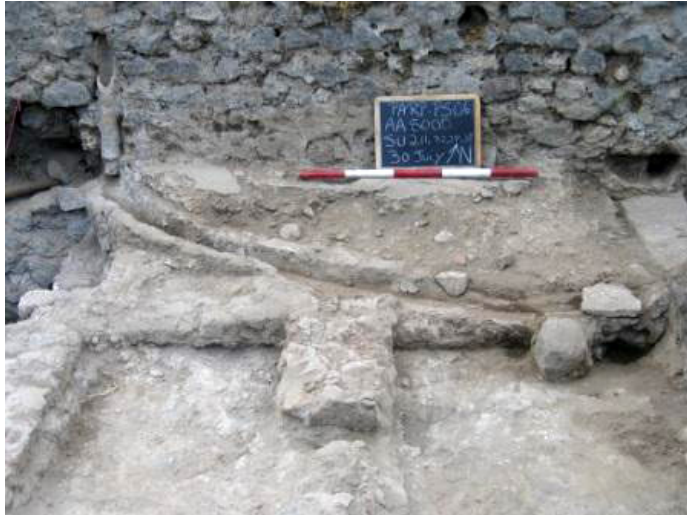
Fig. 28. Northern entrance with limestone threshold, at right. The drain feature was fed by the downpipe in Wall Face 460.

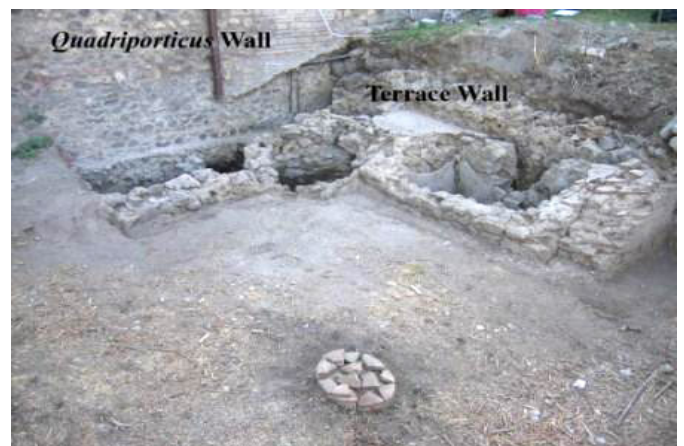
Fig. 30. Terrace wall (Wall Face 340/400/404) along north side of Trench 9000.

WF 340/400/404 represented the earliest activity for this area, and necessarily so, given that this wall served to buttress the elevated terrace space to the north (figs. 30-31). All other features with a physical relationship to this terracing wall were stratigraphically later. This included, very importantly, the construction of the *Quadriporticus* wall (WF 339/459), which illustrates that the construction of the eastern wing of the *Quadriporticus* occurred later than the terracing in the northern half of this *insula*. The creation of this terrace heralded the flourishing urban activities associated with this first phase.

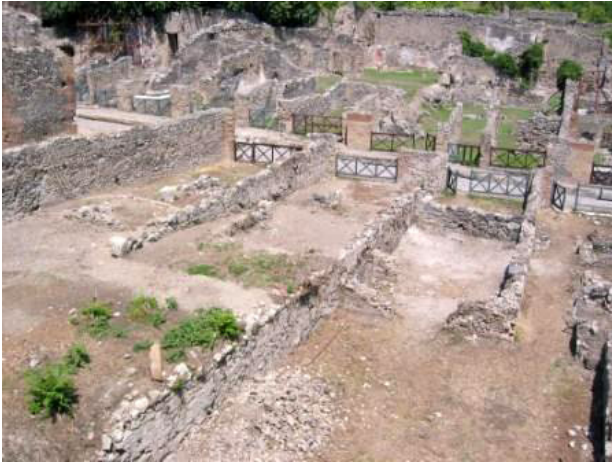
Fig. 31. The eastward continuation of the terrace wall. Note the difference in elevation from one side to the other.

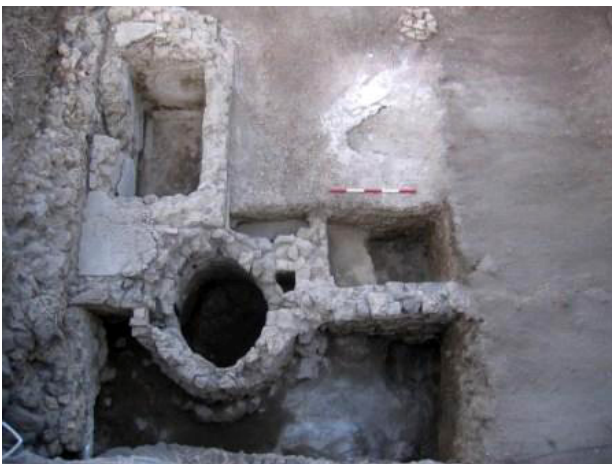
Fig. 32. Overhead view of features in Trench 9000.

With the retaining wall in place, a cesspit was dug into the volcanic soils and lined with roughly cut pieces of masonry, volcanic stones, and tile (fig. 32). The bottom of the pit was not reached by excavation, given issues of safety, although we were able to detect that parts of its western face incorporated the natural plateau of lava (at about 1.4 meters in depth). This cesspit was fed via a large aperture as well as by a channel incorporated into the wall (WF 1064 – built against the cesspit, and probably in Phase 2) that linked cesspit with the terrace wall, and by another drain that was built, more likely contemporary, into north-south wall (WF 341/399). It ought to be noted that these two walls were not in alignment. This north-south wall (WF 341/399) divided properties 11 and 12, although the two properties apparently shared the use of the cesspit. Excavations also revealed a brief section of a wall aligned east-west (WFs 1066/1067/1068) abutting the junction between the cesspit and WF 399 (fig. 32). This wall likely divided the eastern side of the cesspit into northern and southern sides, though only the southern side retained evidence of a floor abutting the southern face of the division wall (WFs 1066/1067/1068).

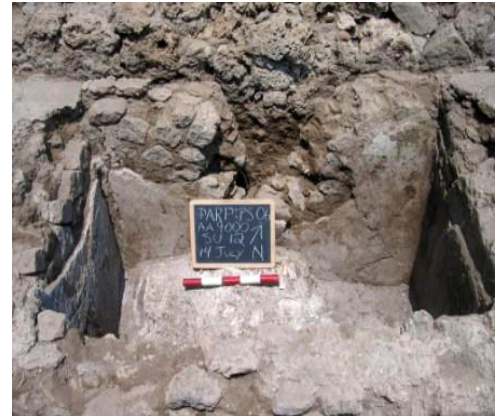
Fig. 33. Large deposit of lime found within the tank.

Modern activities defined Phase 6. Although similar in appearance to the countless deposits known from throughout the city, and believed to have been left-over from the reconstruction activities prior to the 79 CE eruption, the lime pile in the tank must have been created over the past century as it overlaid several pieces of modern construction material, including modern nails and other debris (fig. 33). This deposit, as with many others throughout the city that are often, and sometimes wrongly, interpreted as ancient, is more likely the by-product of early 20<sup>th</sup> century restoration work in the area.

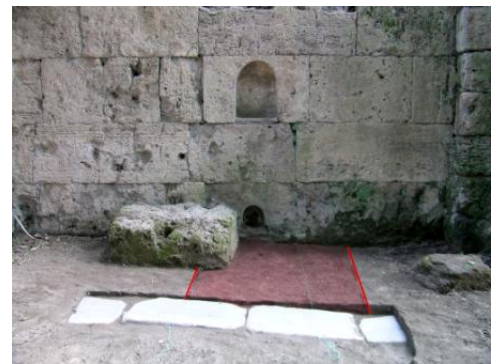
Fig. 34. The two arched shrines cut into the east wall of the Porta Stabia. Location of Trench 10000 indicated by red shading.

carved directly into the stone walls (WF 528) of the gate, which at one point in its post-exhumed life still held traces of painting<sup>10</sup>. Below it is a smaller niche. Given the rarity of such shrines within Pompeii's seven gates, and following from some recent excavations into the sidewalks beneath similar examples in Regions VI and VII (see, for example, Anniboletti 2005, 381-382; Piva 2005, 196-197), we decided to open a trench in the sidewalk beneath the two shrines with the aim of learning more about their construction and any ritual activities associated with them, and also to phase the road and sidewalk that penetrated this important gate into the city (fig. 35).

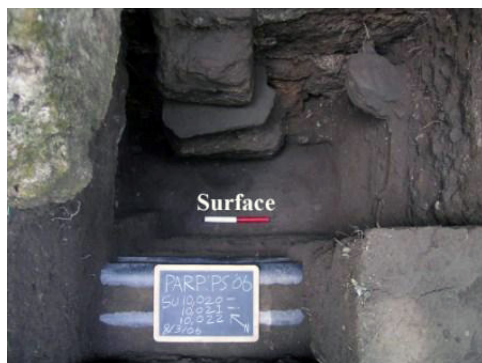
Fig. 36. The earliest surface (the sidewalk, or possibly also the street) in Trench 10000 (scale = 40cm).

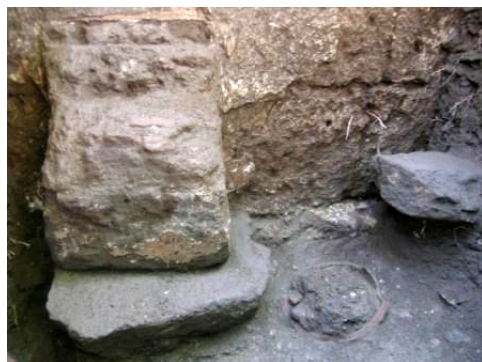
Fig. 37. The altar built against the Porta Stabia.

A square altar was built against the east wall of the gate (WF 528), at which point it is likely that the smaller niche was inserted above (fig. 37). While the floor surface for this space was destroyed by later activities (in Phase 3), the construction sequence for it remained discernible (and represents the same pattern of floor surfaces that overlaid it in the later phases).

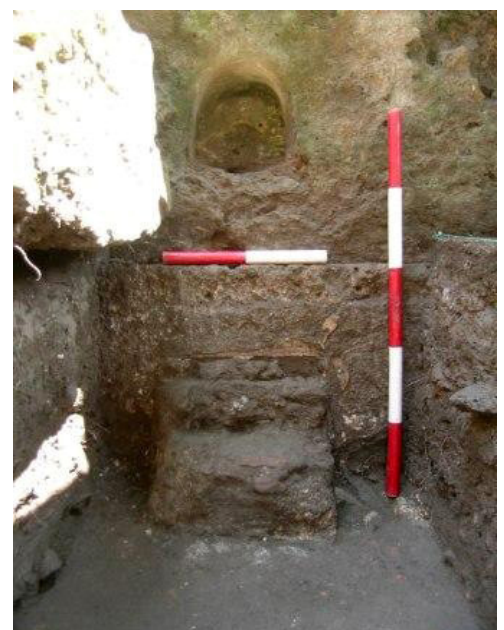
Fig. 38. The altar after the raising of the sidewalk in the third phase.

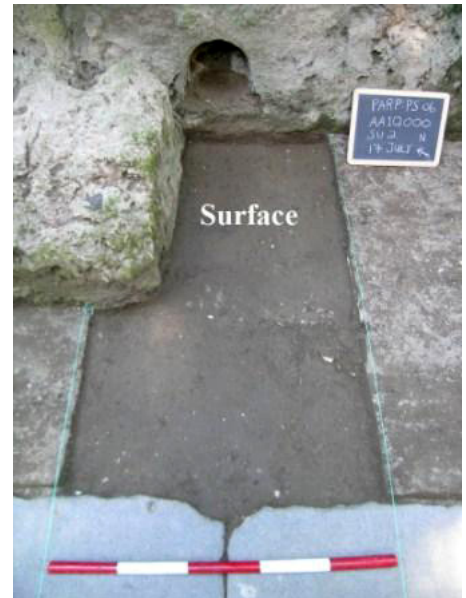
Fig. 41. The final sidewalk surface.

When the sidewalk was raised for the final time in this area, the altar became completely submerged (fig. 41). It is therefore plausible that this action resulted in the cutting of the higher and larger niche into the east wall of the Gate (fig. 34). While the earlier partial covering of the altar resulted in votive offerings, its complete burial produced no observable ritual. This lack of votive deposits may be attributed to the possibility that the (contemporary) creation of the upper large niche required no offerings to be placed in the ground.

The construction sequence for the 79CE surface of the sidewalk was much like the preceding examples, although much more substantial. A lava stone rubble deposit was first laid directly atop the earlier floor surface (that partially buried the altar). This was then followed by a compact silty sand deposit with many clay inclusions. Atop this silty sand deposit was a substantial loose sand rubble deposit with large lava stone pieces mixed throughout, perhaps serving as a drainage deposit for the sidewalk surface. Above this loose sand deposit was laid a compacted lava stone rubble deposit that served to level the surface and provide a stable surface on which to lay the *opus signinum* sidewalk surface.

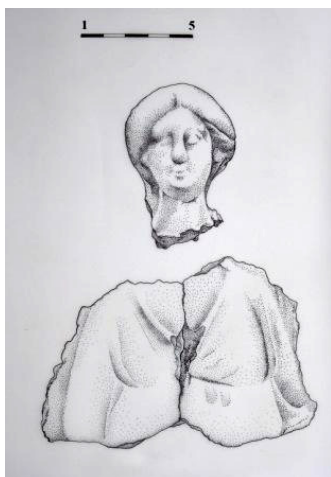
Fig. 40. Female terracotta figurine found with other votive material (Drawn by Gina Tibbott).

Equally important among the votive deposits, again within the levelling fill for the new surface (although in its earliest sequence), was the discovery of a votive bowl in which was found the terracotta bust of a woman broken into three pieces (fig. 40). Her head and the left and right portions of her torso survived. Her secure identification awaits further study and association with similar finds. Other finds included a single vertebra, a
