The Third Season of Excavations at VIII.7.1-15 and the *Porta Stabia* at Pompeii: Preliminary Report

Gary Devore - Steven J.R. Ellis

In 2007, the Pompeii Archaeological Research Project: *Porta Stabia* (PARP:PS) continued its campaign to uncover the structural and social history of *insula* VIII.7.1-15 and the *Porta Stabia* with a third season of archaeological excavations. Five trenches were strategically located with the aim of clarifying the temporal and spatial definitions and relationships of certain properties within the area. Trench 11000 was opened in the street-side room (Room 11) of property VIII.7.5; trench 12000 was located in the entire front room (Room 32) of VIII.7.7-8; trenches 13000 and 15000 were opened in the rear premises of VIII.7.9-11 (Rooms 56 and 55, respectively); and trench 14000 was opened within the *Porta Stabia* (fig. 1).

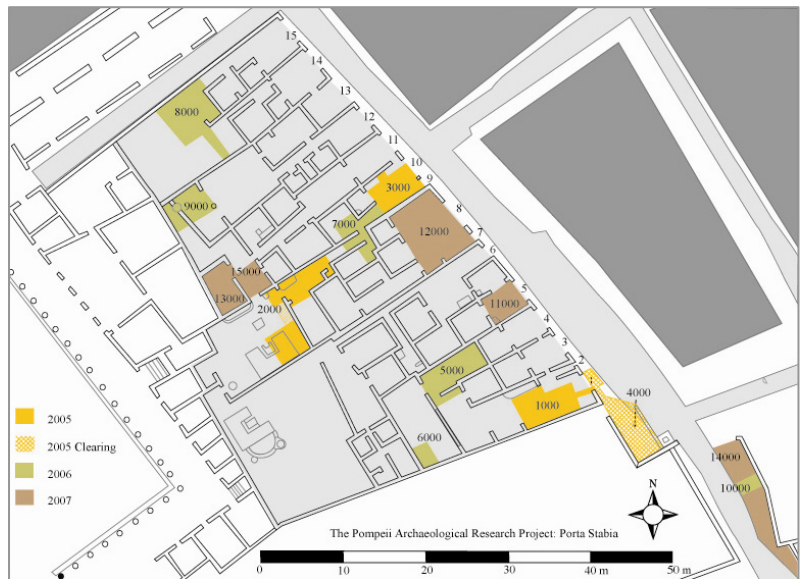
Fig. 1. Location of the trenches for each field season.

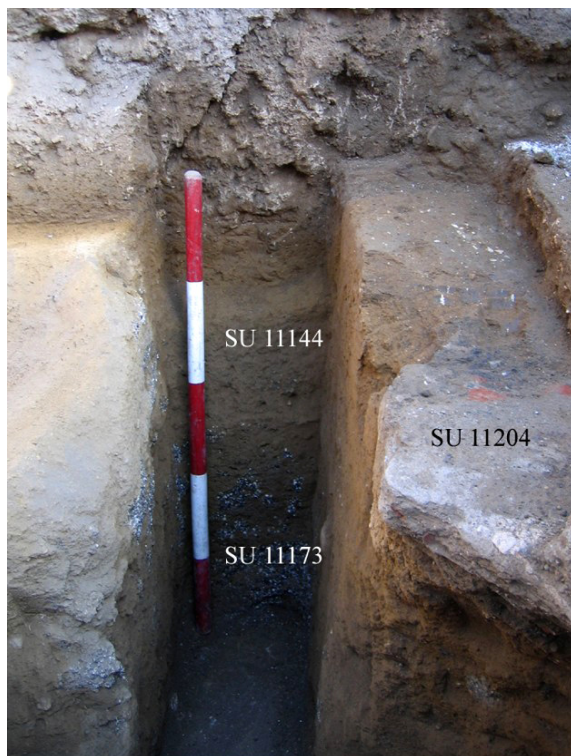
Fig. 3. Earliest sequence of deposits and surfaces for Trench 11000.

The earliest earthen surfaces in the area comprise at least three different floors, each topped by a smear of lime mortar (fig. 3 – SU 11204). No spatial definitions for the extent of these ephemeral surfaces were evident, nor did any physical connections with standing walls survive due to later subsurface developments in the area. As with most of these earliest layers in this dense urban neighbourhood, while we are able to recover them archaeologically, they more or less exist in stratigraphic isolation from later developments.

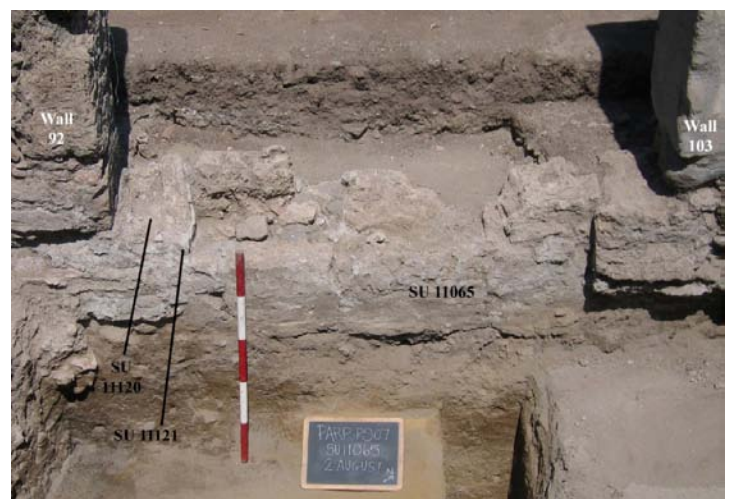
Fig. 4. Remains of the Phase 2 *opus incertum* wall (SU 11065).

It is in the second phase that we can detect evidence for the organization of the space which would essentially remain fixed throughout the subsequent history of the *insula*. The dimensions and boundaries of this square room at the front of the property were established and the packed earthen surfaces of the previous phase were cut for a long *opus incertum* wall (SU 11065) that was installed along the north side of the trench (fig. 4). The latest earthen surface of Phase 1 must have continued to have been used after the construction of this wall since we were able to identify that some of the very earliest wall plaster lipped down over it.

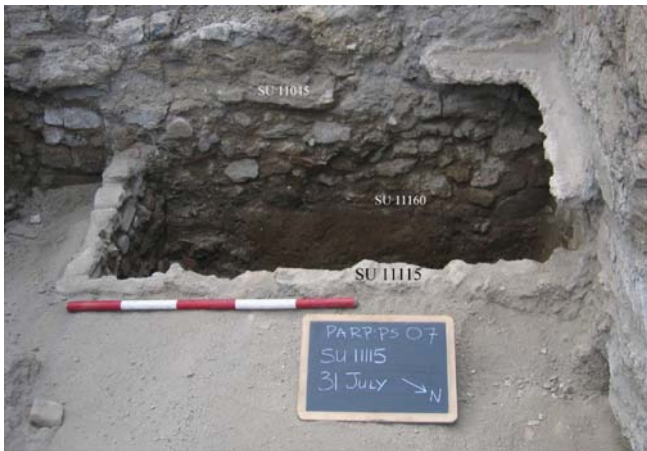
Fig. 5. The masonry tank that occupied the northwest corner of the trench.

A small tank was installed along the west (back) wall (WF 83) of the room in Phase 3 (fig. 5). It was associated with a new earthen floor and cut through all of the earlier earthen floors below it. A round pit of about a metre in diameter was also set into the very centre of the space that must have also been associated with whatever industrial or semi-industrial activity occurring here in this phase (fig. 6). The poor state of preservation for these features gave no indication as to what the tank or pit could have been used for, but unlike all of the other tanks we have found before, this tank never seems to have had any plaster lining.

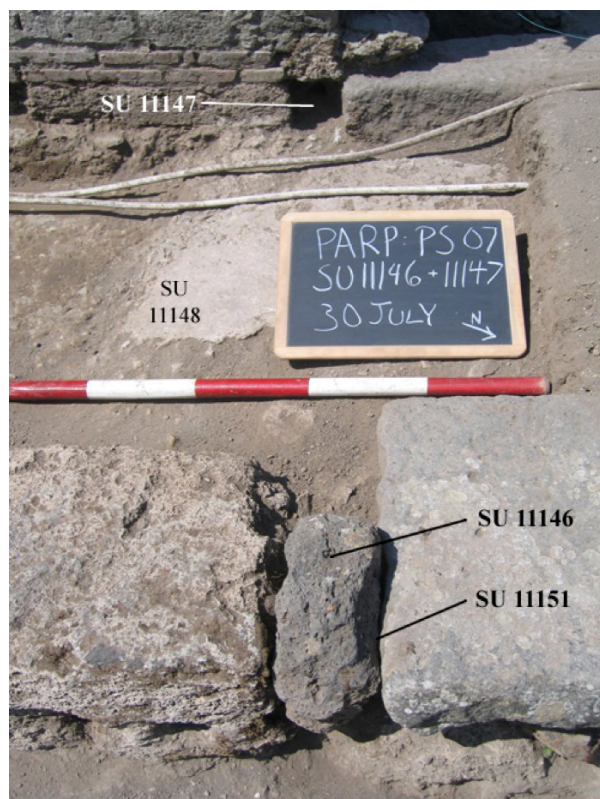
Fig. 8. The outlet of the Phase 5 drain from Trench 11000, through SU 11147, onto the *via Stabiana* (photo taken from the *via Stabiana*).

A drain was installed with the new *opus signinum* floor. This suggests a larger, property-wide reorganization including the course of the drain throughout the building. The channel for the drain issued from the property through a small gap (SU 11147) at the southern end of the threshold from the street (fig. 8). A corresponding notch had been cut into the sidewalk's curbstone to facilitate the flow of the liquid waste into the street.

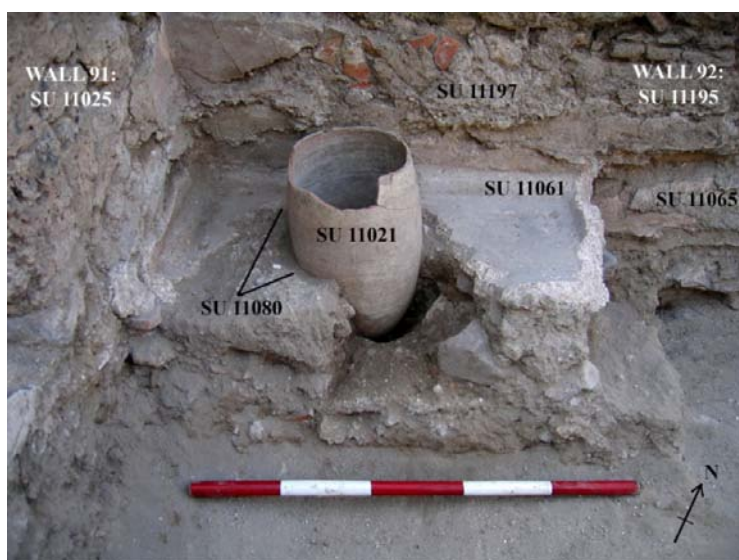
Fig. 9. The shallow *opus signinum* basin from Phase 5 in the northwest corner of Trench 11000. Note the Phase 6 installation of the amphora (SU 11021).

A very shallow *opus signinum* basin (SU 11061) was also installed with the new floor in the northwest corner of the room (fig. 9). There is no indication of what this basin may have been used for, but it will be present through the following phase.

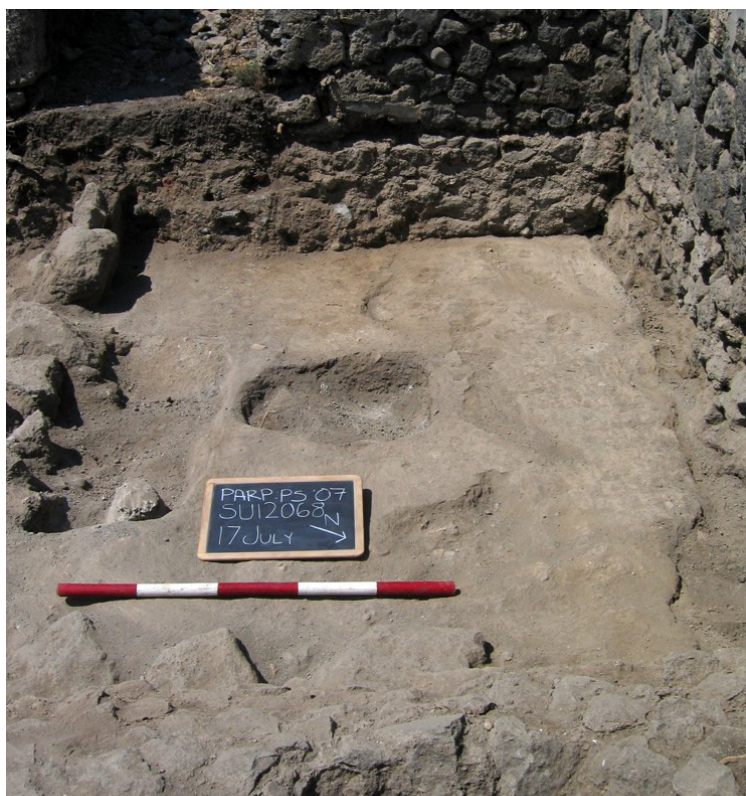
Fig. 11. The earliest earthen floor sequence found in the northwest corner of the room, and as partly defined by the remains of the shallow wall seen at the far left of the image.

Because of the lack of a construction trench, direct dating for this property wall was impossible except through associated contexts. The ephemeral remains of a small room with an earthen floor and shallow walls sat in the northwest corner of Trench 12000, all of which were also built directly atop the lava plateau (fig. 11). Pottery within this floor surface provided a *terminus post quem* of around the second half of the II century BC. It is not clear, of course, how long the property wall may have been standing before this early room was built.

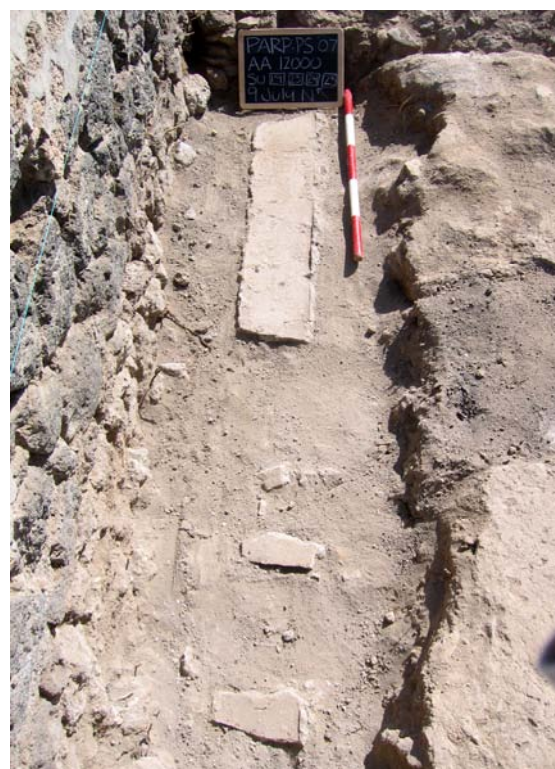
Fig. 13. The partial remains of the eastward flowing drain from Phase 3.

Another spatially isolated feature found during excavations was the remains of a long, well-made drain that ran eastward from the back of the property, along the northern property wall (WF 231), to empty onto the street (fig. 13). It was constructed mostly of plaster and a small amount of masonry. Another stretch of this drain was excavated in 2006¹³ where it illustrated how that area (Room 43 and the corridor, 42) had a clear connection with Rooms 44-46, at least, in the back of the property; these premises would eventually be absorbed into the property of the northern neighbour at VIII.7.9-11. Although this drain was likely in use while the tank from Phase 2 continued to be maintained, its construction certainly obliterated the small room from Phase 1.

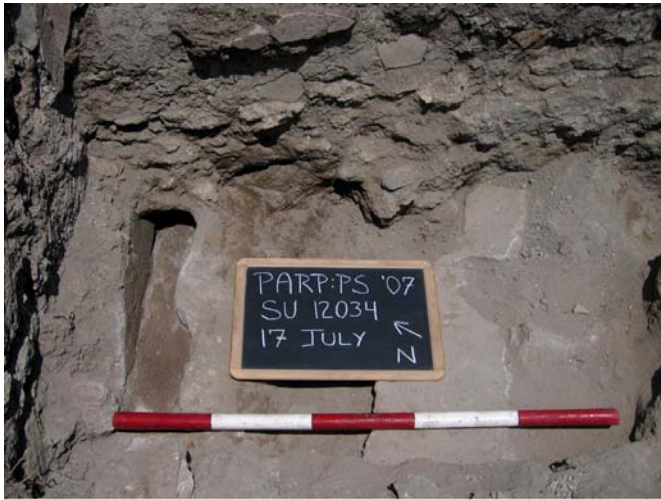
Fig. 14. The later drain, at left, from Phase 4.

Because the drain from Phase 3 was rendered inoperable once this property no longer maintained access to the origin of that drain, another less substantial drain fragment was found above those remains of the earlier drain in the northeastern corner of the room (fig. 14). While this feature was considerably incomplete, its presence may suggest that there was some continuity between Phases 3 and 4 in the room before the wholesale switch to commercial activity in the next phase.

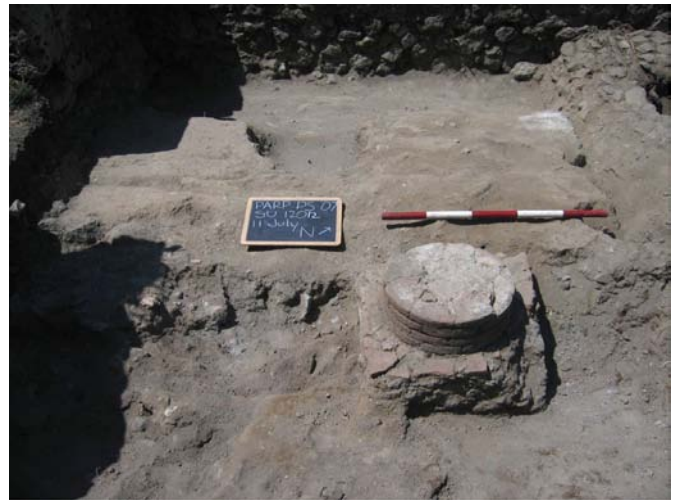
Fig. 15. The column base from toward the centre of Room 32.

It was also in this phase that a single column was installed in the centre of Room 32, with a diameter of 0.45m, and preserved to a height of about 0.2m. The column was built of brick and sat on a mortar base, surviving until 79 CE (fig. 15).

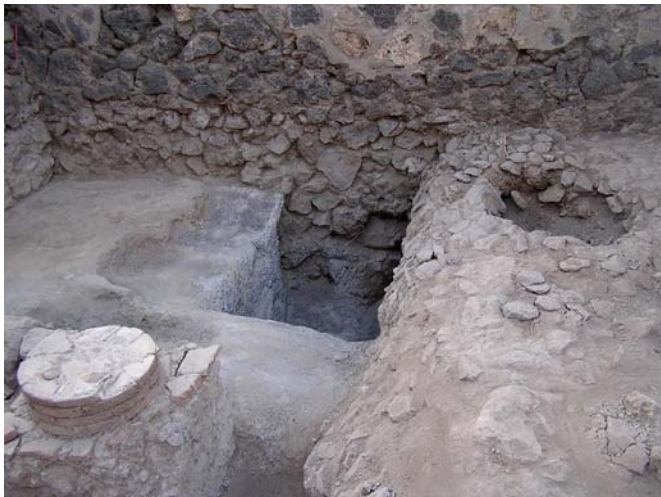
Fig. 16. The remains of the cistern, at right, as built against the northern wall (WF 231) of Room 32.

The northern property wall of Trench 12000 (WF 231) was built directly atop the lava plateau foundation that exists across this area of Pompeii (see fig. 16). Built of *opus incertum* it did not possess any discernable foundation trench – probably given the hardness of the bedrock – but clearly represents the earliest substantial construction for this area, and possibly for the *insula* itself since this wall also represents a major long-standing division in the neighbourhood, neatly dividing the entire *insula* in half. This wall also was the most enduring feature that would determine the subsequent developments within Trench 12000.

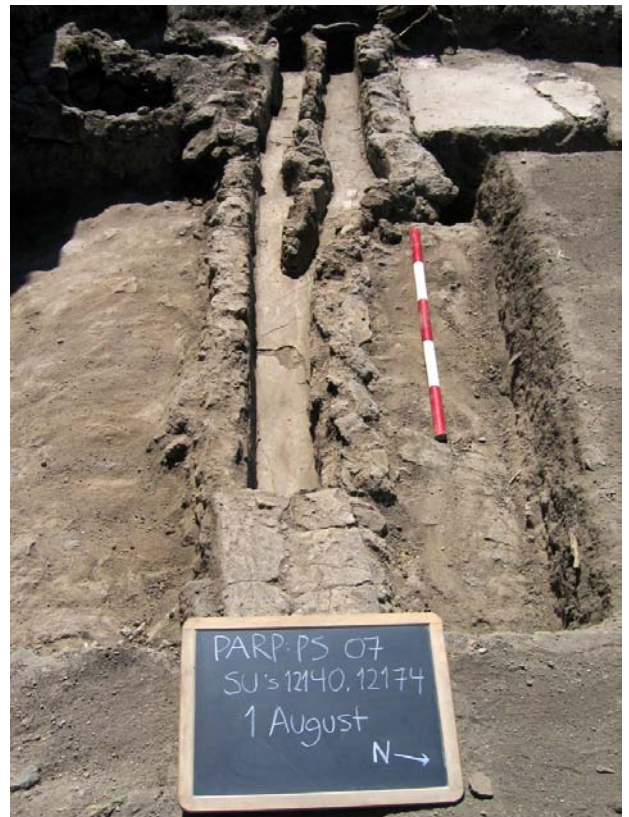
Fig. 17. The double-drain from Phase 5.

Constructed directly on the *opus signinum* surface, but seemingly still part of this general phase, an equally impressive double-drain ran from the back of the truncated property eastward along the southern corridor of the property to the *Via Stabiana* (fig. 17). One channel had a terracotta pipe access hole that could funnel liquid directly into the southernmost cistern via its single access hole. The second channel – constructed later than the first, but probably as part of the same general event – ran alongside the first before joining it beyond the access hole to the cisterns, flowing as a single channel into the road (fig. 18).

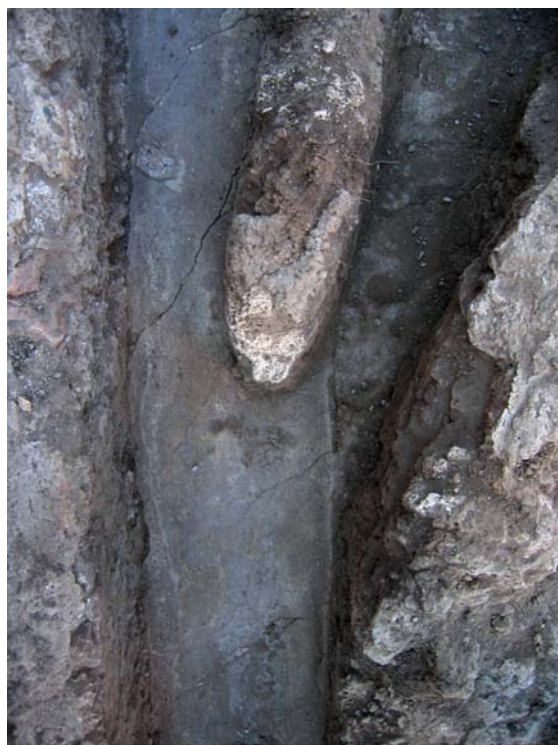
Fig. 18. Detail of the later attachment of the second drain, at right.

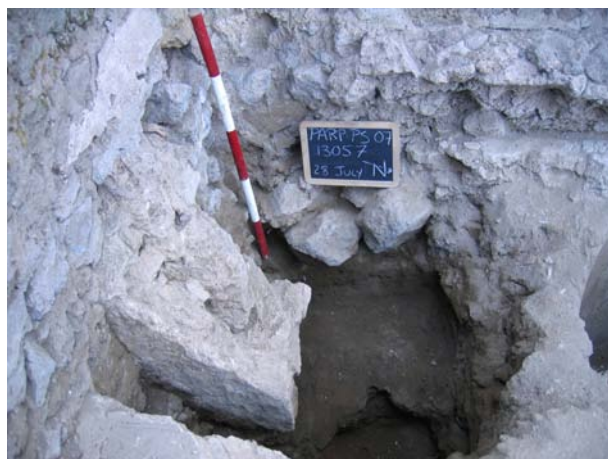
Fig. 20. Remains of the early Sarno stone wall from Phase 1.

Only a small part of a north-south aligned Sarno stone wall survives to represent the earliest phase for both trenches. This wall was discovered under the southern wall (WF 332) of Trench 13000, cut into natural soil (fig. 20). Some hard packed clay that was found in association with the wall stub might suggest an associated floor surface. Although a construction trench was revealed, none of the few artefacts recovered from it were of any assistance for dating the wall's construction. A cleaning of the area to the south of this room, Room 46 in property VIII.7.7-8, revealed that the wall likely terminated at the (later) property division of WF 332 and so did not extend further south. The wall projected about 80cm north from its junction beneath the later WF 332 but was sheered off during building activities for the following phase.

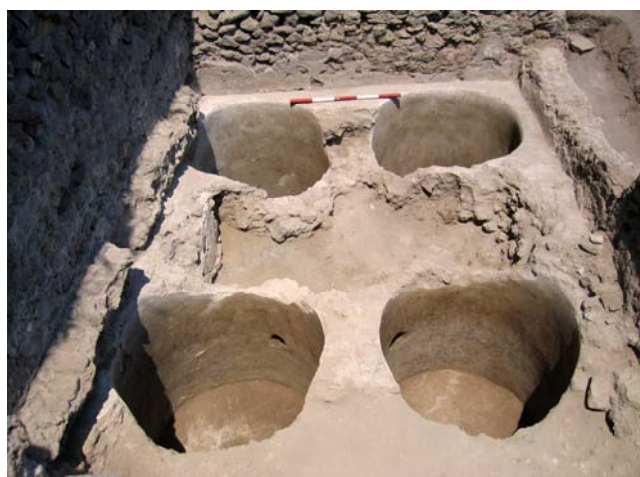
Fig. 21. The arrangement of the four circular tanks that occupied the northern portion of Room 56.

With the *Quadriporticus* built, a large industrial operation was installed against this back wall of the property, configured as a room (Room 56) now for the first time with the construction of the three other walls of Trench 13000 (WFs 331, 332, 334; see fig. 19). Four large circular tanks (each measuring close to 1 metre in diameter and about 1.4m in depth) were installed, arranged in pairs in a cloverleaf pattern, lined with plaster, and occupying the northern two thirds of Room 56 (fig. 21). Each had footholds built into the side walls to facilitate access, while a walking platform ran between them and along their southern limit (fig. 22). The room now functioned as a tannery (*conceria*), and this identification marks it as only the second known tannery in Pompeii¹⁹, and one of only five in all of Italy²⁰.

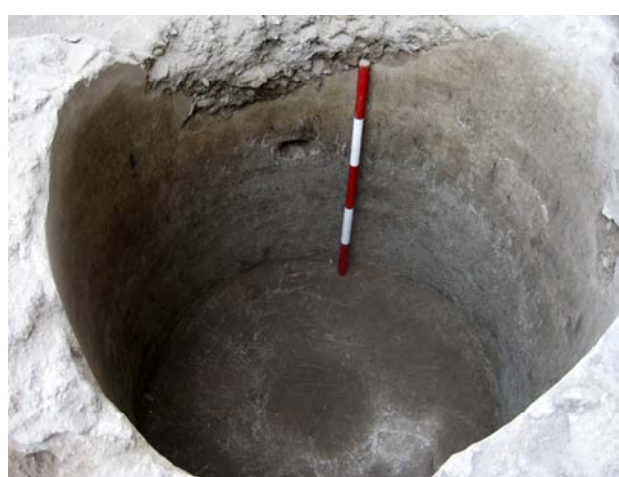
Fig. 22. Detail from the inside of one of the tanks. Note the 'foothold' built into the side wall.

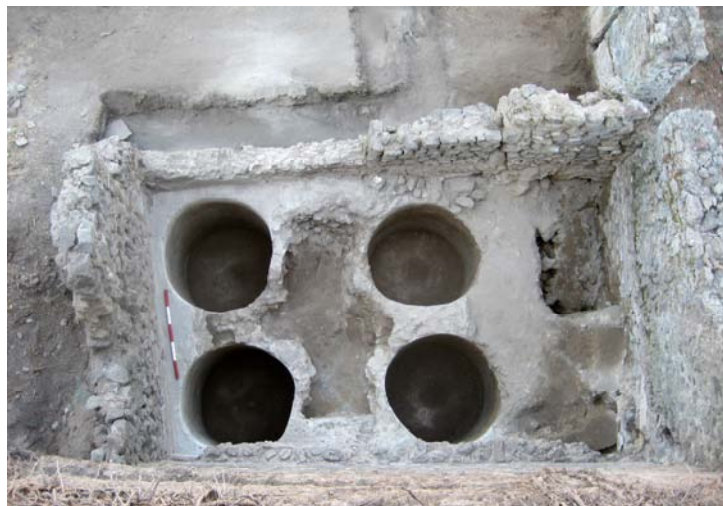
Fig. 23. Aerial view of Room 56, illustrating the primary features from Phase 2: the four tanks, the stone-lined rectangular tank (top right of room), and the original (although blocked in Phase 3) doorway.

Associated with these tanks was a rectangular stone-lined tank, located in the southeast corner of Room 56 (figs. 23-24). A drain ran from this tank through WF 331 to connect with another drain in the room to the east (Room 55 in Trench 15000), thereby linking the phases and activities of each room, which is to be expected given that space, otherwise unavailable in Room 56 because of the tanks, would have been necessary to prepare the skins for tanning. Access between the two spaces was through a doorway in the centre of WFs 331/329, which would eventually be blocked in the following phase (see figs 23 and 25).

opus signinum floor that extended across the entire room. The small doorway was blocked up and to the north of it a larger doorway was opened into Room 56 (see fig. 23). This wider entrance was now aligned with the long central passageway through the property and, as a result, visually connected with the street. It was in this phase that the owners of this property probably acquired the rear suite of rooms at the back of the neighbouring property to the south at VIII.7.7-8 (Rooms 42-47, at least)²². The area of Trench 15000, for which all of the (industrial) features were also sealed by a fine *opus signinum* floor in this phase, was converted into a passageway with access into the southern garden and dining space (Room 46) that was complete with a masonry *triclinium* couch, water displays, and a kitchen²³.

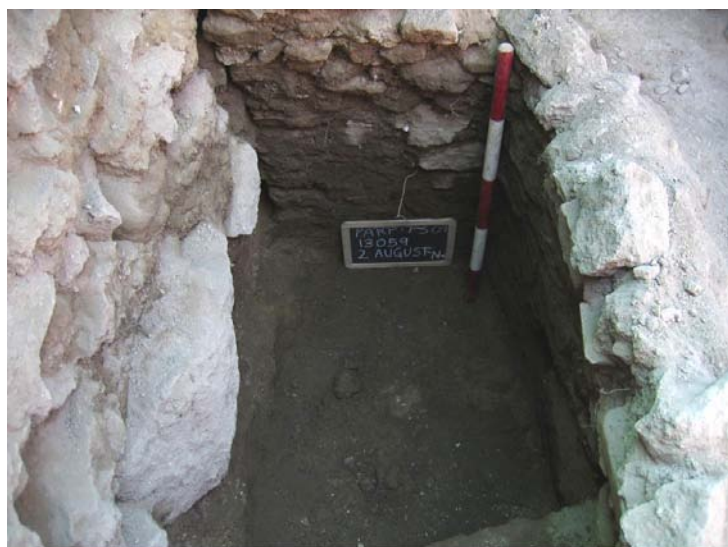
Fig. 24. Detail of the rectangular tank from Phase 2.

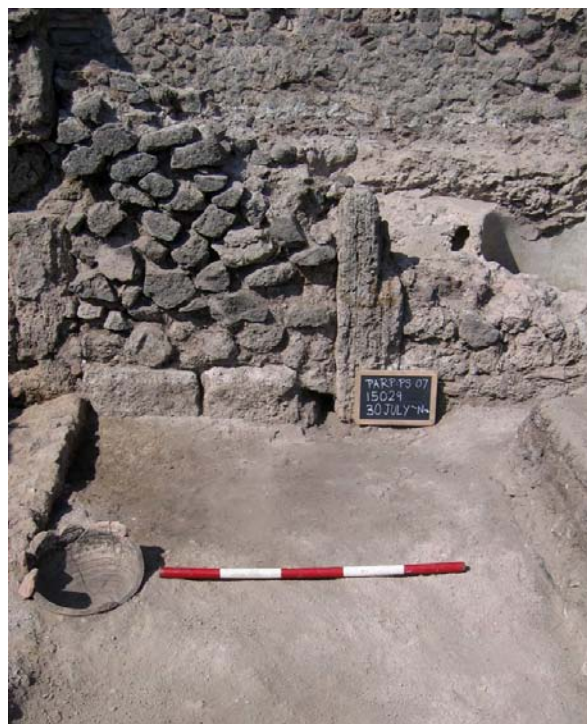
Fig. 25. The original mortar floor of Room 55. Note the original doorway into Room 56, later blocked.

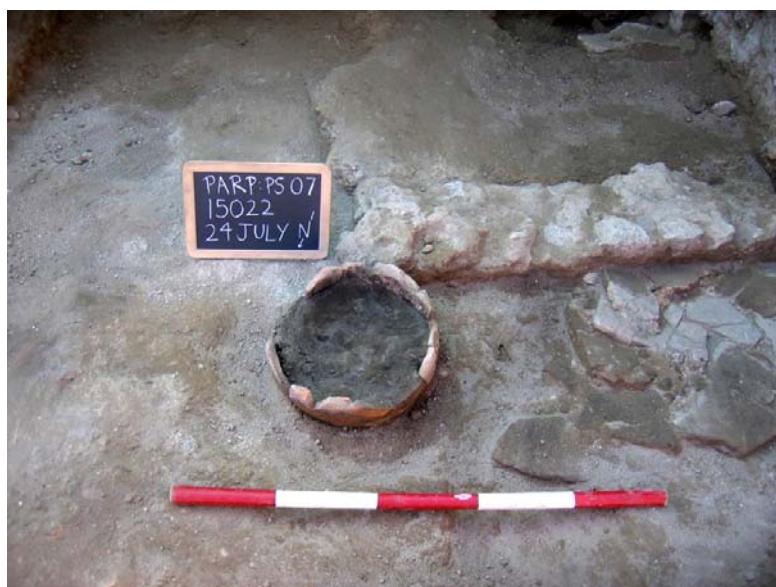
Fig. 26. The pitch-sealed amphora base sunk into the earliest floor of Room 55.

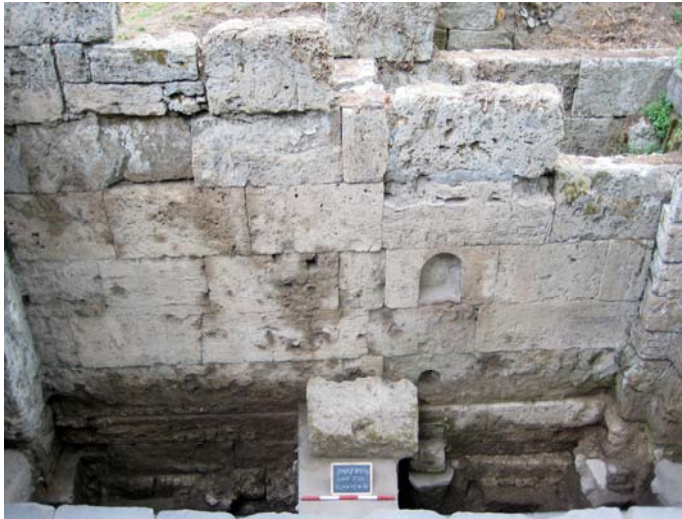
Fig. 28. The northern length of Trench 14000, abutting WF 528.

The activities of Phase 2 were dominated by the construction of the Sarno limestone fortification wall (WF 528; see fig. 28) and the first phase of the gate. Substantial foundations were first created to support the monumental architecture. These foundations consisted of three alterna-

The surface that had bisected the altar was then cut for the foundation of a new arched gate (that which is present today) during the early Roman period of occupation. This foundation was of *opus incertum*, and built directly on top of the earlier configuration for the gate, as mentioned above, as well as the second tier of Sarno foundations for WF 528. This event, which might be considered a ‘monumentalising’ effort by the Roman colonists, caused the altar to be completely sealed by the raising of the *opus signinum* sidewalk in this area²⁹. The religious significance of this space, however, was not abandoned in this process. Rather, a larger (religious) niche was cut into the wall, and at a higher level consistent with the raising of the sidewalk (see fig. 28).

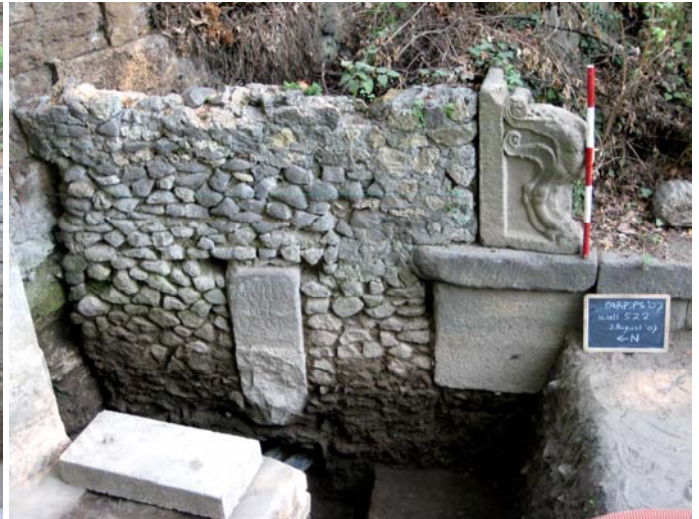
Fig. 29. The southern extremity of Trench 14000 and the northern limit of the tomb of Marcus Tullius (right).

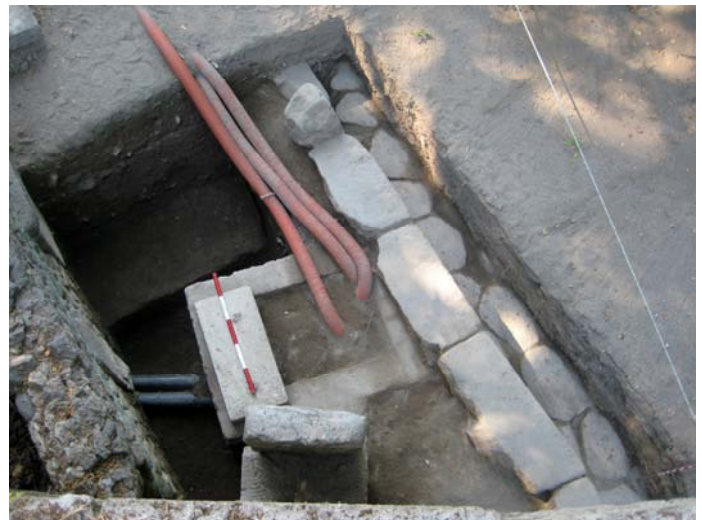
Fig. 30. Aerial view of the southern extent of Trench 14000.

Several modern pipes that were encountered in Trench 10000 during the 2006 excavation season were found to be even more obtrusive through Trench 14000 than we had originally imagined. While the pipes ran along the entire length of the sidewalk curbstones, as had been expected, at the southern limit of the trench these pipes entered a large utility channel/manhole from where they turned eastward to cut through WF 522. As a consequence, only a small portion of stratified contexts remained *in situ* in the southern limit of the trench, therefore greatly impeding our potential to yield information on the stratigraphic relationship between the *Porta Stabia* and the construction of the tomb of *Marcus Tullius* (fig. 30).

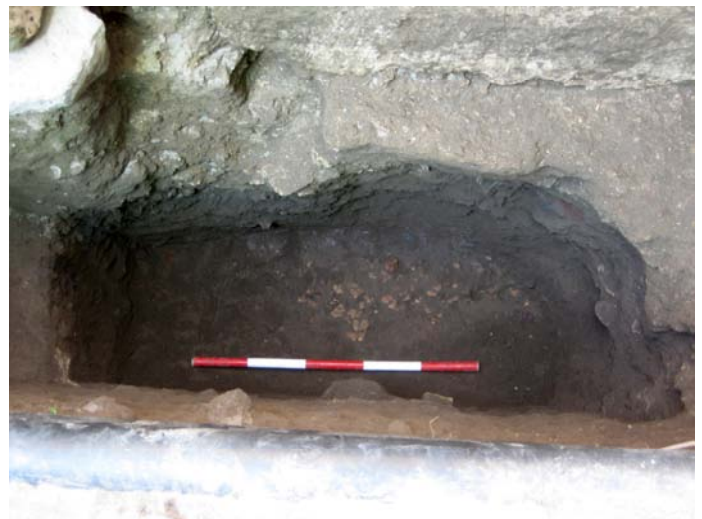
Fig. 31. Small patch of the earliest recovered surface in Trench 14000.

The earliest phase of activity consisted of a hard-packed earthen surface that predated the construction of (the present standing version of) the *Porta Stabia* (fig. 31). Granite pebbles were embedded into a thin layer of clay to form this surface. Given the depth of this surface below the modern ground level (close to 3 metres), only small patches of it were revealed, and from which no datable materials were recovered. Excavations through this surface revealed a deep section of sterile soil to confirm that this surface represents the earliest known activity. The only sign of activity associated with the surface was the cutting of a pit. The homogeneity of the pit's fill, which consisted of sand/silt, suggests it may have served as a post-hole.

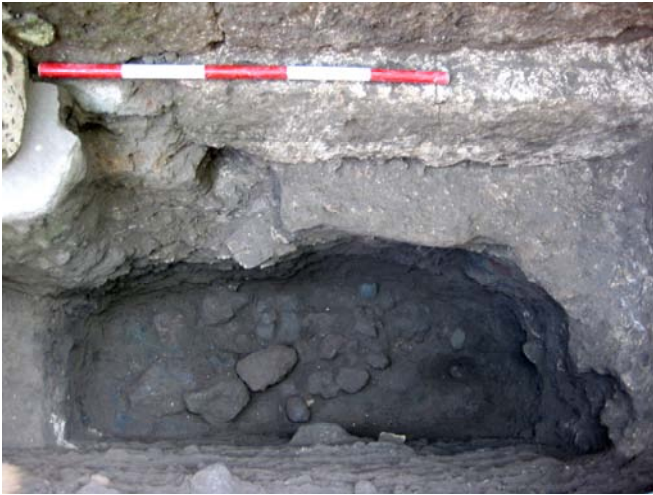
Fig. 32. The first foundation layer for the construction of the Porta Stabia.

ting layers of lava stones and sand/silt. The first of these layers, which incorporated the largest lava stones of approx. 20cm diameter, was laid directly onto the earthen surface from Phase 1 (fig. 32); if a construction trench existed, no evidence for it could be found within the confines of this trench. These lava stones were then levelled with a deposit of sand/silt, onto which a second layer of smaller lava stones were laid. This second level was equally topped by sand/silt for a third layer of yet smaller lava stones. Three levels of large Sarno limestone blocks were built directly onto the foundation in a tiered, or slightly stepped, formation. The upper portion of the wall (WF 528) was then built onto this stepped platform.

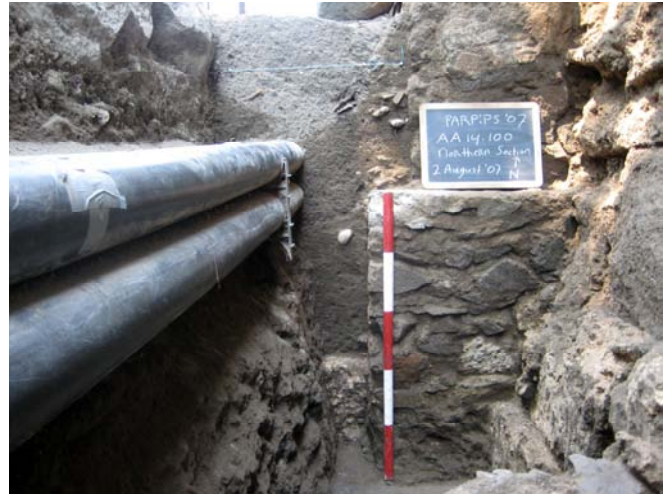
Fig. 33. The limited remains of the projection of the east-west course of Sarno limestone.

Associated with the construction of WF 528, an east–west running course of Sarno limestone was laid perpendicular to the northern terminus of WF 528, corresponding to the level of the lowest course of foundation stones for WF 528 (fig. 33). This likely represents the foundation for the original gate itself, which would later be rebuilt for the arched gate that stands today (see Phase 3, below). It is noteworthy that the alignment of the later version of the gate would be exactly the same as this earliest version, and so somewhat skewed toward a southwest–northeast alignment from that of the fortification wall and the street itself.

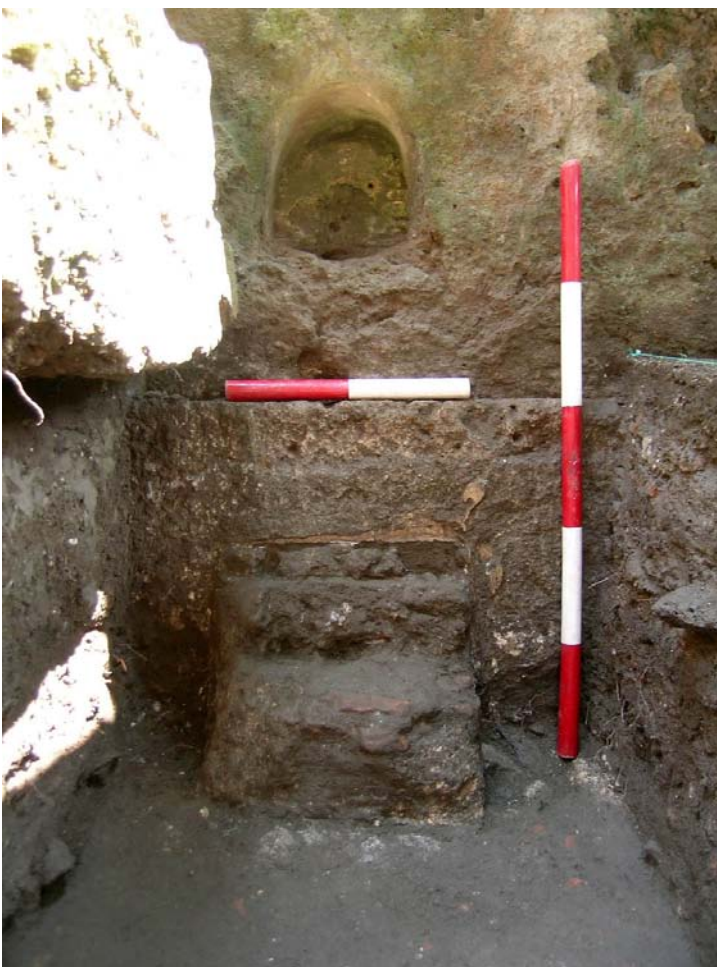
Fig. 34. The first installation of the altar and niche in the eastern side (WF 528) of the Porta Stabia.

It was in this phase that the altar and small lower niche discovered in Trench 10000 during the 2006 season were installed (fig. 34)²⁷. A semicircular feature of mortar and masonry might also have been built at this time, or a little earlier, against the second tier of Sarno limestone for WF 528, a little over 1 metre to the south of the Sarno limestone projection

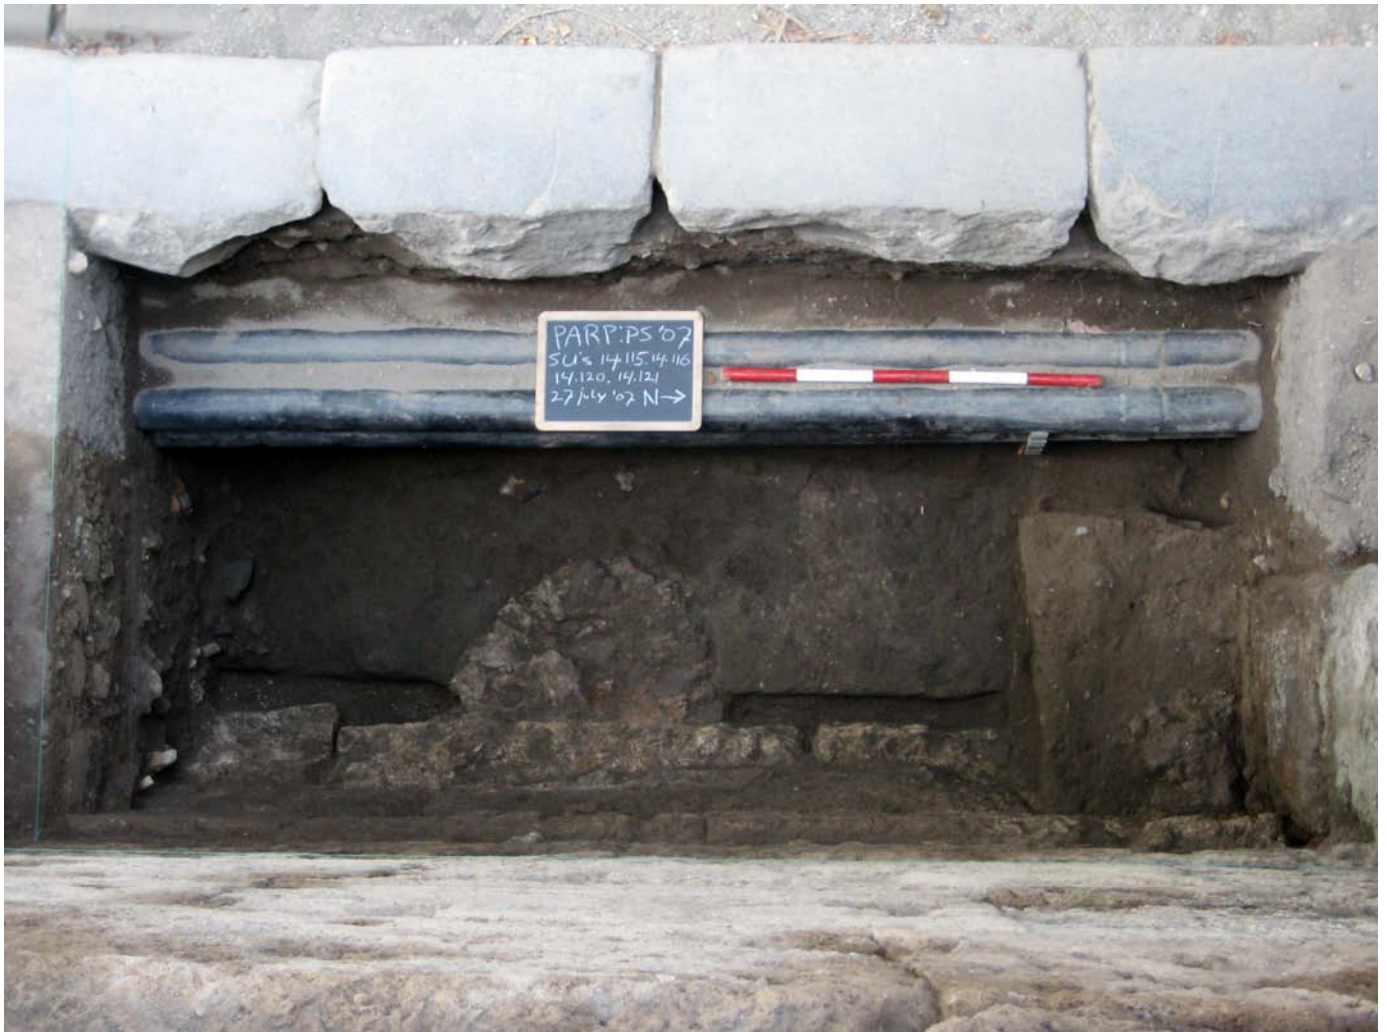
Fig. 35. Semi-circular masonry base (against WF 528) for an as yet unknown purpose, but probably associated with the operation of the gate.

of the gate (fig. 35). This feature might therefore have been laid for a device associated with the operation of the gate itself. This feature had an associated beaten earth surface that was replaced during this phase by an *opus signinum* surface of which small traces survived against WF 528.
