The 2011 Field Season at I.1.1-10, Pompeii: Preliminary report on the excavations

Steven J.R. Ellis, Allison L.C. Emmerson, Amanda K. Pavlick, Kevin Dicus, and Gina Tibbott

This article provides a preliminary report on the 2011 excavations undertaken by the University of Cincinnati's 'Pompeii Archaeological Research Project: Porta Stabia'. This was the 7th season of excavations for the project at Pompeii, during which four trenches were excavated within four separate properties across insula I.1. The report focuses on the stratified sequences uncovered in each trench, and outlines the phases of activity and how some of these relate to the development of other parts of the buildings already excavated by the project throughout insula I.1, as well as to the results from our excavations on the other side of the via Stabiana at insula VIII.7. The earliest sequence of activities begins in the 4th century BCE, with major developments occurring in the second half of the 2nd century BCE (the establishment of the standing buildings), the Augustan period (the replacement of light-industrial spaces with retail), and the last decades of habitation (the recovery from the earthquake/s).

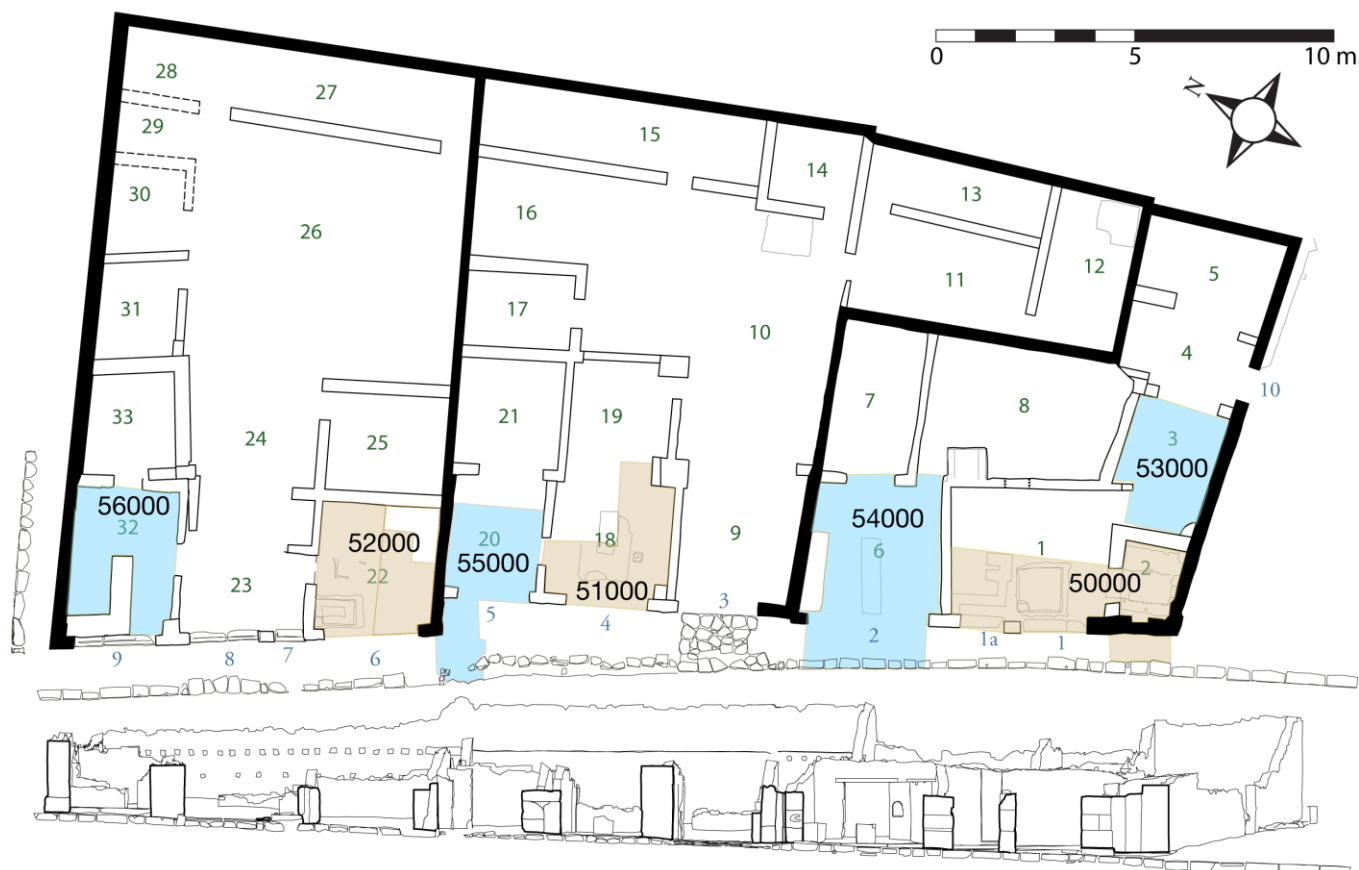
Fig. 1. Location of 2011 trenches (in blue) in I.1.1-10.

The project opened four trenches across I.1.1-10 in the 2011 field season (fig. 1). Apart from allotting one trench for each property, the location of each trench was targeted to build upon our understanding from the 2010 season of the chronological development of each property. Thus we continued to privilege either the frontages and/or the spaces that incorporated a property boundary; our excavations over the previous six seasons have demonstrated that such areas typically provide the most information on a property's structural developments and its various activities. Trench 53000 was opened in the room (Room 3) that constituted part of the southernmost boundary to the property at I.1.1/10 and thus to the *insula* itself; Trench 54000 was located in the street-side room (Room 6) of I.1.2, a property whose standing architectural delineation suggested that it had originally been a part of

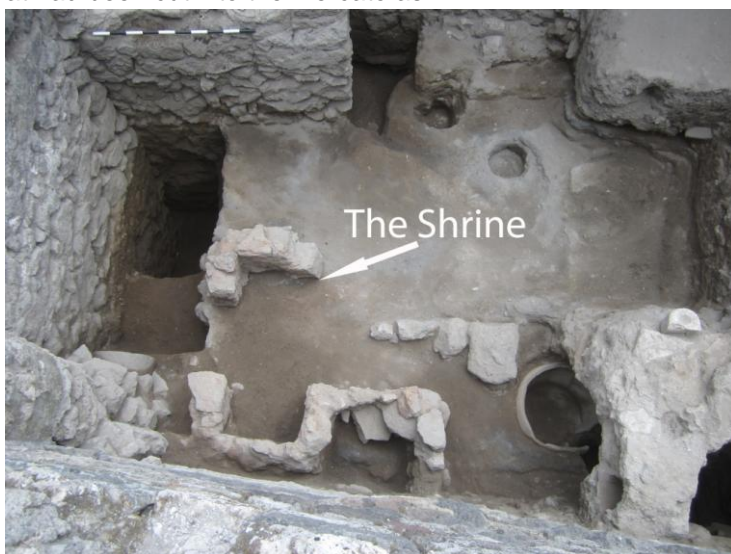
Fig. 3. Structural remains of the 'shrine'.

top of the latest of the Phase 1 surfaces (Phase 1c). Its form was that of a 'T', oriented E-W (fig. 3). At the western edge, a small doorway gave access to the interior. The structure ended suddenly at the east, destroyed by later phases of activity; construction during Phase 6 erased any evidence of an eastern extension to the feature, while the Phase 4 construction of the southern wall (WF 1006) destroyed the structure's southern trajectory. At what is now the eastern extent of the preserved portion, large stones formed a squared shelf that might be identified as an altar. To the east of this, a large krater was set within a pit that had been cut into the Mercato ash.

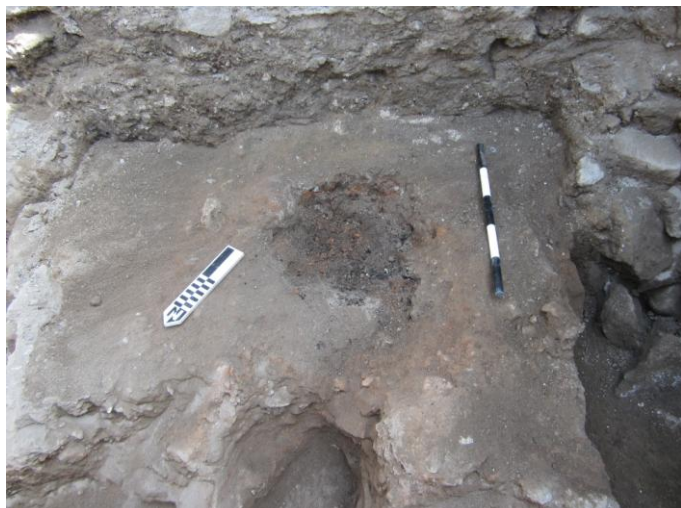
Fig. 4. Votive pit dug into destruction debris and rubble that covers shrine.

The end of Phase 1 was marked by the destruction of the sacred area. The interior fill pointed to unintentional burning as the cause of the structure's collapse. Ash deposits were uncovered on the floor, and the terracotta fragments and the standing walls exhibited heavy burning. Rubble from the collapse appeared to remain where it fell; perhaps the sacred nature of the site precluded the obligation to clean it up, and the remains were covered. A final ritual enacted over the now-covered remains attests to the continuity of the site's sanctity: worshippers dug a pit into the fill and rubble to dedicate a burnt offering (fig. 4). We were able to recover among the

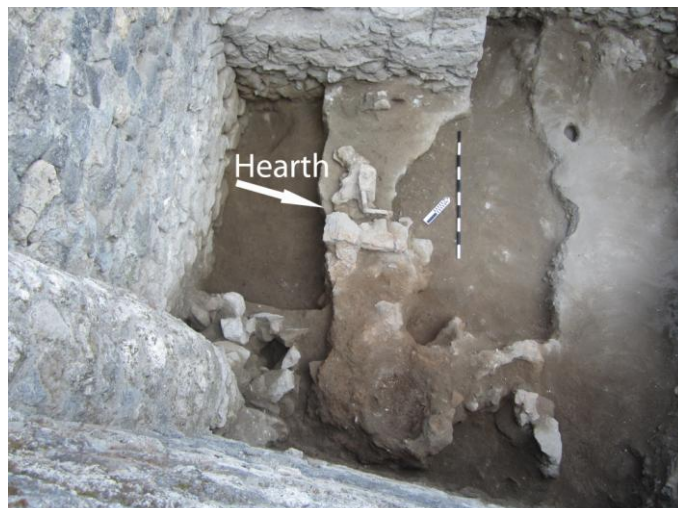
Fig. 5. Phase 2 surface and cleared remains of the hearth (above), abutting debris and rubble of the remains of the shrine from phase 1 (below).

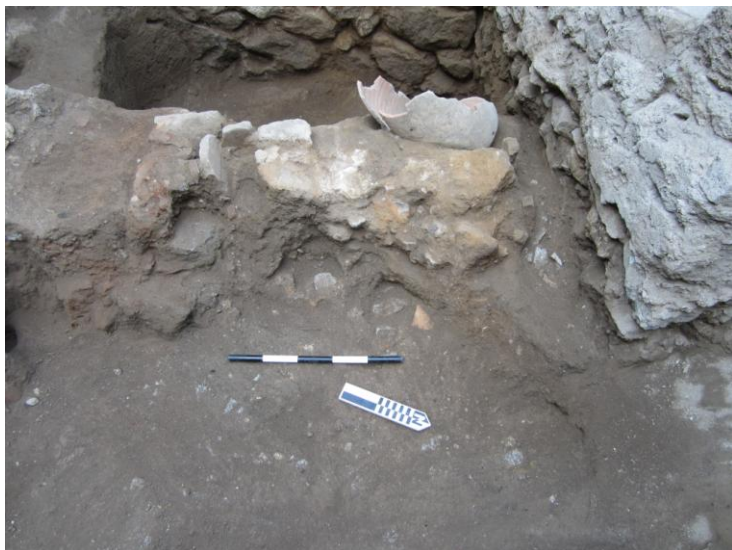
Fig. 6. Remnants of the hearth with ash in situ and Phase 3 soak-away above.

A hearth (0.95m N-S x 0.60m E-W) was built into the hard-packed surface, the remains of which consisted of large terracotta tiles that were set vertically into the surface in a 'U' shape open on the east side (fig. 6). Within the hearth a substantial deposit of wood ash attested to the large amount of burning that occurred within it.

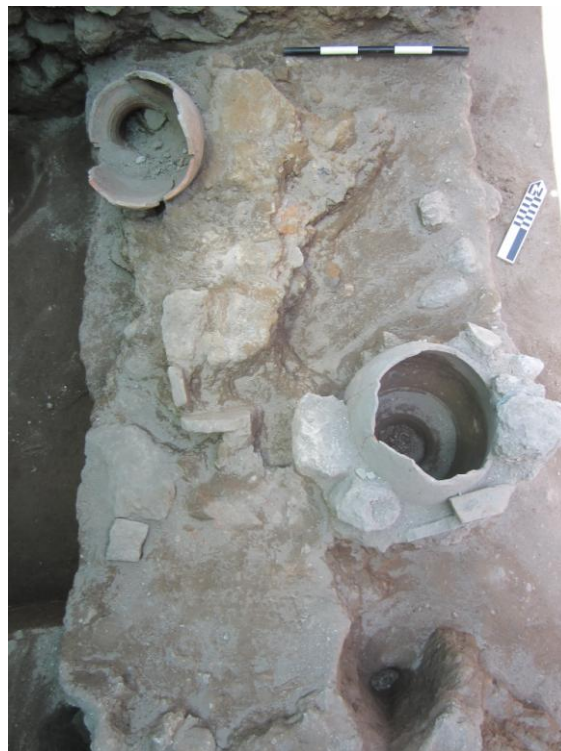
Fig. 7. The two soak-aways associated with the Phase 3 surface, set over and into the Phase 2 hearth.

The construction technique for this surface, as well as the two soak-aways that were found set into it, indicate something of its function in the eastern approach to the public well (fig. 7). It was of a very rough and porous consistency, being made primarily of terracotta fragments. This may have helped in the drainage of spilled water from the well. The two soak-aways also suggest the presence of large quantities of water. The upper halves of both fixtures were sheared off during a later phase (Phase 4), but their placement still provides information regarding their function. One was located against the northern wall, below the phase 4 doorway connecting Rooms 1 and 3, and was set at a 45-degree angle bearing south so that the opening faced away from the wall itself. The second soak-away was found in the centre of the surface, far from any wall. Environmental analyses of the fills within the soak-aways detected mammal bones, fish bones and scales, bird eggshells, and marine shells.

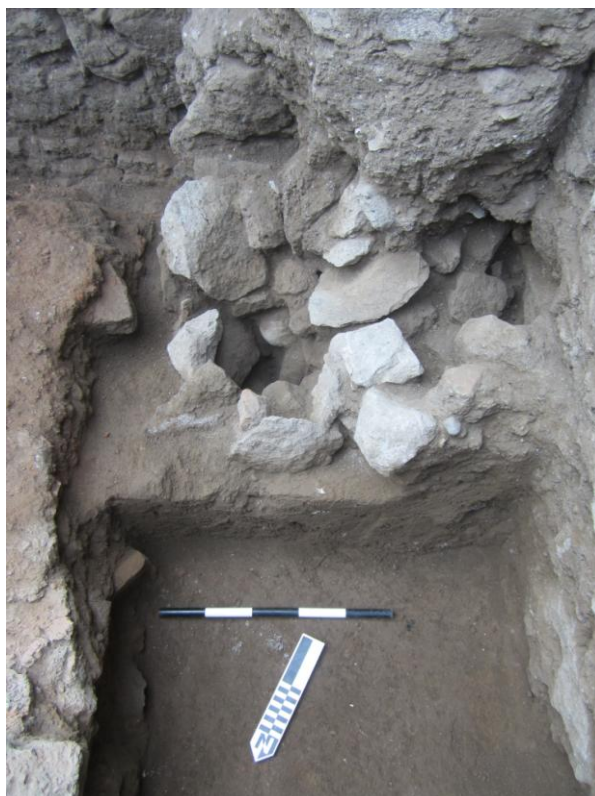
Fig. 8. Stone-lined drainage pit in southwest corner of the room.

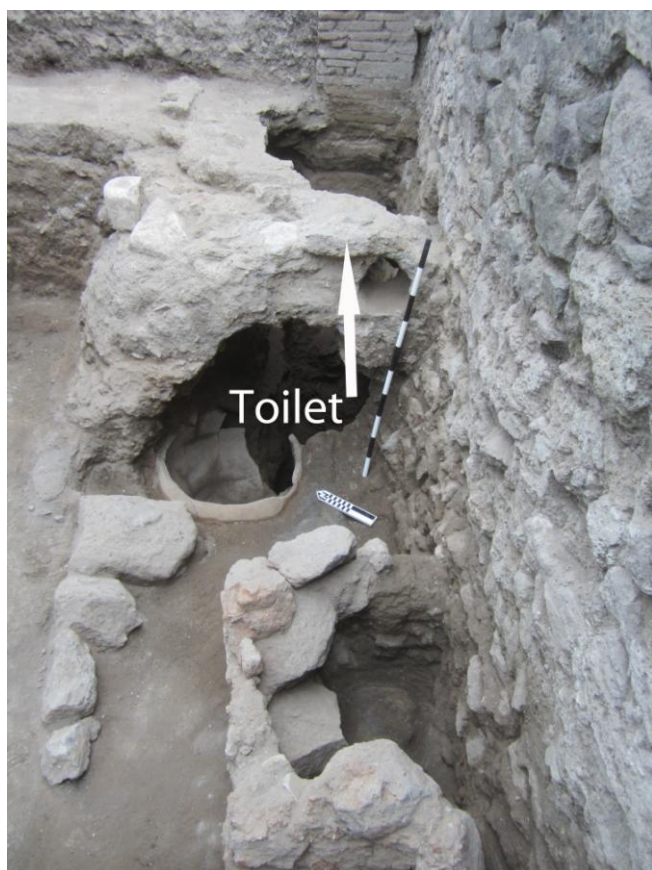
Fig. 9. The interface of the toilet and the Phase 1 shrine. Note that the construction of the toilet cut through the eastern extent of the shrine.

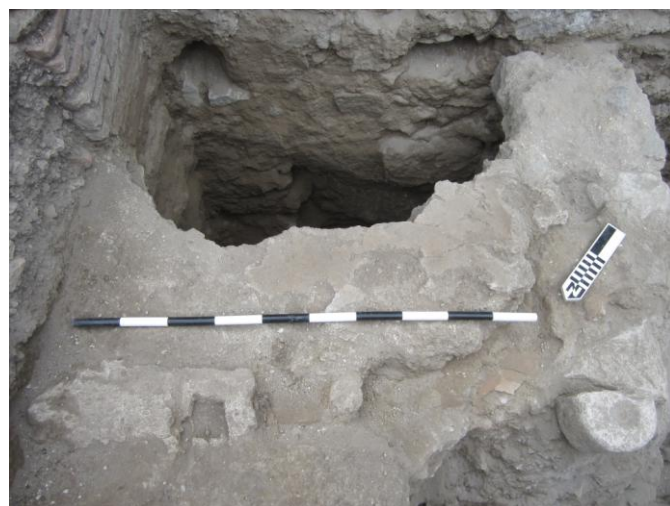
Fig. 10. Toilet opening with surrounding *opus signinum* flooring and remnants of the wall that enclosed the toilet.

While a 10cm thick mortar flooring was found within the small space surrounding the opening (fig. 10), the flooring for the remainder of the room was of *opus signinum* (12cm thick) during this phase. Modern disturbance erased remains of the surface over the majority of the trench, with the exception of the corners where traces were found lipping up against the walls. Along the western edge of the room, a larger strip of the *opus signinum* flooring (0.7m E-W x 1.6m N-S) was found just north of the enclosed latrine, laid on top of the fill of the construction trench.

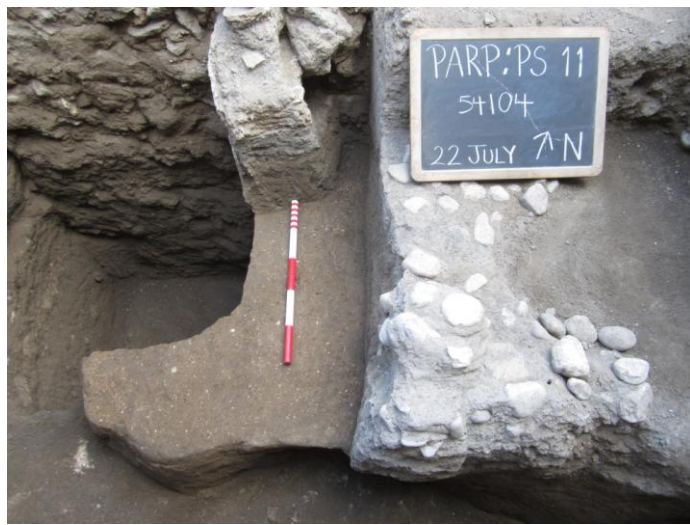
Fig. 12. The Phase 1 surface to the left, overlain by the Phase 2 cobblestone surface (at right).

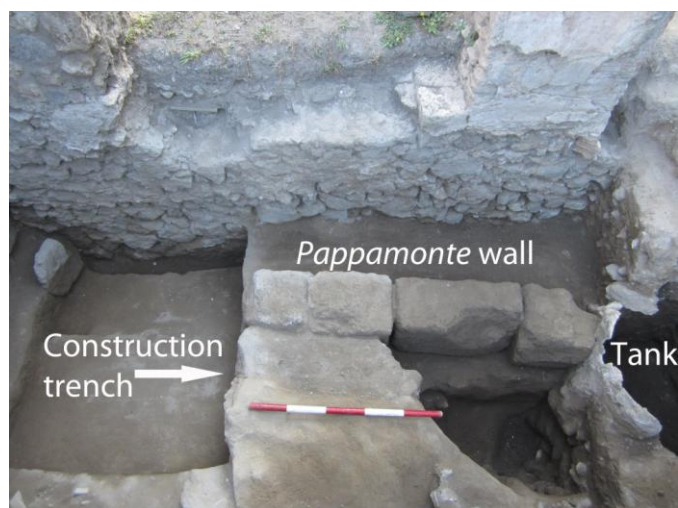
Fig. 13. Foundations for the Phase 2 pappamonte wall. Note also the partial, circular remains of the Phase 3 tank, at right.

In the northeast of the trench, the foundations of a pappamonte wall were recovered (fig. 13). Extending about 2m, and of three distinguishable blocks (each measuring approximately 40cm high, 36cm wide, and 75cm long; the third block was cut short by later activities), this foundation course represents one of the better examples of 4th century BCE architecture that has ever been found in this area of Pompeii²⁶. These foundations were laid within a construction trench that was cut running N-S into the road or sidewalk surface from Phase 1. A second, but mostly lost, section of pappamonte foundations was uncovered just to the north of the first, but little more can be known of its alignment or trajectory due to its poorly preserved state.

The regularity in the construction of these pappamonte foundations is worth detailing. The regularly-sized blocks (approx. 36cm x 40cm x 75cm) were laid into a neatly cut construction trench with surprisingly straight sides and a flat base (fig. 14). Rather than being surrounded by fill on all sides, the blocks occupied approximately one half of the construction trench, braced against the cut's eastern edge, with loose packing material filling just along the western side of the foundations. This fill contained many off-cut chips of pappamonte, as well as a handful of artefacts, all of which dated to the 4th century BCE or earlier.

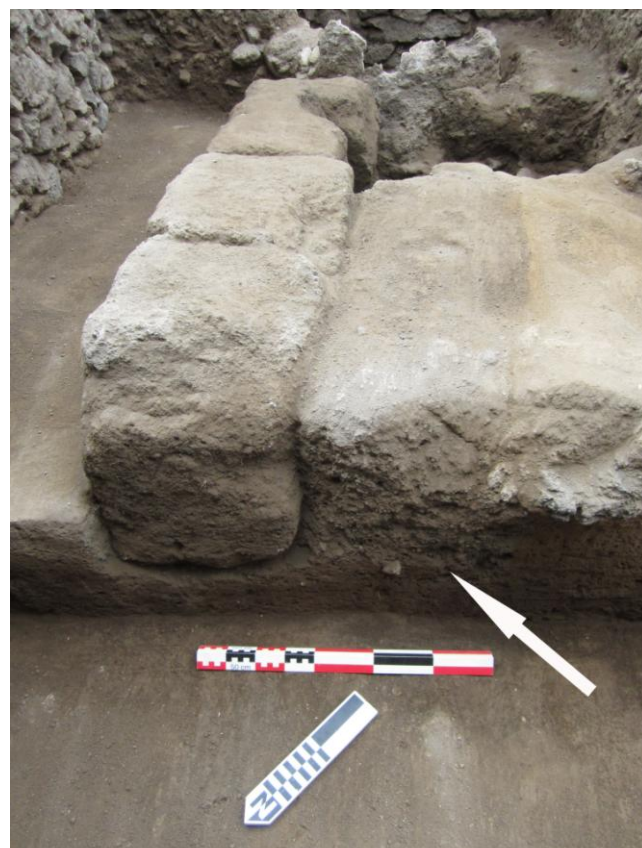
Fig. 14. Detail, in cross-section, of the construction trench for the pappamonte wall and its construction fill (at right).

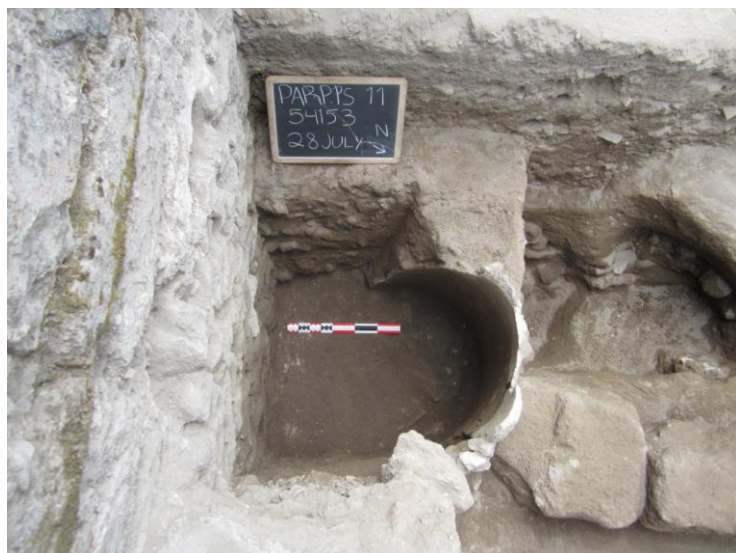
Fig. 15. The remains of the Phase 3 circular tank, viewed from above. Note how the architecture from Phase 4, at left, cuts through part of the tank.

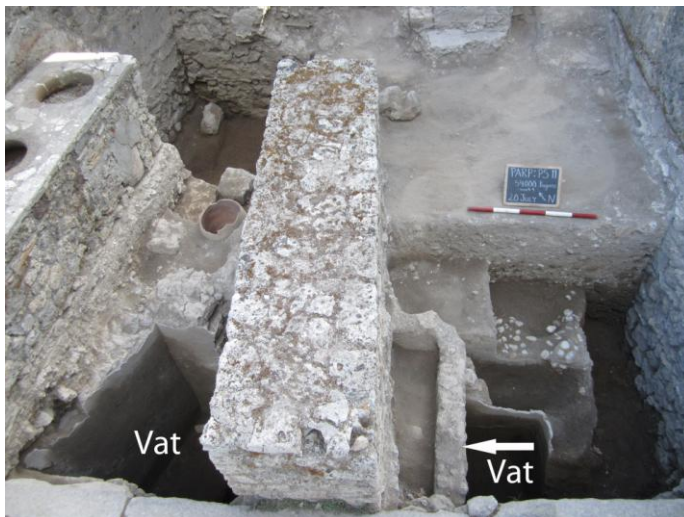
Fig. 16. Fish-salting vat in the foreground, beneath the later (Phase 7) counter.

A yet more distinct change toward retail space for this room becomes apparent in Phase 7 by the construction of two masonry counters (figs 16-17). In the first instance a new mortar floor was laid over the last. Although this new floor was only visible in small fragments, this was enough to demonstrate that the replacement surface was of a seemingly poorer quality than the preceding surface. About 5cm of fill was covered with a few cm of mortar, and the counters were built directly on top of this new surface. The two structures were I-shaped, which is itself unusual (see Phase 11 of Trench 56000, below, which also had an I-shaped counter)³⁶. One ran parallel against the northern wall (WF 1072), measuring 0.92m wide x 2.97m long with a height of 0.82m. The other was almost parallel to the first (0.7m wide x 2.83m long x 0.76m high), providing a 1.4m gap in between each at the street-side end, and a 1.1m gap at the eastern (interior) end; it is possible that some kind of wooden partition was built between each along the front of the property to resemble the more common U-shaped counter, but this cannot be known. Three large ceramic vessels were built into the northern arm³⁷. Also built into the floor at this time was a *repagulum* (door stop) behind the swinging 'night door' (fig. 18)³⁸.

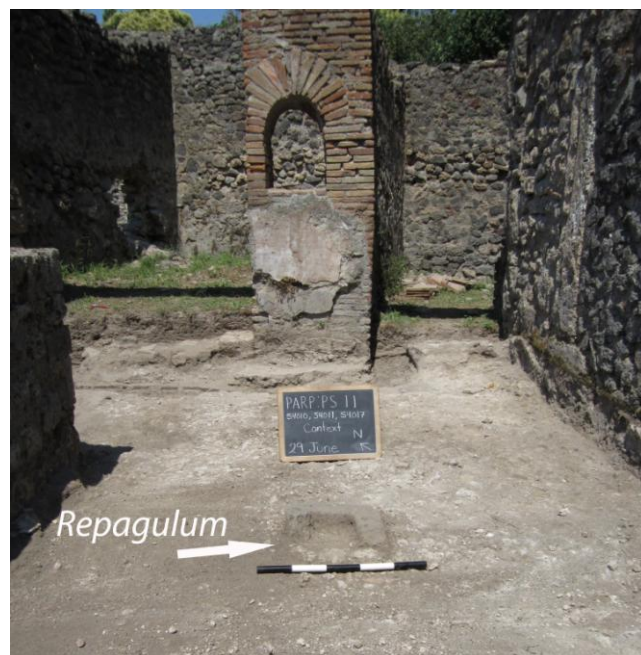
Fig. 18. The repagulum – door-stop – set within the Phase 7 floor surface. Note also the niche built within the brick quoin (WF 1064) at rear.

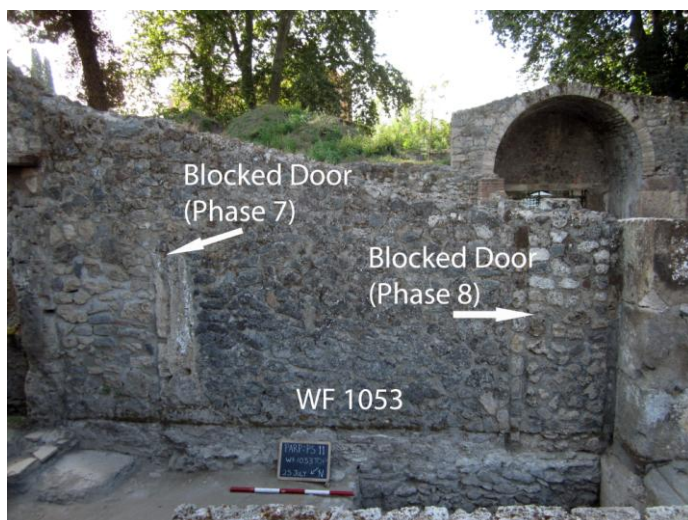
Fig. 19. Partition wall (WF 1053) between Rooms 1 and 6, with two blocked doorways; that on the left was blocked in Phase 7, the other on the right was probably opened in this phase and then blocked in Phase 8.

Some architectural modifications can be registered at this time. The doorway from Room 6 into Room 7 (between WFs 1064 and 1071) was widened by approximately 20cm, based on an examination of the foundations that ran through the threshold; this was achieved by dismantling the original wall and replacing it with the brick pillar with inset niche that is still visible (see fig. 18). This widening of the doorway might have been necessitated by the construction of the counters, which now dominated much of Room 6. Of special importance in this phase was the architectural change in the southern wall (WF 1053). This wall had contained, from as early as its construction in Phase 4, a doorway from Room 6 into Room 1 to the south. That communication and access between the two spaces was reorganized now with a blocking of this doorway at the eastern end of the wall and a (probably) simultaneous opening of a (short-lived) doorway at the western end of the wall and a (probably) simultaneous opening of a (short-lived) doorway at the western end (see Phase 8, below) (fig. 19).

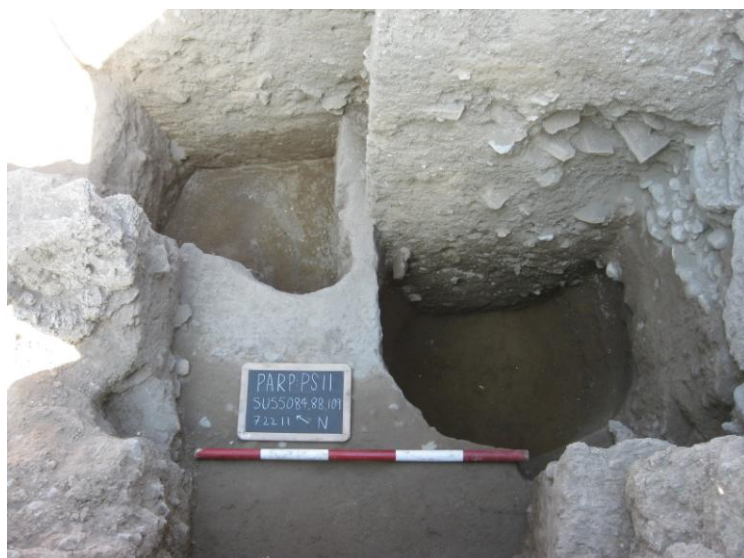
Fig. 21. The earliest surface in Trench 55000 (cut by later pits from Phases 4a and 5a).

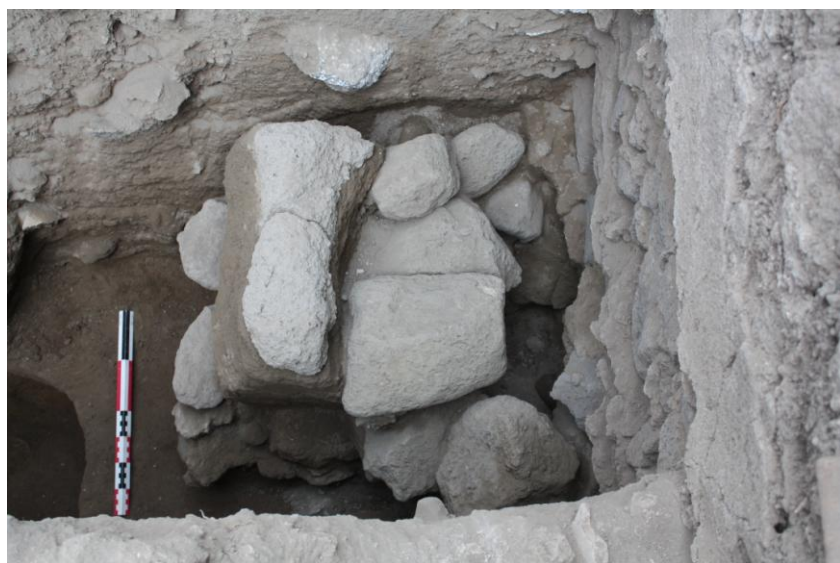
Fig. 22. The remains of a collapsed wall and/or its foundation (in pappamonte).

To the east of the surface, in the southeast corner of the trench, were found the remains of a collapsed wall or the foundation course for a wall, constructed of *pappamonte*, tuff, lava stone, and Sarno limestone (fig. 22). It sat within and above the terracing associated with

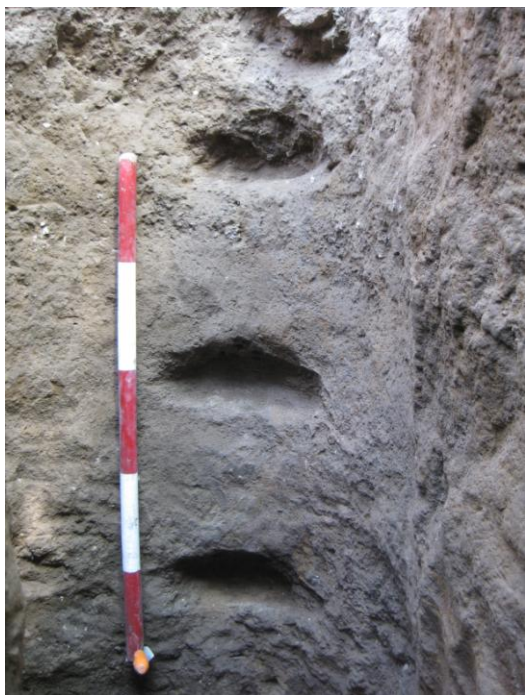
Fig. 23. Footholds cut into the northeast side of the well.

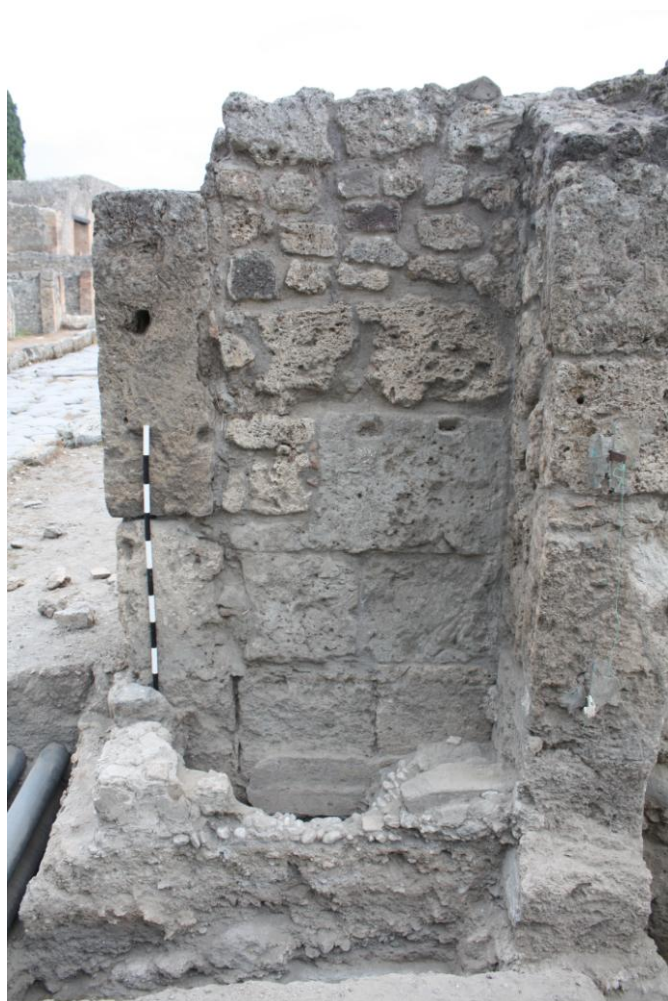
Fig. 24. The low-walled masonry structure built into projecting façade of I.1.6-9.

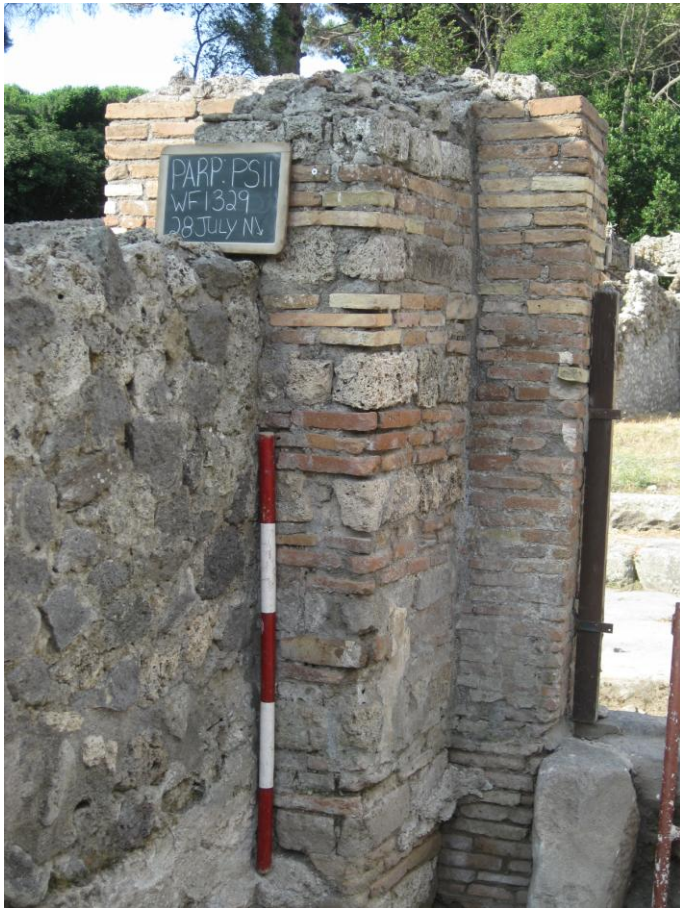
Fig. 26. Quoin of opus mixtum, looking west. Note the later additions of the brick quoin to the right and the opus incertum wall at left (Phase 11).

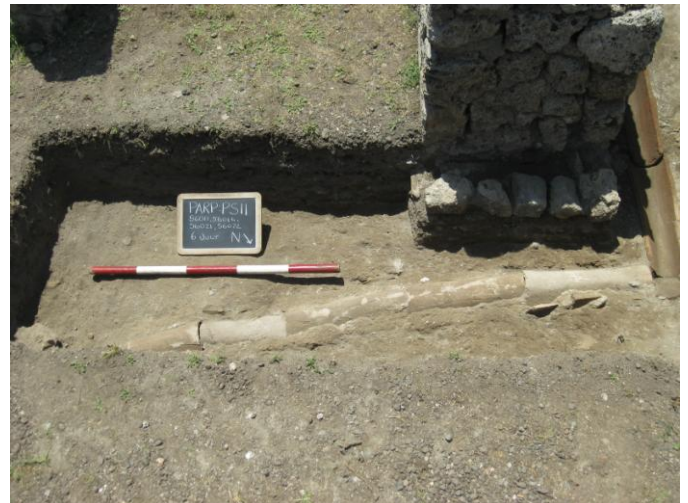
Fig. 27. Phase 11 drain with cover-tiles. Note that its construction and trajectory respects the pre-existing counter.

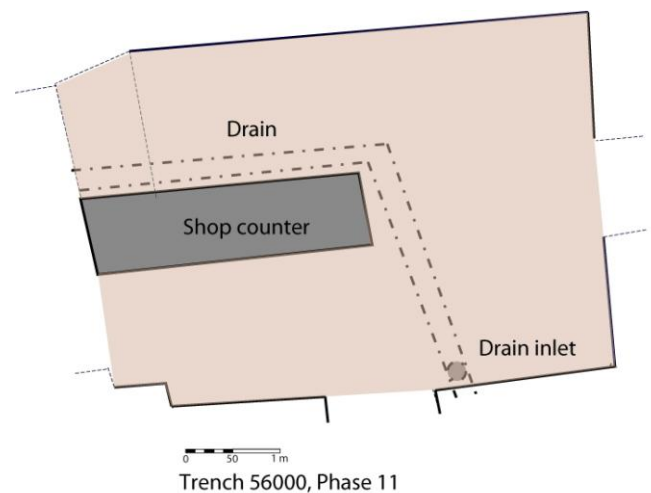
Fig. 28. Trajectory of the Phase 11 drain, running from left (west) to right (east).

A masonry bar counter was also constructed in Phase 11 (figs 28, 30). This counter was originally I-shaped, devoid of any inset containers, and ran E-W through the centre of the room, flush with the threshold stones in the west (cf. Phase 7 of Trench 54000 above for two equally unusual I-shaped counters); the L-shaped version that survives today is based on an alteration to its shape in the following phase and is largely a modern reconstruction.

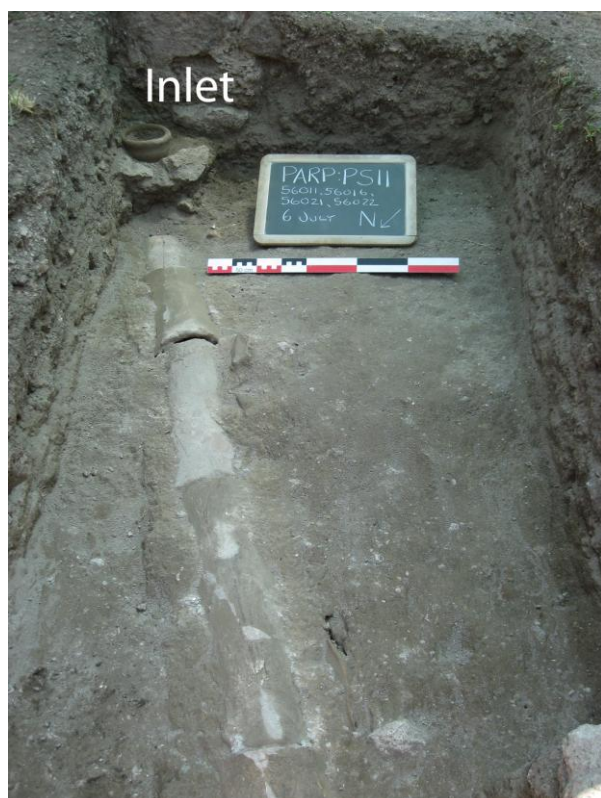
Fig. 29. Inlet to the Phase 11 drain.

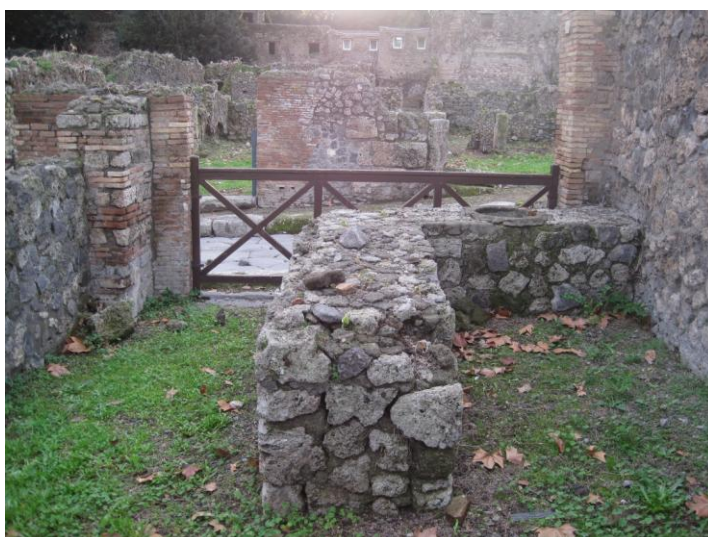
Fig. 30. The counter at I.1.6-9, looking west toward the via Stabiana.

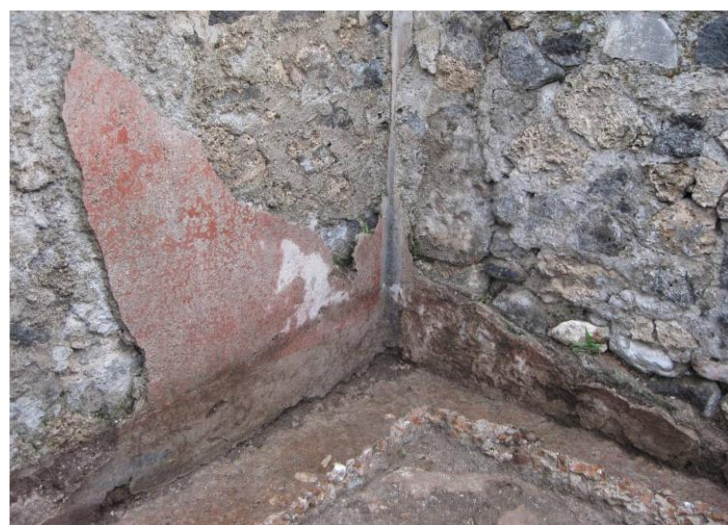
Fig. 31. Remnant of surviving *opus signinum* surface and painted wall plaster from Phase 11.

Following the installation of the bar counter, an *opus signinum* floor was laid to cover the extent of the room (fig. 31). The inclusions in this *opus signinum* were unusual compared with other such floors found in *insulae* VIII.7 and I.1; about 70% of the inclusions were chunks of tile and 30% were large and variously shaped (and doubtless
