Aquileia: first results from the market excavation and the late antiquity town walls (part two)

Patrizia Basso - Diana Dobрева (eds.)

Introduction

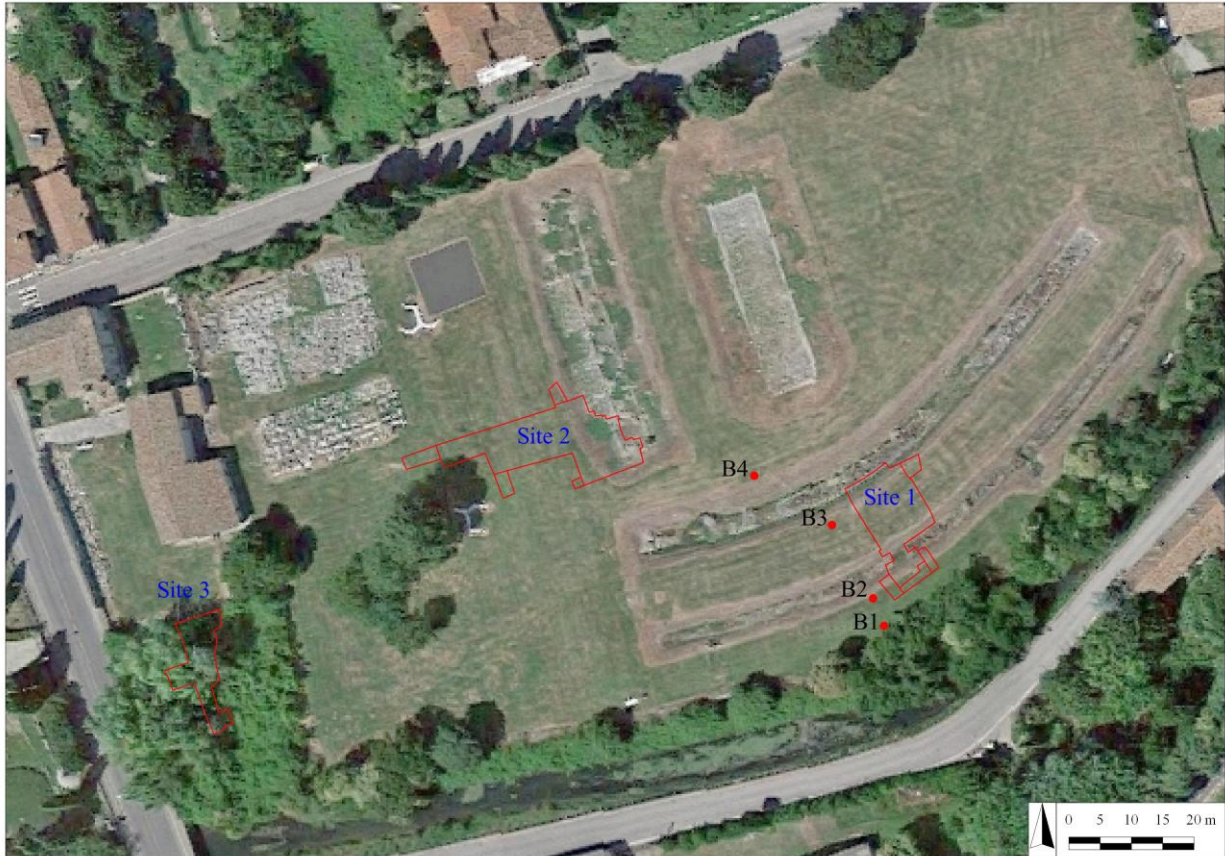
Fig. 1. General view of the site from a drone: the remains brought to light by Brusin in 1953-54 and the three sites and the four cores opened by University of Verona in 2018-2019 (Explora s.r.l. drone survey, reworked by Valeria Grazioli).

The site covered some two hundred square metres. It lay between the two stretches of wall uncovered by Brusin, encompassing the furthest west of the three openings in the outer wall (figs. 1 and 2).

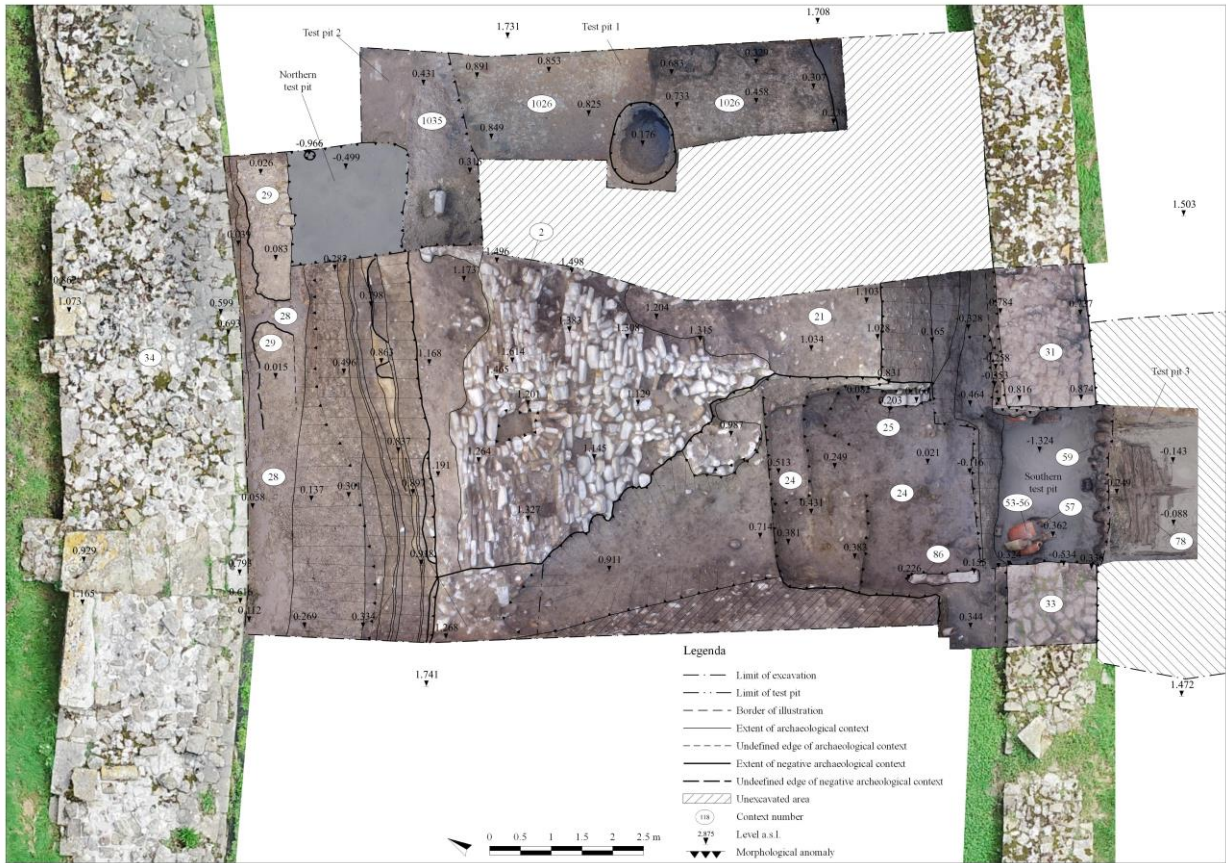
Fig. 2. Zenital image of Site 1 (reworked by Valeria Grazioli).

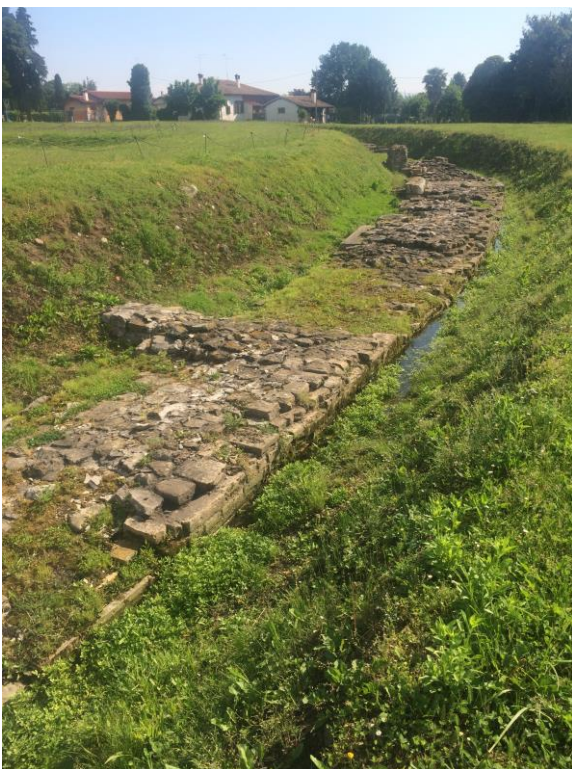
Fig. 3. The inner curtain wall (photograph Patrizia Basso).

Brusin excavated over ninety metres of what he considered the third century CE curtain wall of the town⁴ (34). The wall's width oscillates around three metres, curving slightly. Five courses of ashlar blocks have survived. The blocks are uniform in size and shape. A variety of architectural elements were also reused in its construction, along with monumental inscriptions (fig. 3). An abundant amount of resistant mortar was used. Fragmented or whole tiles and bricks were used more rarely and tend to be found in the *caementicium* mix of the wall's core. A narrow, 0.05 metre wide foundation recess sits on an imposing sandy dump layer (28), any-

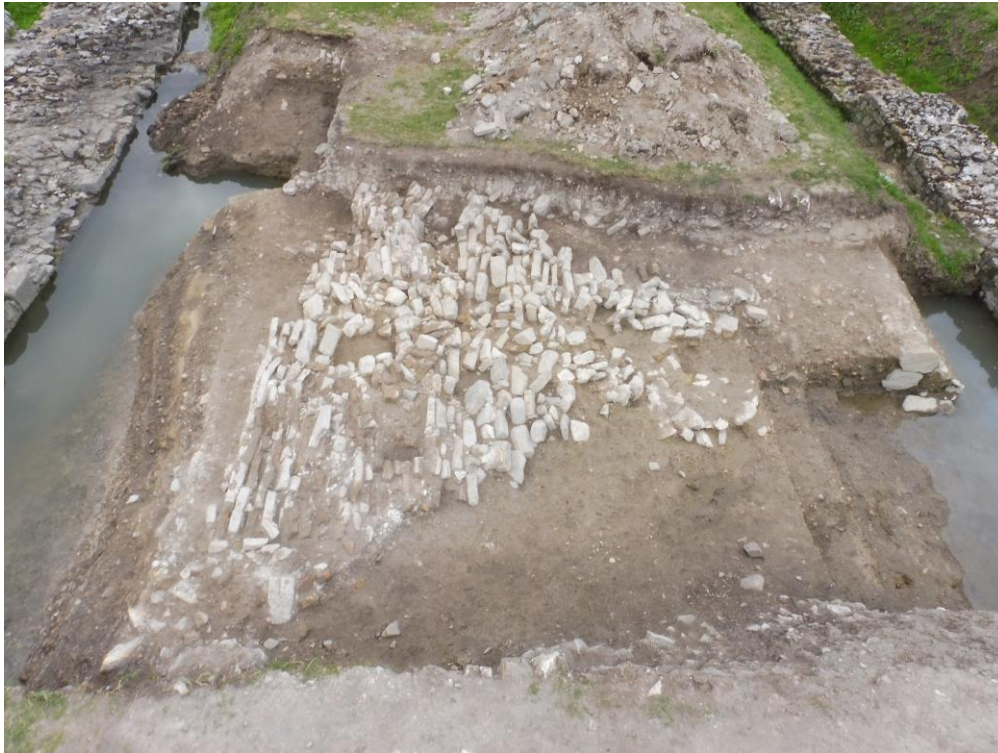
Fig. 4. Site 1. The collapsed inner curtain wall (photograph Patrizia Basso).

One element of considerable interest was the discovery of a sizeable chunk of collapsed wall elevation, some 5.5 metres by 5.3. It lay just 0.2 or 0.3 metres below the ground surface in an area untouched by Brusin's excavation⁵ (2). It had been cut by modern intrusions⁶, but nearly thirty courses remain. These included bricks, river cobbles and ashlar blocks (fig. 4). The ashlar blocks had been laid slightly inclined to one side, causing the wall to fall southwards. A silty sandy sediment mixed with frequent grains of mortar was probably all that is left of the mortar used to bond them when the course was laid. At the northern end there is what appears to be a small rectangular window with a semicircular brick ferrule. The stretch of collapsed wall was an absolute novelty in the face of what we knew about Brusin's excavations⁷. The scholar makes no mention of a collapsed wall but had conjectured that there may have been a sentinel walkway along the inner face. He put this at about 5.5 to 6 metres up, a similar height to our stretch of collapsed wall.

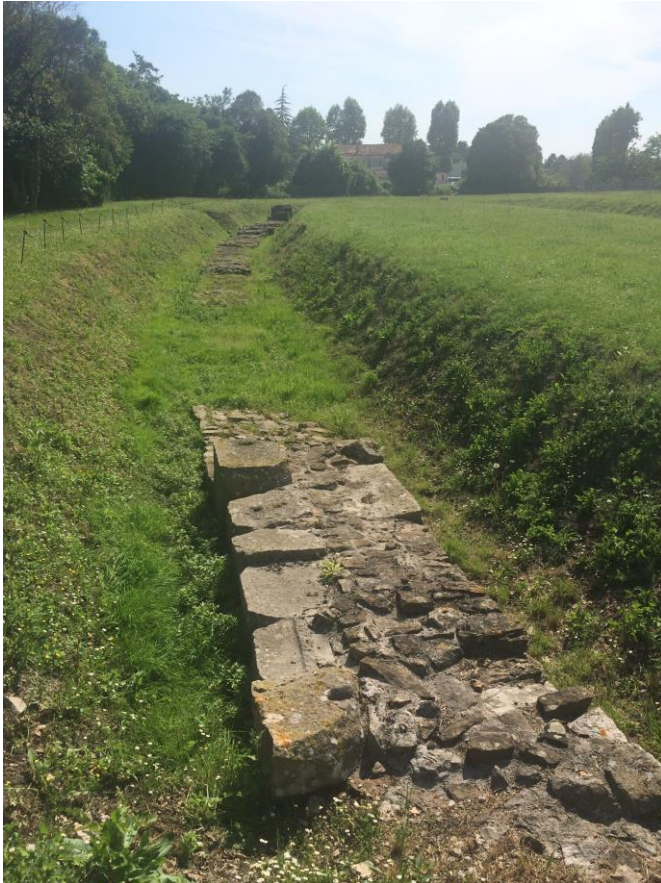
Fig. 5. The outer curtain wall (photograph Patrizia Basso).

In the 1950s Brusin uncovered over 110 metres of the outer curtain wall (**31/33**). He believed it was built to reinforce the already existing curtain wall, dating it to the fifth century CE⁸. It differs considerably from the inner one in both its width and structure. It is half as wide, just one metre fifty, but the courses of ashlar stone blocks are very orderly with virtually no other reused building material (fig. 5).

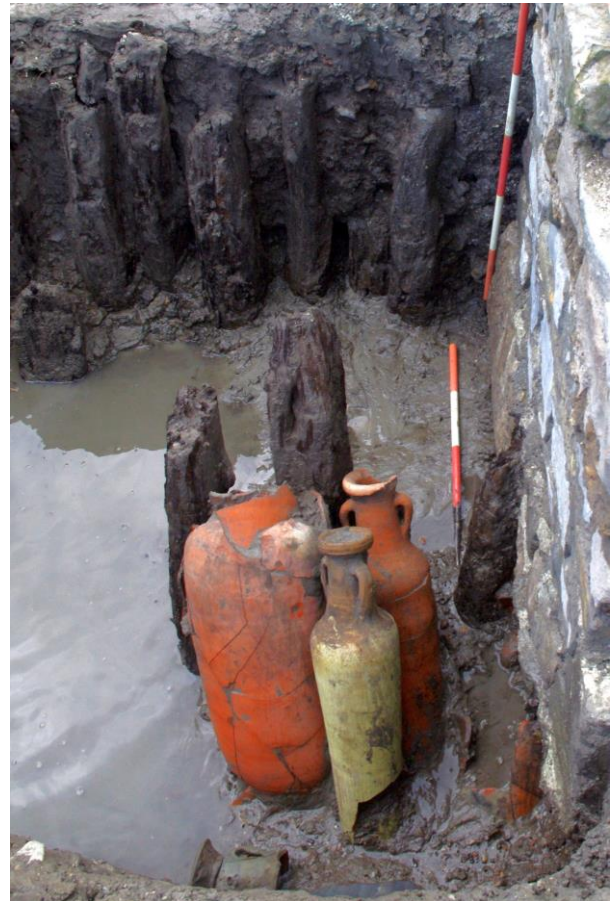
Fig. 6. Site 1. The timber piling and land consolidation amphorae put in place prior to the construction of the outer curtain wall (photograph Patrizia Basso).

Brusin had described the technique used to build the wall's foundation. To verify this a square test pit was sunk next to the westernmost of the three wall openings. A series of vertical wooden piles were exposed. There was also a row of *amphorae*, positioned vertically in the soil, both beneath the wall (**1006** about - 0.74m asl), and alongside its inner face (**57/53-56**: fig. 6). A row of wooden piles (**59**) had also been driven along the outer face of the wall. The idea would have been to underpin the wall in a very marshy terrain. Timber samples were taken from the piles for dendrochronological analysis and radiocarbon dating. In this way it will be possible to date the wall more precisely than simply "fifth century CE", a date arrived at thanks to the type of amphora used (see details in § 4.2.1). Our results confirm those of Brusin, adding that the wall was also underpinned with vertical timber piles and *amphorae*, as opposed to just the horizontal alder beams mentioned in his site documentation⁹.

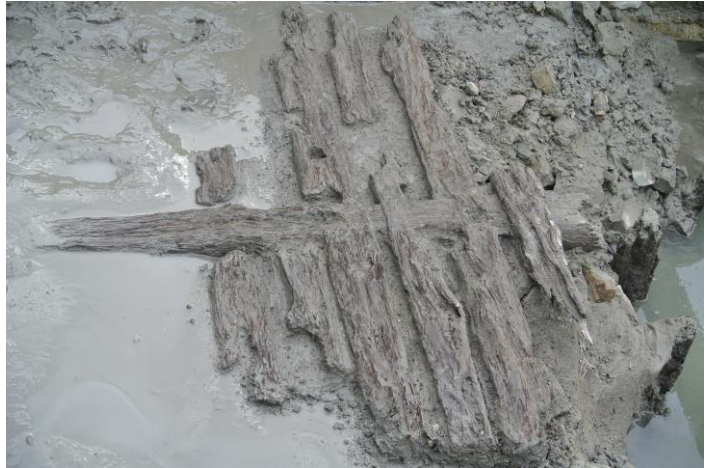
Fig. 7. Site 1. The timber structure uncovered just outside the wall, in front of the wall opening (photograph Patrizia Basso).

This gate may even be the timber structure (78) uncovered *in situ* just outside the curtain wall (fig. 7). It lay at 0.35m asl. Its three parallel beams, at least 1.5 metres long and 0.18 metres thick, have not yet been fully excavated. The beams lie north/south, sloping gently to the south. The two outer ones are slightly thinner. The three would have been joined to at least six planks that were found running east/west, at most 1.7 metres long. They are not particularly thick and had been badly carpentered; one even has the pointed end of a branch still sticking out of it. Given the logistical difficulties of digging with so much rising water, any interpretation must be taken with a pinch of salt. Future excavation will hopefully provide the answers. It may be that the wooden structure was a riverside

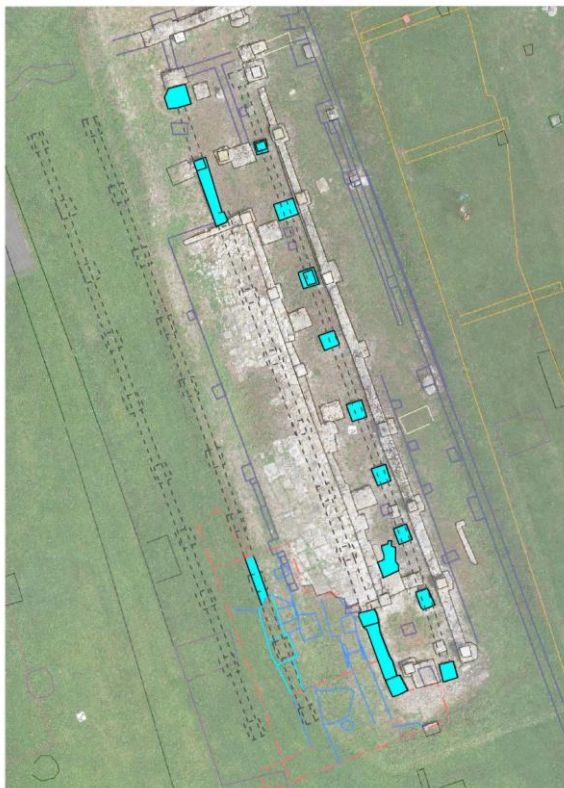
Fig. 9. Site 2. Reconstruction of the ground plan of the first layout of the market building (illustration Fiammetta Soriano).

The evidence points to the existence of a first market building, about 5.4 metres wide, with a portico along each side. The first and fourth row of bases of the portico that Brusin excavated to the east remain, along with the symmetrical structures that we brought to light to the west (fig. 9).

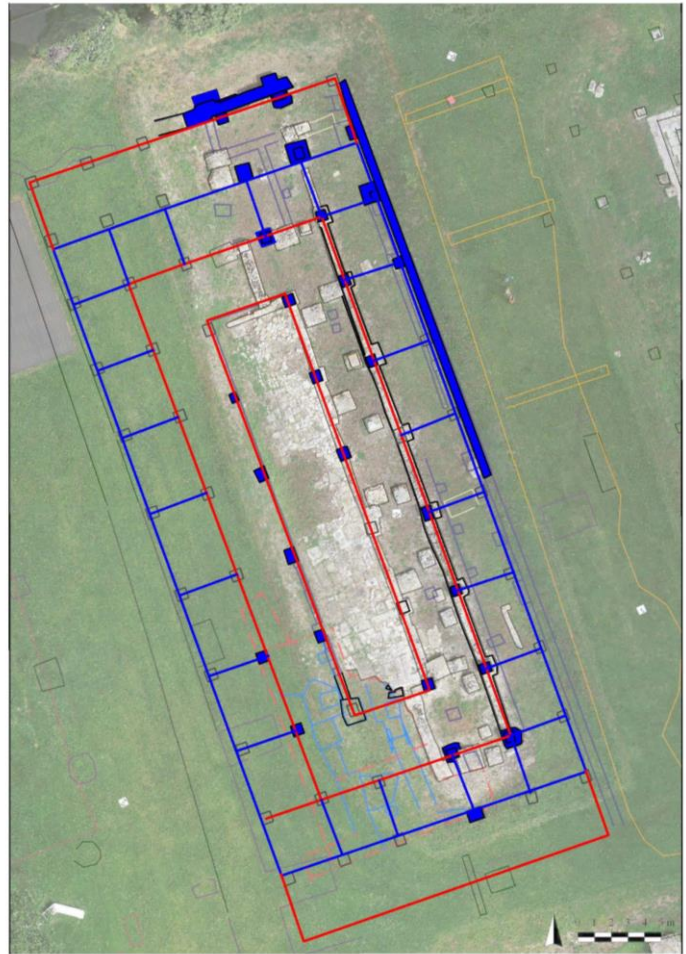
Fig. 10. Site 2. Reconstruction of the final phase of the western market building (illustration Fiammetta Soriano).

At a later point the western market building was reorganised, taking on the monumental form visible to this day (twenty-five metres long and 4.4 metres wide). It was repaved with stone slabs of various dimensions, for the most part rectangular, and surrounded by a kerb (161). Some of the slabs were reused architectural elements, visible on site to this day. The open space was surrounded with new buildings replacing the earlier structures. In the east these included the second, fourth and fifth row of walls or piers that Brusin had brought to light. These are accompanied by the two matching piers on Site 2, of which only the robber pits remain along with a row of stone built piers (204, 205, 206) found in Sector A. The same structure also includes a square brick-built pier, 0.87 metres wide, and a 0.6 metre wide north/south wall in *opus caementicium* found in Sector B. The above evidence suggests that during this phase the square was surrounded by a double portico some 8.1 metres wide. Another possibility, though less likely, is that there was a single arcade, 2.8 metres wide, in front of a string of *tabernae*, though no walls to separate them have yet been uncovered (fig. 10).

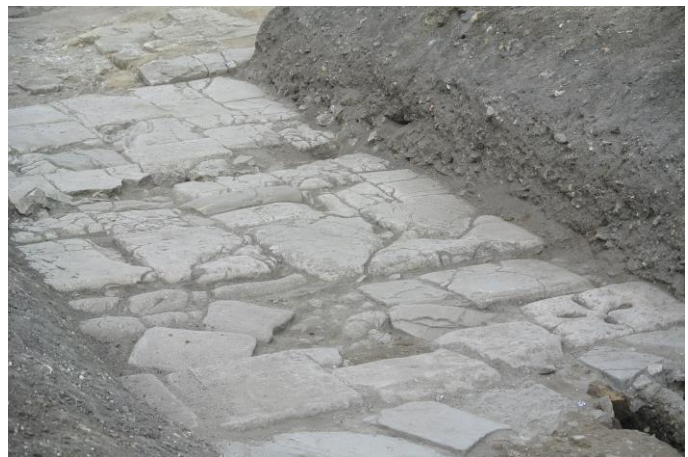
Fig. 11. Site 2. Stretch of paving of the new market building brought to light during the 2019 excavation (photograph Fiammetta Soriano).

The 2019 excavation uncovered a previously undocumented open market building, 5.6 metres wide (fig. 11). It lies 17.6 metres further to the west than the previous one. Its position corresponds with the geophysical anomalies. The stone slabs (258, 1.6m asl) are for the most part limestone of various sizes. There are also some slabs reworked from earlier stone architectural elements. One of these was originally a drain cover. A kerb (265) runs along the eastern limit of the market building, made from rectangular blocks, positioned slightly higher than the paving slabs (1.73m asl). Along its western limit the kerb is missing. Instead there is a row of trachyte stone slabs (264) which are not aligned with the paving stones and have probably been robbed further to the west. It is unclear whether they had been used to patch up the paving of the market building or were part of a road that ran along the edge of the market. If the latter were true the road would have run over an apparently square pier that came to light in the southern corner of Sector D. All that remained was the cut for its

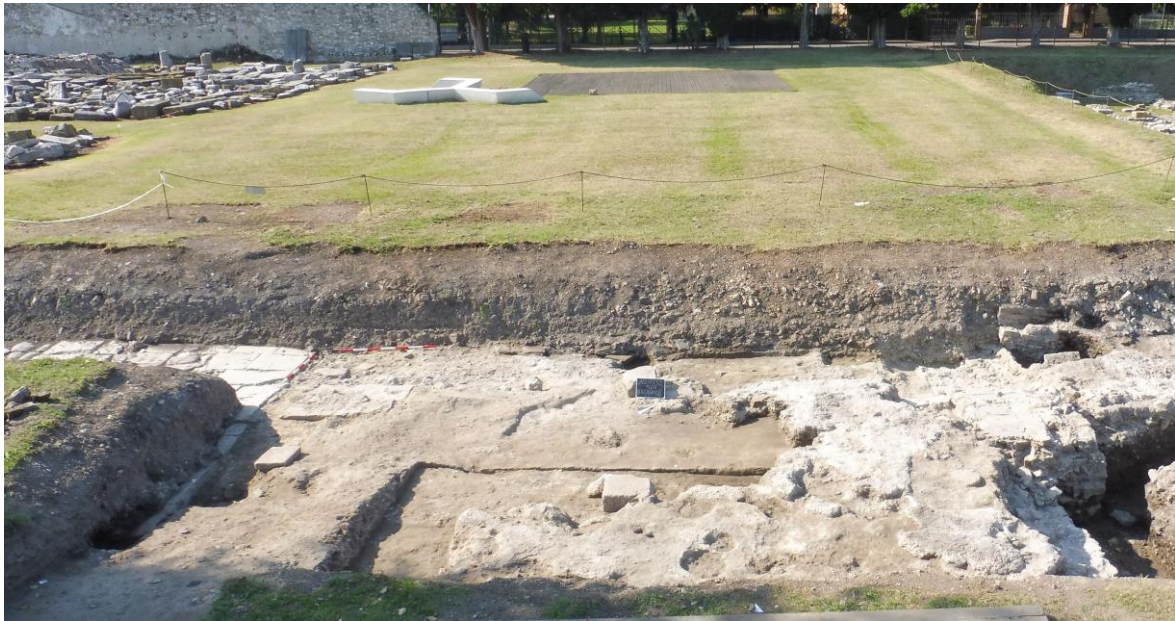
Fig. 12. Site 2. The probable portico at the eastern end of the market building discovered in 2019 (photograph Fiammetta Soriano).

foundations in *opus caementicium* (282). Another square pier (249), 1.25 metres across, was part of the same system. It was built with sesquipedale bricks (0.3x0.4x0.8m) and mortar. So far only the uppermost part has been documented, what was left after the area to the east of the market building was razed. Both piers showed up as anomalies on the geophysical survey. The presence of these two piers suggests that the market building stretched some twenty-six metres north/south. There would have been seven piers down the north and south sides, with about thirty-six metres between the first and last. Their excessive dimensions suggest that they may have supported a trussed roof over the centre of the space. It seems more likely that they are part of an earlier structure, given how similar they are to the third row of piers found by Brusin east of his western market building. Adjacent to the eastern end of the market building, in Sector C, what was probably a *porticus duplex* was uncovered. This stood on a row of piers, two stone built ones remain (247 and 248: 0.48 x 0.49 x 0.20m and 0.42 x 0.55 x 0.20m)¹⁴ (fig. 12). The piers sat on a silty clay layer that had been spread over the whole site. This was a very compact levelling layer prior to laying the paving stones. All that is left of the paving is the odd trace of a layer of mortar and bits of brick. These were found at the extreme northwest limit of the portico around one of the piers (248).

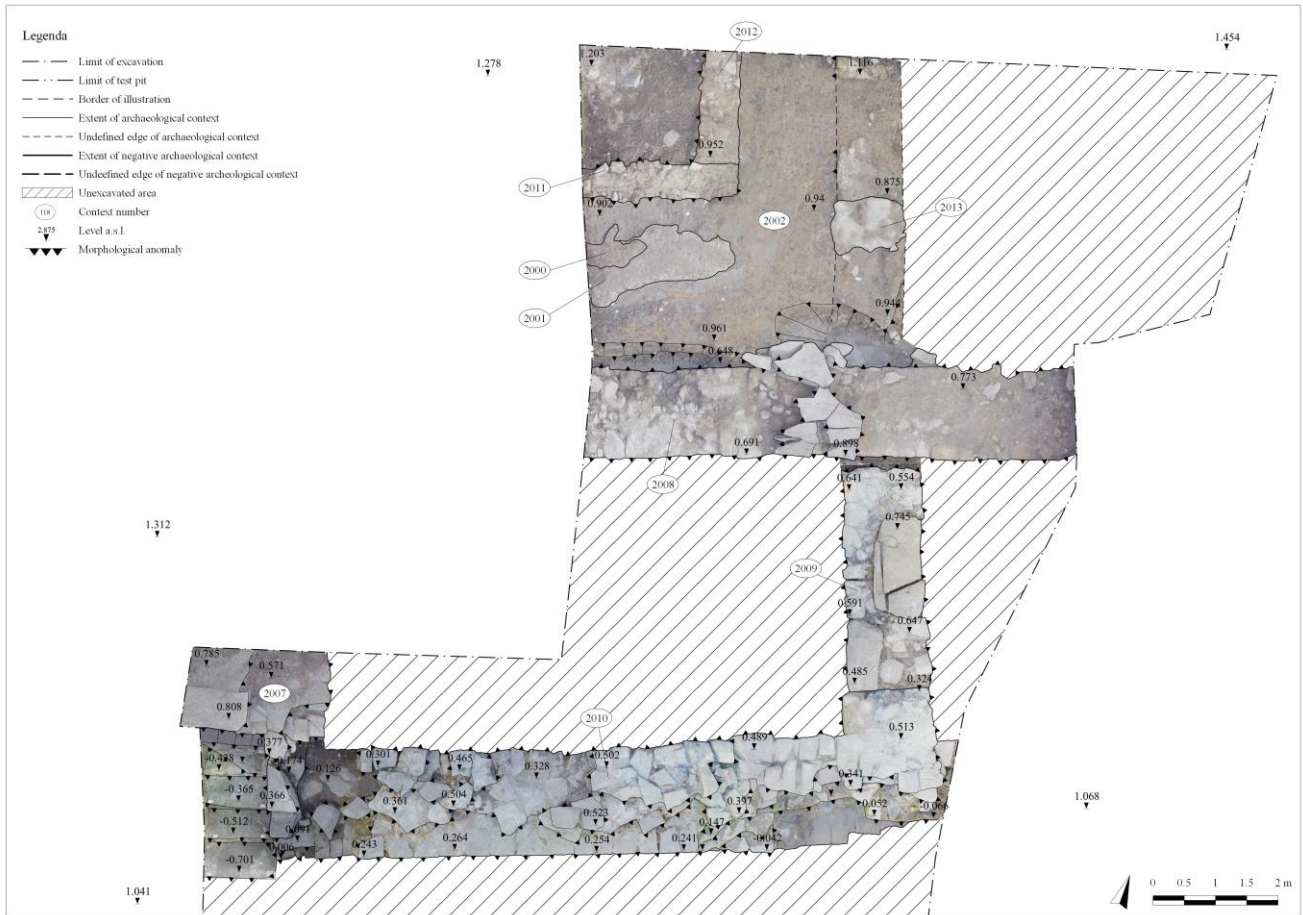
Fig. 13. Site 3. Zenital photograph (graphics Valeria Grazioli).

Site 3, 19.5 metres by about 10.8 metres, was opened in 2019. The aim was to take a second look at the stratigraphy brought to light on numerous occasions between 1993 and 1996 in the fields known as Braida Pasqualis¹⁹. The main desire was to clarify the interpretation of the various stretches of wall that had been uncovered (fig. 13). First of all, it should be pointed out that on site logistics were severely hampered by the high water table²⁰ along with the roots of the large plants that had grown up in the backfilled soil left by the 1990s excavations.

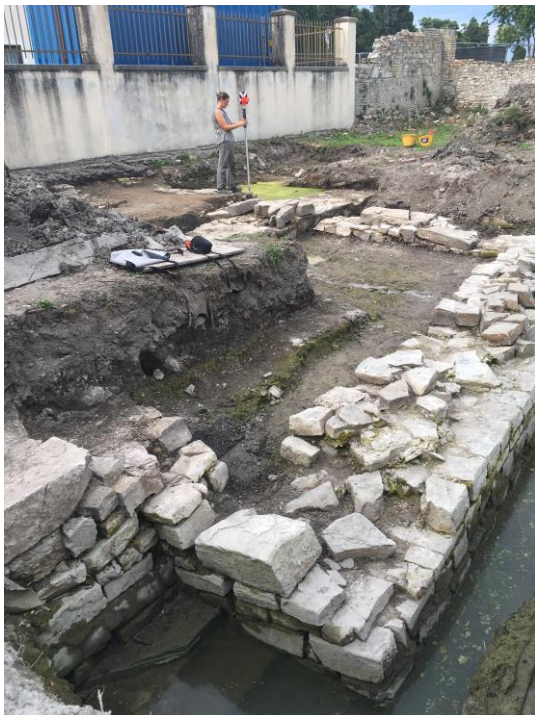
Fig. 14. Site 3. The wall's East/West facade (photograph Marina Scalzeri).

The two most imposing walls are one running east/west (**2008/S1**)²¹ and a second L-shaped one further to the south. They have been interpreted as a system of river control between the first and early second century CE (**2009-2010/S17-3**). The northern one was one metre wide and made from blocks of sandstone and mortar alternating with courses of brick. The crest was sealed with a course of thick sandstone slabs, some 0.3 by 0.4 metres²². At least 1.2 metres of the elevation of the other wall were brought to light, it is 1.5 metres wide, built with courses of sandstone blocks, *sesquipedale* bricks and a very resistant mortar (fig. 14). At its western end it turns north for about one metre. At its end four steps led down to what probably used to be the ancient river

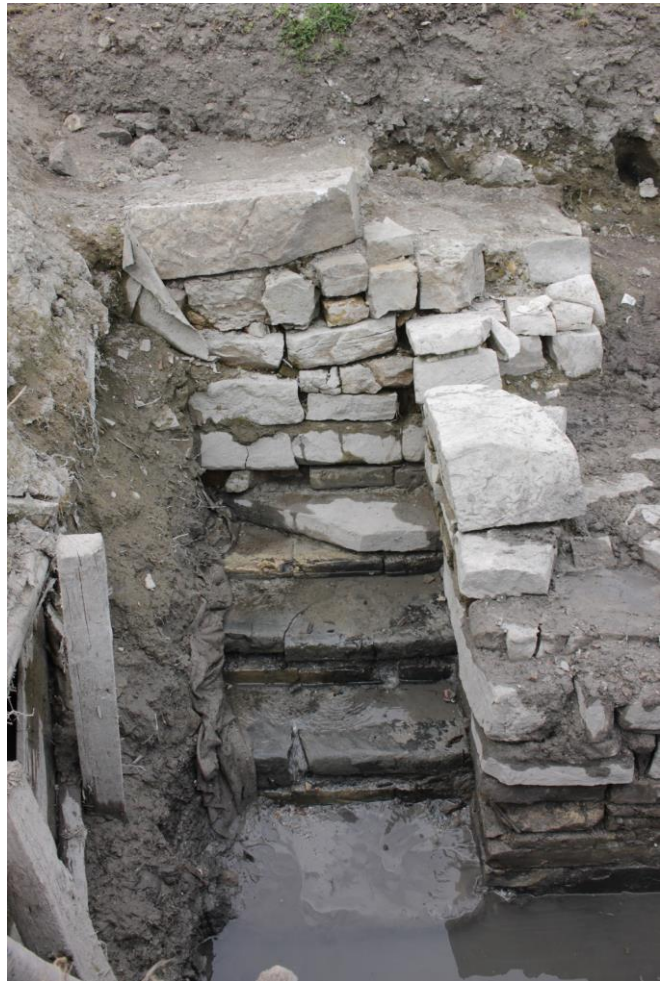
Fig. 15. Site 3. Flight of steps leading down to the river (photograph Marina Scalzeri).

course. It is unclear how many steps there are in all as they continue on under the western site section. Each step had a sandstone slab resting on a course of *sesquipedale* bricks lain as headers (fig. 15). At a later moment a dry stone wall (2007) was built over the steps with sandstone blocks and other architectural elements, forming an L-shape. Some 1.16 metres of the elevation has survived, continuing under the western section. Though with some uncertainties given the site logistics, the technique used in the construction of wall 2010/S3 appears to be very similar to that of the wall that came to light under the inner curtain wall during the Site 1 2018 excavation (29: see § 1).

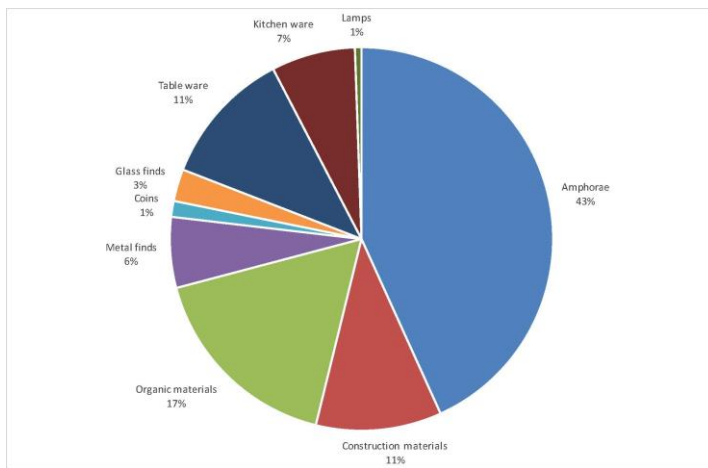
Fig. 16. Graph showing the quantity relationships between different functional finds groups attested on site. The percentage is calculated on 13.962 of total amount of fragments (graphics Diana Dobreva).

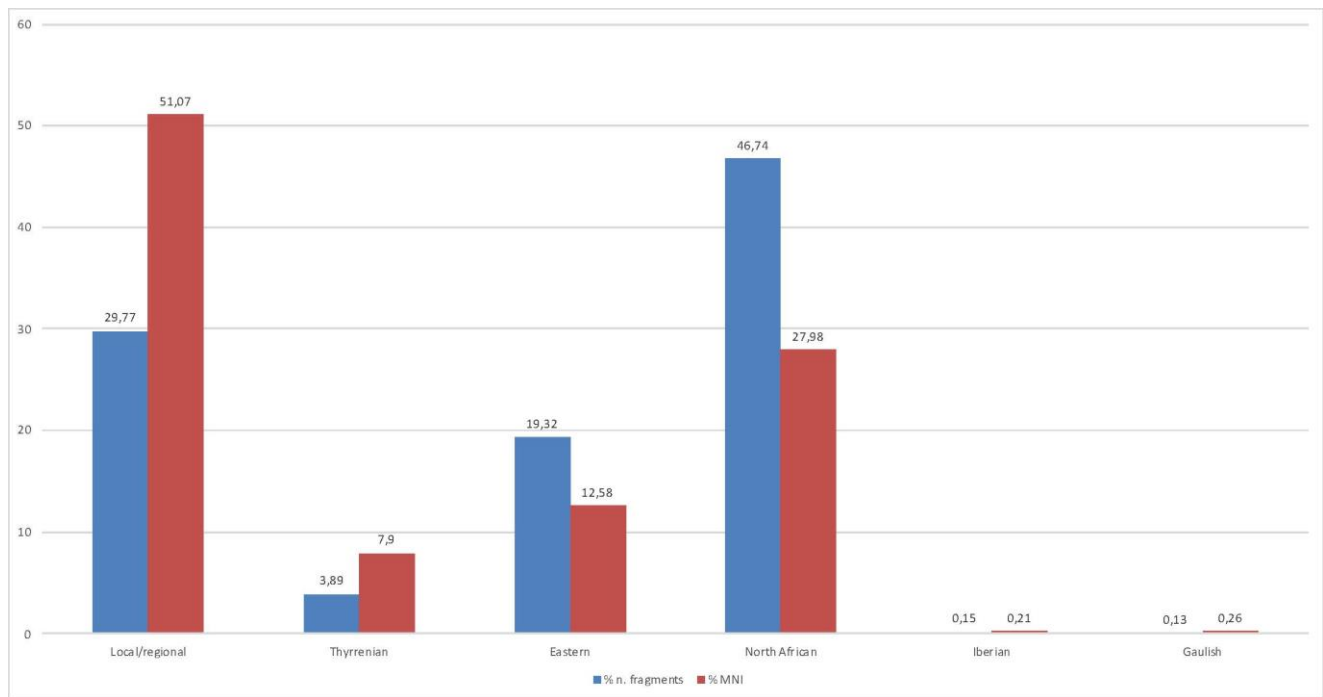
Fig. 17. Quantitative comparison of the pottery productions estimated in percentage value of the number of fragments (6.786) and of minimum number of individuals (1.923 MNI) (graphics Diana Dobrevá).

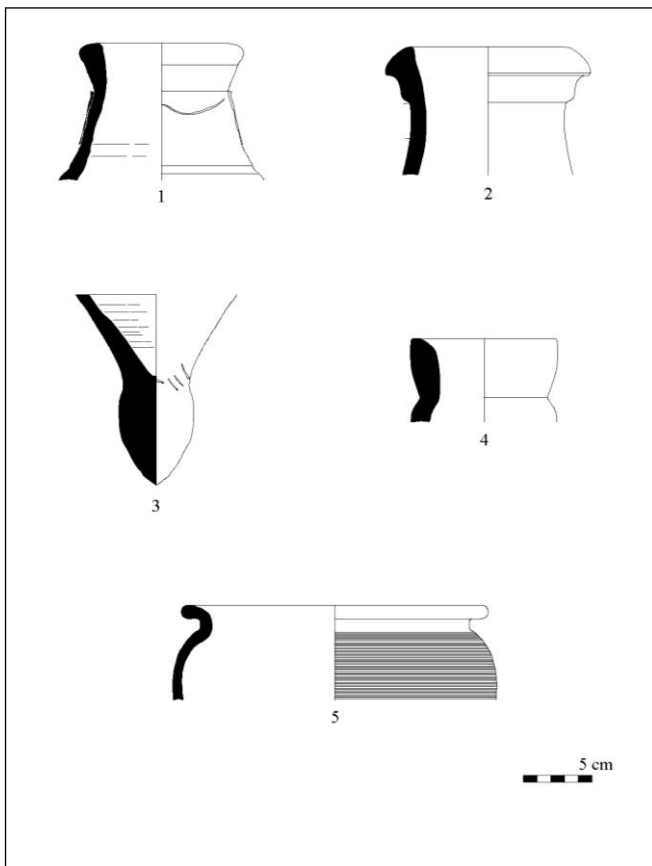
Fig. 18. Site 1. Selected pottery from the inner wall, context 28: 1-4. African amphorae; 5. Cooking pot of local/regional coarse ware (drawings Vittoria Canciani).

century. The *amphorae* date to the same period. For the most part they come from Africa. They include Tripolitana II and Keay 25.1 types (fig. 18, 1-2), alongside earlier examples such as the African IID (fig. 18, 4) and the early version of a Keay 25.1 type. These date to between the third and early fourth century. There are also locally produced coarse ware cooking pots, very similar to examples from Invillino (fig. 18, 5). The latter date to between the fourth and seventh century CE²⁴. There are also a few fragments of a jug made of African common ware, usually dated to the fourth century CE²⁵. All of these go towards affirming a fourth century date for the context. However, only a careful and complete excavation of the sector will provide correct data to precisely date the construction of the inner curtain wall.

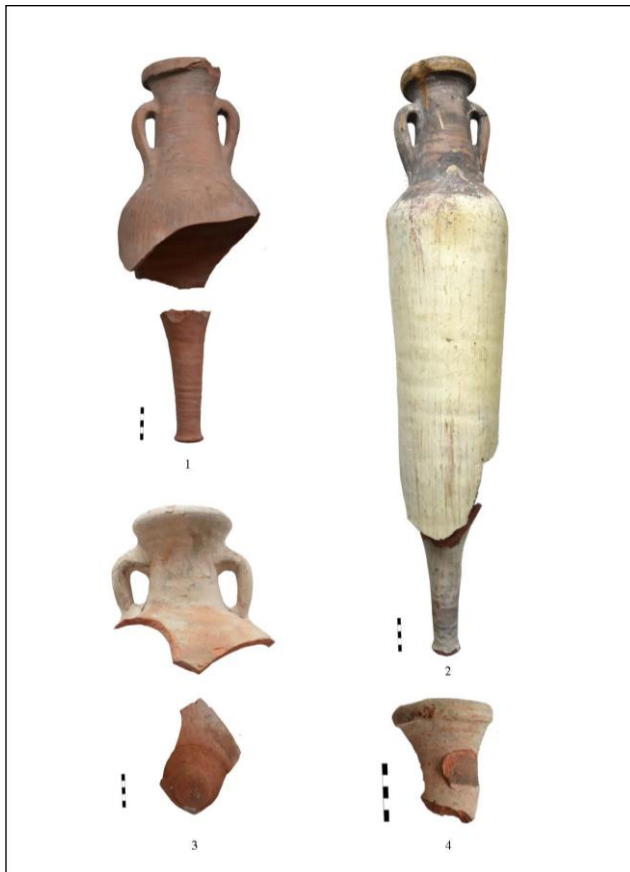
Fig. 20. Site 1. Some of the amphorae found beneath the outer curtain wall (53, 54 and 55): 1-4. African amphorae (photo Sabrina Zago).

Moving on to the outer wall, the most interesting aspect is the method of ground consolidation and underpinning. This consisted of a complex system of whole *amphorae* inserted vertically into the ground (53, 54, 55, 56 e 1006) along with timber piling. This French drain worked as a conduit, draining the water off the site via the cavity formed by the empty *amphorae* (fig. 6). The types of amphora are typical of the fifth century CE. They include a Key 25.2, a Spatheion 1 (fig. 20, 1-2), found in the first half and mid fifth century, and a Key 36, commonly found in contexts from the same century (fig. 20, 3).

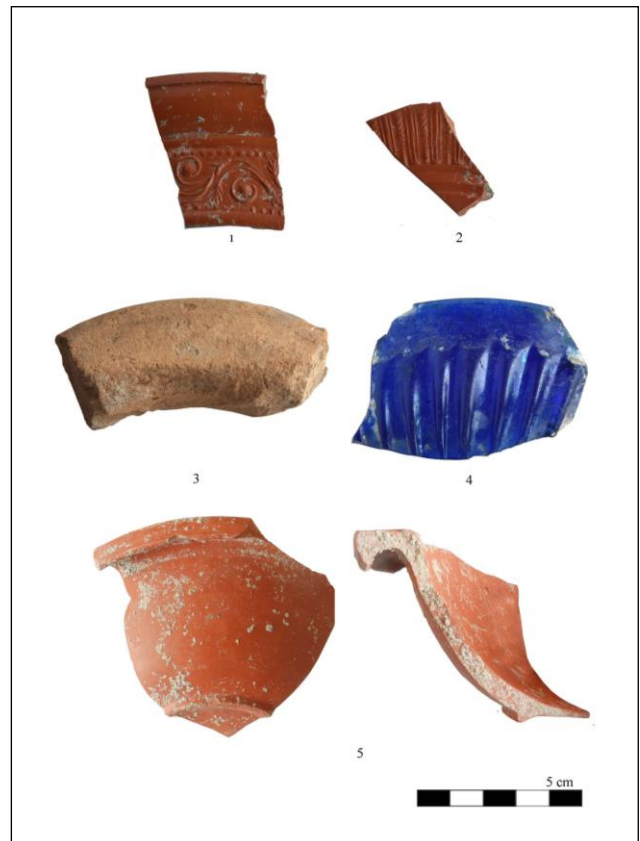
Fig. 24. Site 2. Pottery sherds and coins recuperated beneath the burnt timber beams of the collapsed portico roof of the west market building (118): 1-2. ARSW plates; 3, 5. *Follis*/centenionales GLORIA EXERCITVS type (330 – 340 CE ca); 4, 8-9. AE4 SALVS REI PVBLICAE type (388 – 402 CE); 6-7. Valentinian coins (364-388 CE). See clipping traces on the coin n. 6 which testify coin debasement and its circulation still in the mid V century CE (drawings Vittoria Canciani, photo Andrea Stella, graphics Diana Dobreva).

From the evidence on hand the market building seems to have become derelict at the end of the fifth or in the first decades of the sixth century CE. This followed a violent fire (§ 2.3). Evidence for this date comes from the finds recuperated beneath the burnt timber beams of the collapsed portico roof of the west market building (118, 246, 309). These included eastern Ephesus 56 and LR 2 type *amphorae* as well as African Albenga 11-12 type ones. The ARS D Atlante X type lamp dates to the same period (table 3). The finds record for the traces of fire destruction excavated on the central market building in 2018 date to the same period. It may be that both market buildings fell into disuse at the same time. The finds from the central market building point to a date between the second half of the fifth and the first quarter of the sixth century CE. A date for the fire is suggested by the coin, pottery and glass finds, most of which date to the second half of the fifth century CE³¹. The ARS includes a late variant of a Hayes 91B type plate along with a Hayes 87A/88 type (fig. 24, 1-2). There are also Hayes 81 type cups and African Spatheion 1 type and eastern Ephesus 56 *amphorae*.

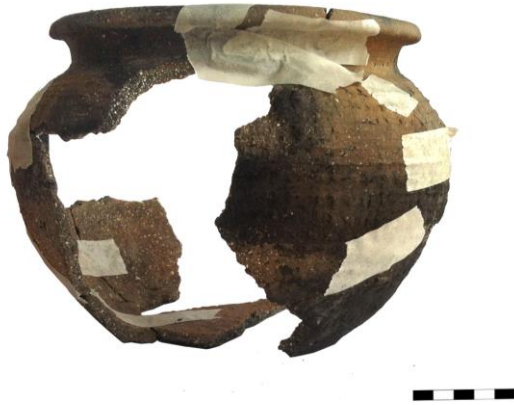
Fig. 25. Site 2. Cooking pot in local/regional coarse ware from context 228 (photo Sabrina Zago).

Even after the second fire the area remained in use, though for different purposes. A fragment of a coarse ware jar may date the rectangular structure it was found in from the sixth century CE onwards (fig. 25). The structure may have been a cistern (228) (§ 2.3).

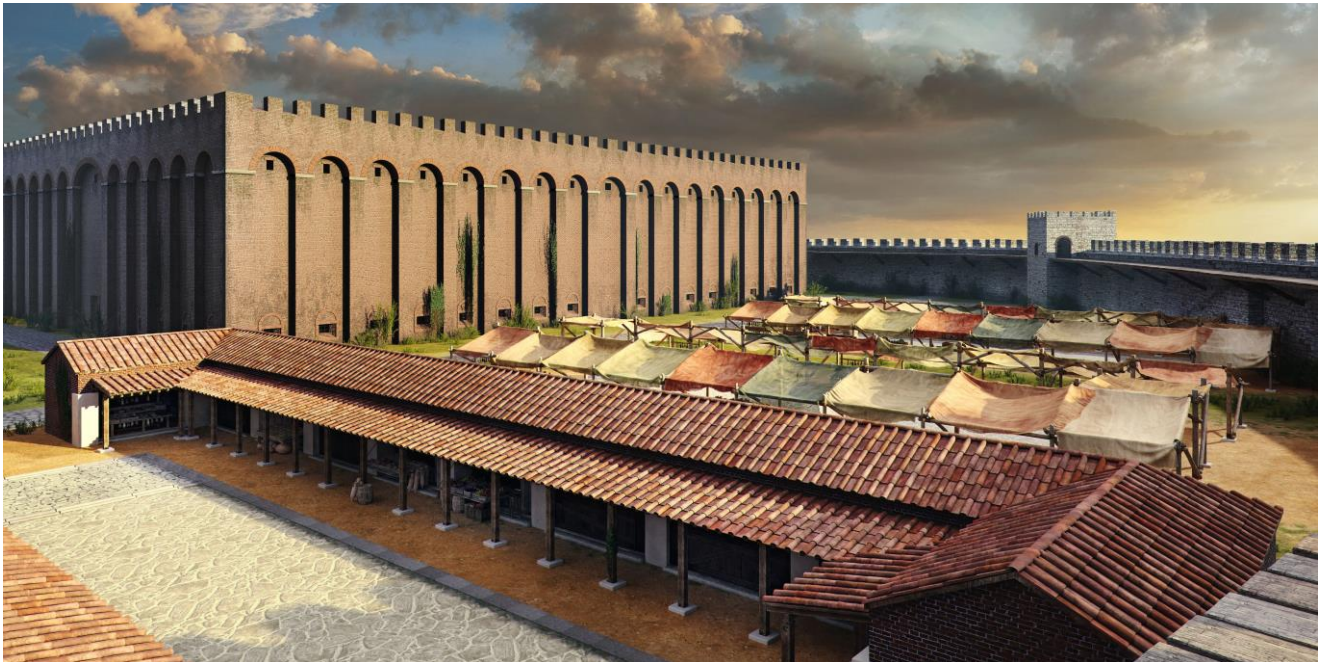
Fig. 27. 3D reconstruction of the horreum and the market building (thanks to the Fondazione Aquileia).
