Cleaning the Laundries III. Report of the 2008 campaign

Miko Flohr

After two successful campaigns in 2006 and 2007, the 2008 campaign constituted the third and final season of the 'Cleaning the Laundries' project. The general aim of the project was to come to a better understanding of the recognizable Pompeian fulling workshops by investigating the remains of work installations on or above the AD 79 floor level, which are often hidden below modern deposits, such as sand and debris. The results of the first two seasons had already confirmed that by carefully removing these modern layers and cleaning the ancient remains underneath a lot of additional information about the history and use of these workshops could be gathered and it had also become clear that such data could add significantly to our understanding of *fullones* and *fullonicae* at Pompeii. In 2006, three small *fullonicae* were investigated in *tabernae* I 4, 7, VI 15, 3 and IX 6, a.1; the 2007 season focused on two large *fullonicae* in houses VI 8, 20.21.2 and VI 14, 21.22 and another small workshop in *taberna* VII 2, 41¹. The final season in 2008, the results of which are presented here, served two purposes. On th

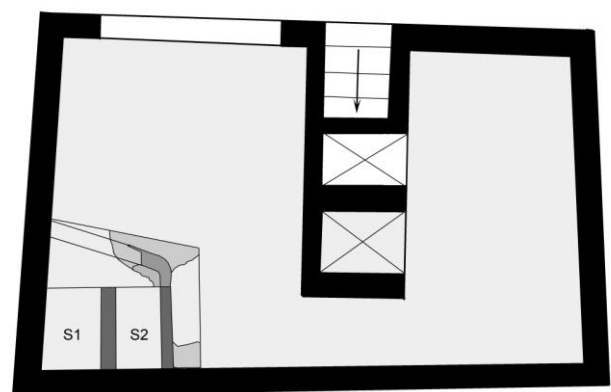
Fig. 1. Fullonica I 10, 6: overview of remains.

This small shop (fig. 1), which is thought to have belonged to the property of the neighbouring House of the Menander (I 10, 4), and which consisted of a shop and a back room, was excavated in the early 1930s and a report with a brief description, a list of artefacts discovered and a map was published shortly afterwards.² In subsequent decades, the remains of the work installation in the southwest corner of the shop gradually became covered by modern sediments, and disappeared. Hence, while the workshop was included among the *fullonicae* listed by Moeller, its identification as a fullery was disputed by Ling and Allison³. The workshop had been investigated by a team led by Philippe Borgard in 2004, but despite a brief note mentioning their activities, no results of this work have been published yet⁴.

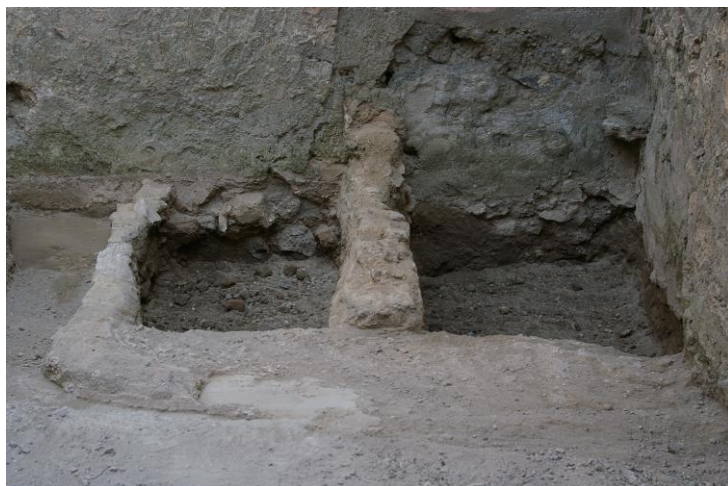
Fig. 2. Fullonica I 10, 6: map.

of pottery. By contrast, the main floor was rather fine and had a smooth surface. As in most other fulleries, the work floor was separated from the surrounding environment by a low rim. Only a small part of the floor has been preserved, but comparing the visible remains with Elia's map, one can reconstruct that it was curved on the east side, started relatively narrow, but became increasingly wider towards the west wall.

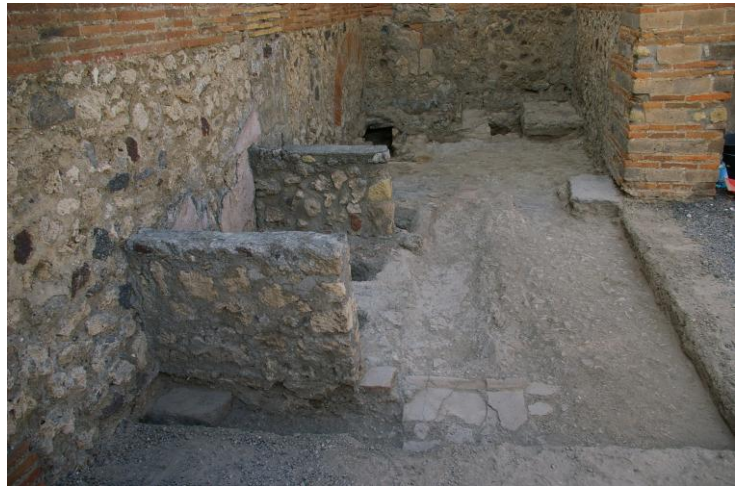
Fig. 4. Taberna V 1, 2: overview.

between the two stalls. Based on what was visible, identification of the shop as a *fullonica* already seemed secure⁷. Hence, surface cleaning focused on the specific details of the fulling installation, and on understanding its relation with other remains that were visible in the northwest corner of the room. For this purpose, a large rectangular area, including most of the western half of the shop was cleared of modern sand and dust (fig. 4).

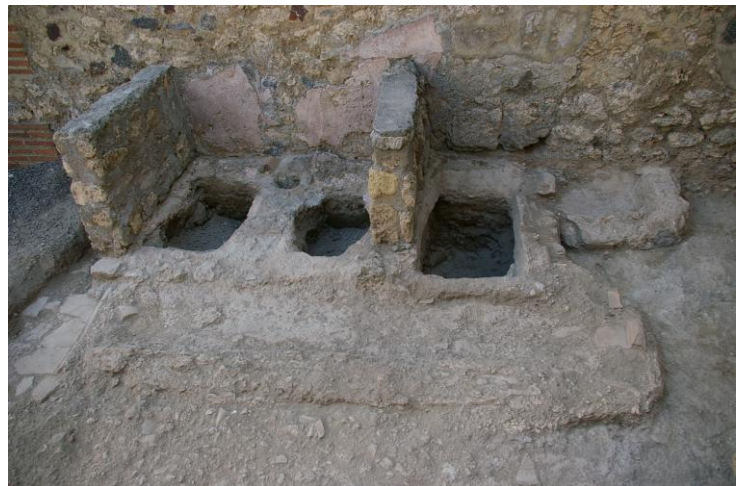
Fig. 5. Taberna V 1, 2: fulling stalls.

After removing the uppermost layer of dust and lapilli, it appeared that the two fulling stalls had been filled in with a layer of modern concrete, obviously during restoration works. This was removed, except for parts where it had stuck to the ancient *opus signinum* bed, in order not to damage the archaeological remains. Subsequently, the holes in which the fulling tubs had been placed were emptied to a depth of about 20cm, but no ancient remains were discovered. The cleaning, however, did make it clear that the two stalls had been separated from each other by a wall – as in most fulling installations studied during the project. In cleaning the hole left by the amphora that had been embedded in this wall, no remains of the amphora itself were found. The two stalls slightly differed in the shape of the mortar surrounding the tub (fig. 5): the tub in stall S1 was more rectangular (stall: 52x98cm; tub: 35x60cm), while the tub in stall S2 had a more oval form (stall: 45x96cm; tub: ca. 32x56cm). Both had the characteristic sloping edges on all four sides and a rim in their entrance. In front of the stalls, there turned out to be the usual *opus signinum* work floor, surrounded by a low rim of stones and mortar (walking surface: 202 x 38cm; rim: 20cm). The work floor continued north of S2, but gradually lost its rim there; at the height of the south wall of room 2, it stops. At the north and south side of the floor, fragments of roof tiles have been used in the rim, with the upright side of the roof tile above. In the rim along the east side of the work floor, more than one polished surface is visible, suggesting at least two phases.

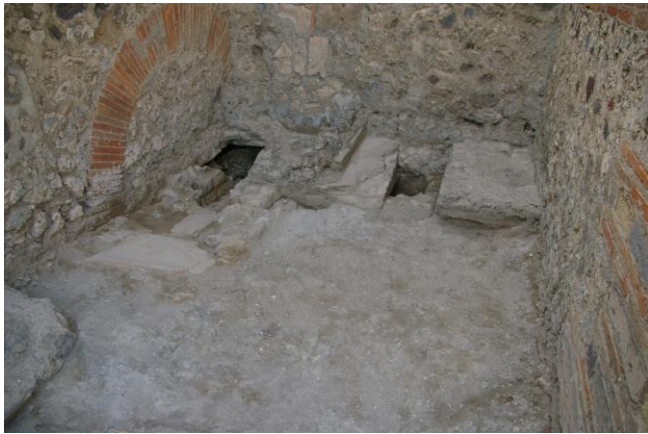
Fig. 6. Taberna V 1, 2: remains against north wall.

Attached to the north side of the stall, against the west wall of the shop, was a rectangular mass of stones and mortar of which the function is not precisely clear (ca. 60x50cm). As its surface seems finely polished and is on a lower level than the sides, it may have been a small basin, but this is not certain. While its function remains unclear, the fact that the mass covers the *opus signinum* surface of the side rim of stall S3 makes it clear that it postdates the third fulling stall, again showing that the history of this workshop was more complex than its shallow remains may suggest at first sight.

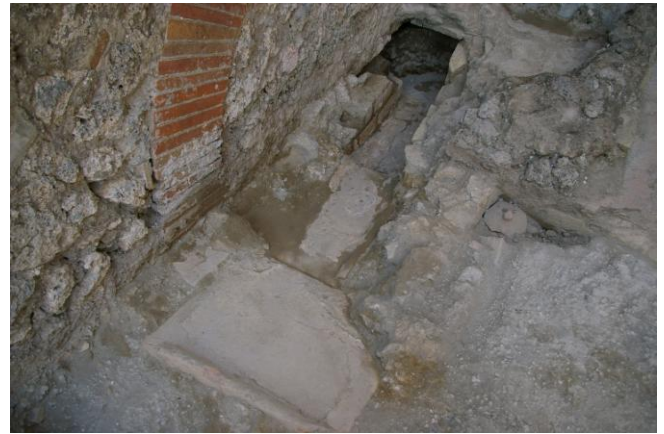
Fig. 7. Taberna V 1, 2: drainage installation.

South of the staircase podium, a drainage installation emerged (fig. 7). The installation consisted of a small, slightly sloping work floor made of a large roof tile, and a narrow, more steeply sloping channel with a floor of tiles (width: 25cm). The channel ran towards the northeast corner of the room, where it debouched into a larger drain which ran underneath the *atrium* of house V 1, 3. The drainage channel is probably contemporary with the staircase podium, as the walls of the channel and the remains of the podium are connected by mortar. The installation was separated from the surrounding part of the workshop by the standing rim of the tile, so that the drainage waste could not cause pollution in the rest of the establishment. Probably, the drainage channel is to be equated with the '*fusorium*' mentioned by Fiorelli⁹. This would also explain why the fill of the drainage channel almost exclusively consisted of sand: the installation was excavated with the rest of the shop, but then was left to disappear under modern sediments.

The precise functional background of the drainage installation was not directly clear. Significantly, however, the surface of the work floor, the floor of the channel and the walls were partially covered by a whitish sediment. While it was not, unfortunately, possible to sample and chemically analyze the substance, it is worth emphasizing that such whitish sediments are fairly common in *fullonicae* both at Pompeii and Ostia: they often cover the inner sides of fulling tubs, of storage jars, of rinsing basins and parts of the shop floor. While this could be sinter, merely indicating water use, there are indications that the sediment at least partially consists of remains of the alkaline

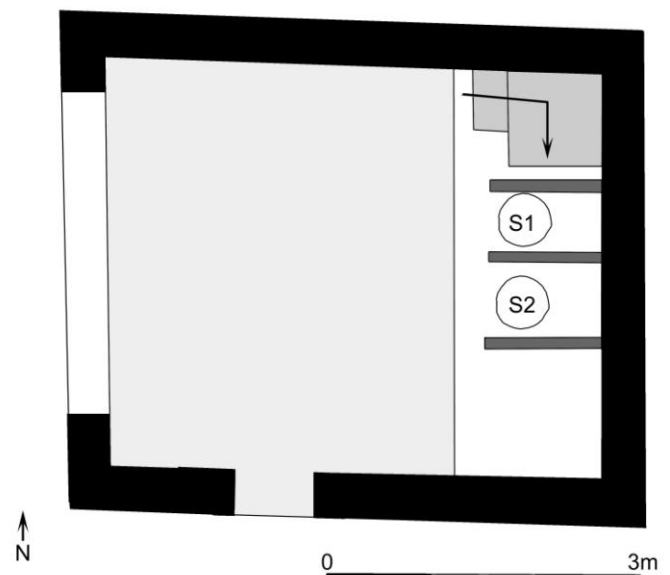
Fig. 8. Taberna VI 3, 6: map.

This small shop along the Via Consolare (fig. 8) was excavated in the early 19th century, but has never before been interpreted as a *fullonica*¹³. Its possible relation to fulling was noted during a preparatory visit to the site during which I specifically addressed the areas that had been excavated before the first Pompeian *fullonica* was discovered in 1826 (VI 8, 20-21.2). What was visible – before intervention – were the remains of two rather large vessels that had been embedded in the floor more or less next to each other, both ca. 50 cm from the east wall, their rims separated from each other by some 30cm. In remarkable correspondence with these vessels, there were traces of three small holes in the wall covering of the east wall, all at the height of some 70 cm above the present day floor level. The holes, which had been filled in with modern mortar, were placed to the north of the north vessel, to the south of the south vessel, and in the middle between the vessels. The distances between the holes were comparable: 69cm and 79cm respectively – not an abnormal width for fulling stalls (cf. above, *fullonica* I 10, 6). Significantly, traces of waterproof plaster – clearly different in composition from the plaster on the wall – could be seen around two of the holes, and the

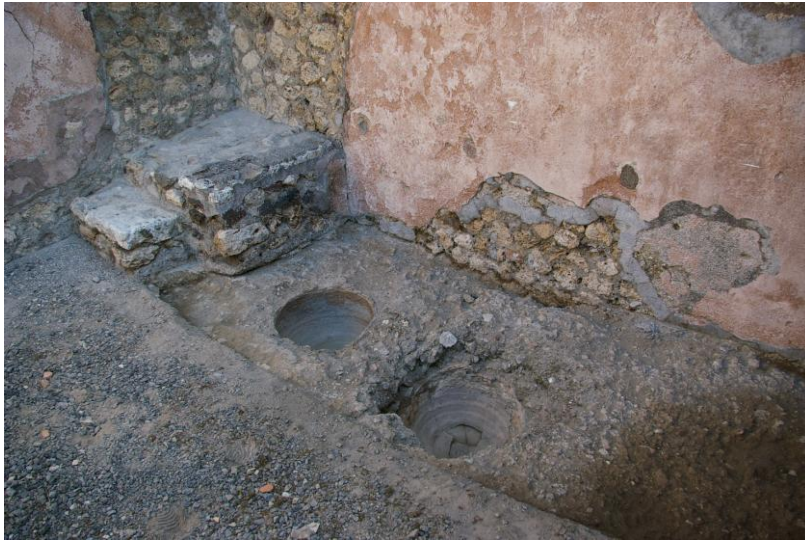
Fig. 9. Taberna VI 3, 6: overview.

To see whether more remains of this installation could be traced, the back part of the shop was cleared to its AD 79 floor level, and the two vessels were emptied (fig. 9). No structures were found, and the floor appeared uninterrupted apart from the holes with the two vessels; yet, as the top layer of the floor had vanished completely throughout the room, this was insignificant: the possibility of a structure standing on top of the floor cannot be excluded, and if it had

been made of wood, as is perhaps suggested by the three holes in the plaster of the back wall, it would not easily leave any traces. Moreover, the vessels appeared large enough to provide space for the two feet of a worker, even though they are slightly smaller than the average Pompeian fulling tub, and most tubs found in Ostia were larger as well¹⁴. The northern vessel was best preserved and had a slightly conical shape; the southern vessel showed little more than the bottom. Typically, the walls of both tubs were for a large part covered with the typical white sediment found in many fulling installations, which also strongly suggests that the tubs were used for fulling.

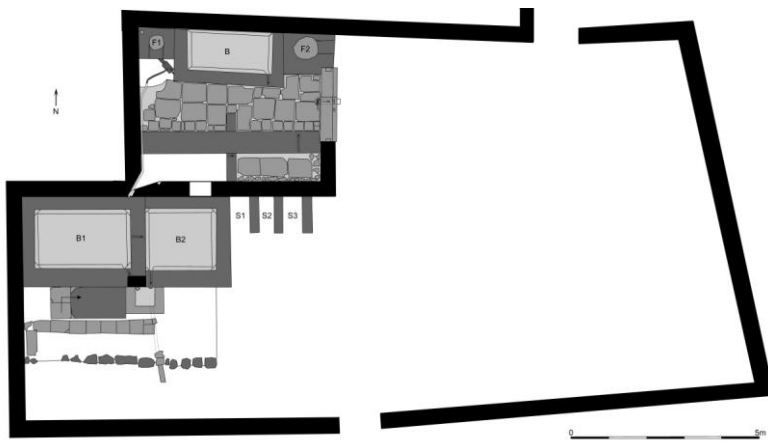
Fig. 10. Workshop VI 16, 3.4: map.

This work area in the southeast corner of *insula* VI 16 consisted of a large uncovered area surrounded by a wall and a roofed space (I) in the northwest corner (fig. 10). The area was accessible through two doors – one in the south wall, and a second one in the north wall. The walls in the northeast part of the area were structurally related to the adjacent *Casa degli Amorini Dorati* (VI 17, 7.38). The workshop was excavated in the 1890s and relatively accurate descriptions of its remains, including a detailed map and a picture of the *fullonica*, were published shortly afterwards¹⁵. Unfortunately, and contrary to the small *fullonica* in VI 16, 6, this workshop was not included in Seiler’s publication of the *Casa degli Amorini Dorati*¹⁶. It was felt that at several points, more information was needed to fully

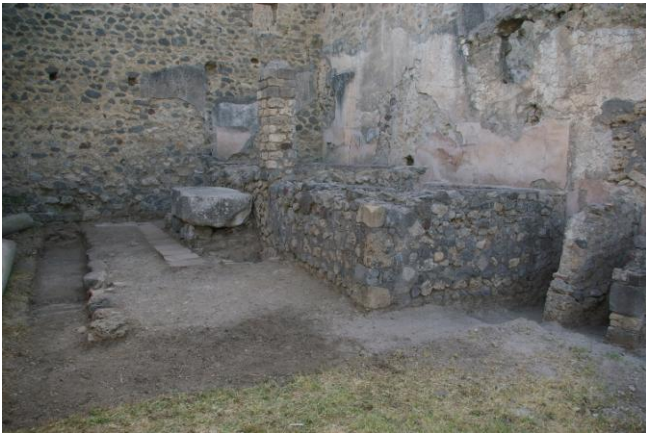
Fig. 11. Workshop VI 16, 3.4: overview of fullery.

To be able to study the *fullonica* in its entirety, a large area was cleaned, starting with the three fulling stalls and the two rinsing basins (fig. 11). Surface cleaning in the fulling stalls yielded no significant results, as no ancient floor level was preserved in this part of the workshop, and there were no remains indicating the nature and position of the tubs. The emptying of the rinsing basins made it possible to measure their capacity and to understand their water system. Basin B1 measured 251x157cm and had a capacity of 3,750 litres ; basin B2 measured 183x168cm (height: 83cm),

which resulted in a capacity of about 2400 litres. Surprisingly, the two basins were not connected on the floor level, but only through an overflow at a height of 95 cm above the floor of basin B1. As this overflow is at a higher level than the walls of basin B2, the water supply must have mouthed in basin B1, and basin B2 could only be filled when basin B1 was completely full. The drain of basin B1 was found in its SE corner, and that of basin B2 in its (adjacent) SW corner; both drains were made of narrow terracotta pipes with a diameter of 5 cm. To understand how the water was transported subsequently, the area in front of this part of the rinsing basins was cleared, and it appeared that the water from the two drains was collected in a small, shallow basin from where it was further transported through an underground channel, the entrance of which was visible in the southeast corner of the basin (fig. 12). Remarkably, as the entrance to the channel was exactly as wide as the two drains, it could only handle the water from one of them at a time: the two rinsing basins could not be emptied at the same moment as it would make the small collection basin overflow. This is fundamentally different from most other rinsing complexes at Pompeii, where it was possible to drain the entire complex at once.

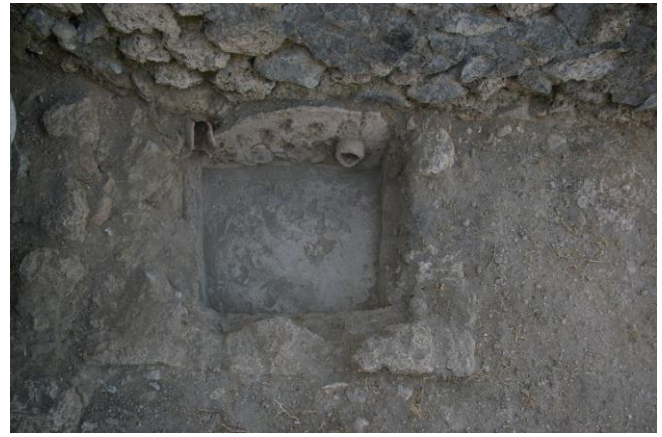
Fig. 12. Workshop VI 16, 3.4: work podium with steps.

The drainage installation appeared to be surrounded by a large working platform, which, rectangular in shape, extended over the entire length of the rinsing complex and had a width of 200-220cm; the south side of the platform consisted of a more or less regular border of stone blocks, but the east side was less clearly delineated. Besides the drainage basin, the only fixture found on the platform were the steps to the podium from which basin B1 could be reached, which had already been visible. Most of the platform appears to have been covered by water-proof plaster, of which fragmentary remains were found at several places, especially in the NW corner between the steps to basin B1 and the wall. Yet, in front of the small drainage basin started a row of *pedales* which continued straight to the west wall of the workshop and then bended southward to the border of the platform (fig. 13). While it was originally thought that these tiles covered a drain, this turned out not to be the case: the drainpipe transporting the water from the basin towards the street went in southeast direction, and ended at the height of the platform border; from there, it seems to have continued uncovered towards the south wall of the area, but it was impossible to

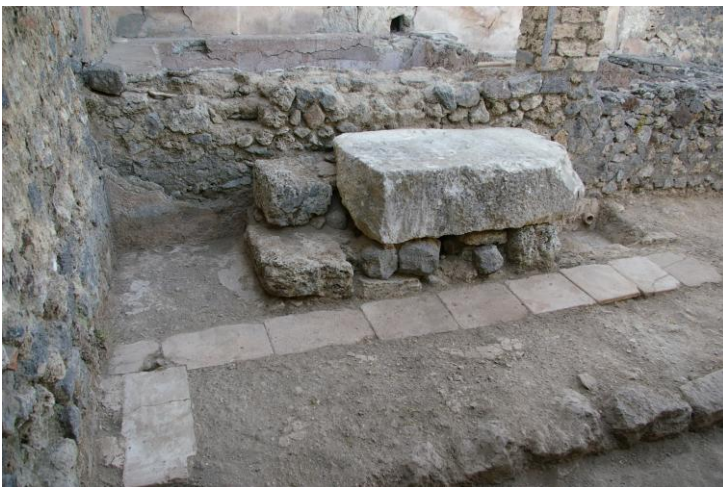
Fig. 13. Workshop VI 16, 3.4: drainage channel.

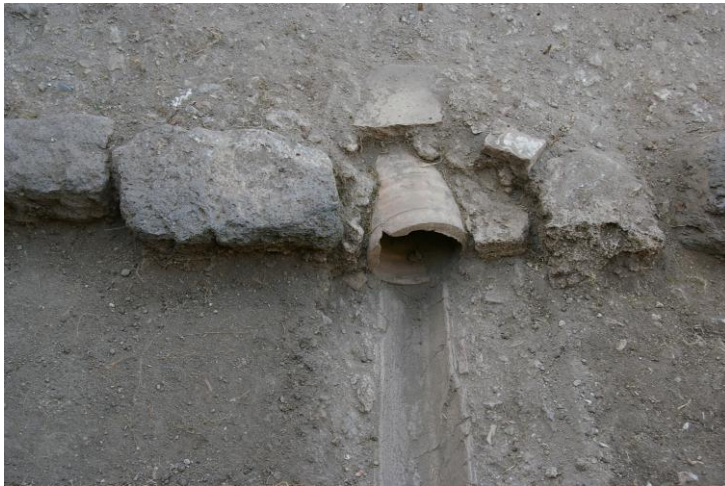
Fig. 14. Workshop VI 16, 3.4: discharge basin.

follow it further, or to trace its end on the street side of the wall (fig. 14). The drainpipe had a rather improvised character: the first part near the rinsing complex consisted of a terracotta pipe, the part near the south end of the platform was made of the lower part of an amphora, and the subsequent canal consisted of an *imbrex* turned upside down. This illustrates how in the construction of workshops, people made the most of whatever material was available – a phenomenon that can be seen in many *fullonicae*.

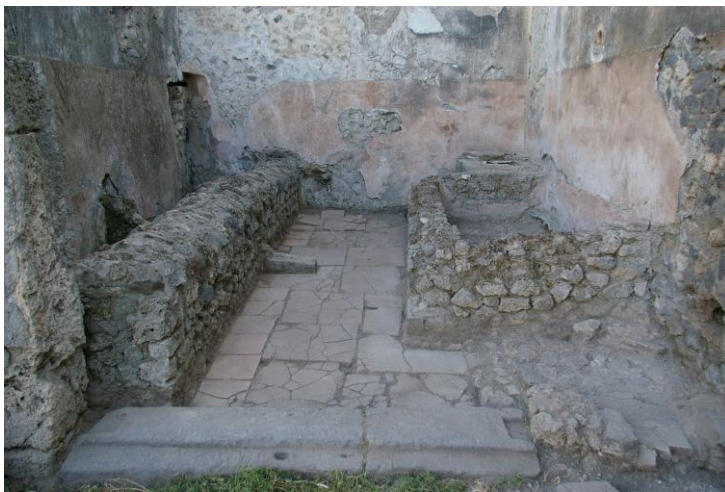
Fig. 15. Workshop VI 16, 3.4: room I, overview.

It appeared that the central area had a floor of *pedales* and *bipedales* (fig. 15). In the east half of the room, the floor shows a number of small rectangular holes (ca. 3.5 x 7 cm each), all near one of the corners of the tile in which they had been carved out (fig. 16). The floor surface was some five cm below the threshold, and directly in front of the threshold was the entrance to a drainage channel of which a short part was found on the other side of the thresholds as well. Basin B had a floor sloping towards its southeast corner (115x225cm; 65cm deep; capacity: ca. 1600 litres) where there was a small drain consisting of a terracotta pipe (diameter: 3.5 cm). Remarkably, this drain opened in the main floor of the room, indicating that the floor served as a central node in the water system of the workshop. This makes it attractive to see the rectangular holes in the floor as related to some kind of wooden construction that had been placed on top of the floor – allowing the workers to keep their feet dry.

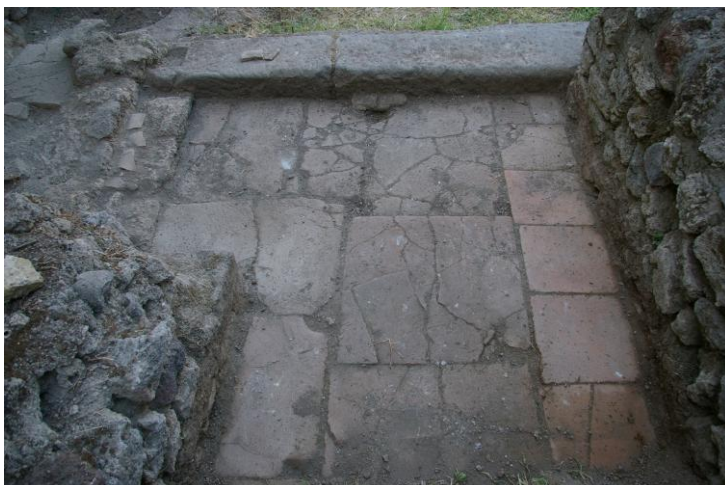
Fig. 16. Workshop VI 16, 3.4: room I, floor.

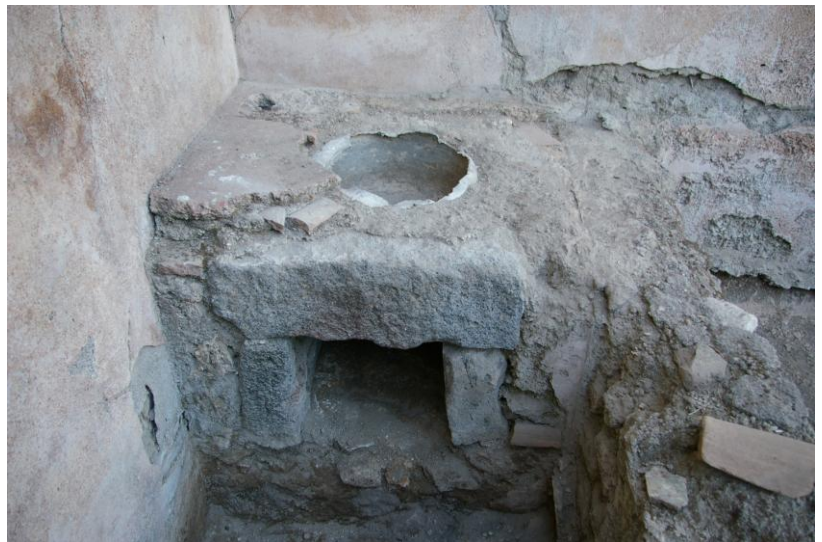
Fig. 17. Workshop VI 16, 3.4: furnace 2.

Of the two furnaces, the one in the northeast corner of room I (F2) was almost completely destroyed, but surface cleaning revealed the floor level was more or less intact; the fire-hole, which had a terracotta tile in the opening, was oriented towards the east side, so that the worker operating the fire actually would have been standing outside the room in the workshop's main area (fig. 15). The furnace in the northwest corner (F1), on the other hand, was almost completely preserved, and had a circular cauldron with a flat bottom above the fire; with a diameter of 45 cm and a depth of 78 cm, it had a capacity of ca. 125 litres (fig. 17). On the lintel of the fire-hole, burning traces are still visible. Just like most furnaces, the installation had a vent in the northeast corner,

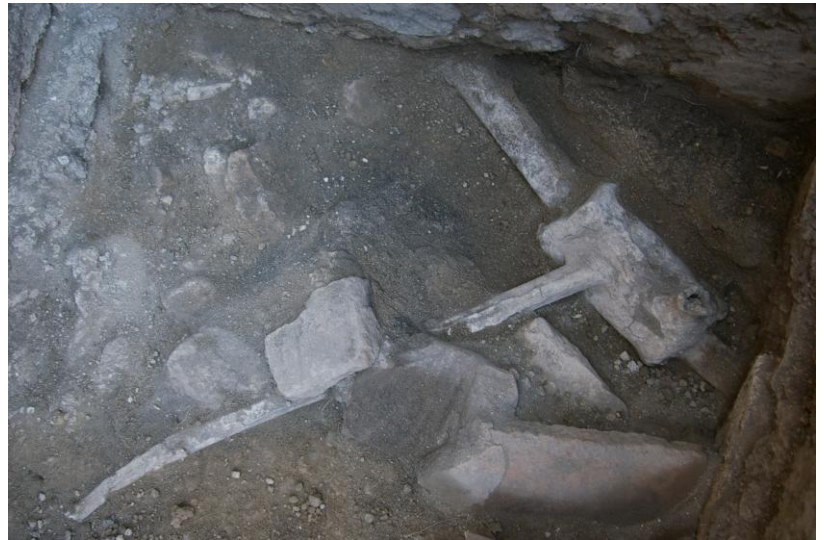
Fig. 18. Workshop VI 16, 3.4: water division box.

A highly relevant discovery was made while examining the AD 79 floor level in front of the furnace in the NW corner of the room. While the floor level appeared disturbed and could not be traced, a large water-division box was discovered on a slightly lower level (fig. 18). It was fed from the northeast by a wide pipe coming from underneath

the furnace, and from it sprang three narrower pipes. One of these continued straight in a westerly direction underneath the basin, but it could not be traced further. Its destination is unknown, but it is unlikely to have been within room I. The second pipe started from the top, but was not preserved at all. It is unclear whether it served the cauldron (as was the case in workshop I 8, 19) or the basin directly west of it, or, perhaps, both. The third, interestingly, was preserved for a length of some 65cm, and ran southwest towards the wall. From there, it seems to have run along the wall and after crossing over the large wall of the working tables in the south part of the room, it went through a hole in the south wall, and ended on the upper rim of the basin B1 of the rinsing complex of the *fullonica*.

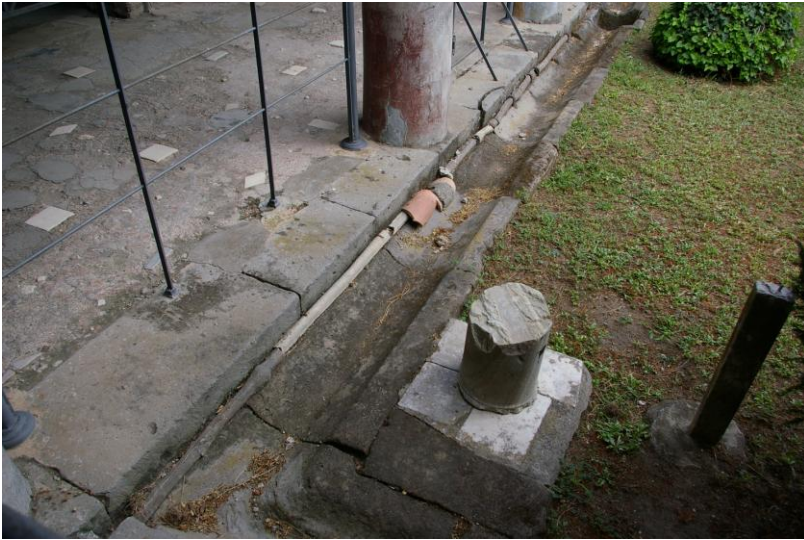
Fig. 19. House VI 16, 7.38: water pipe in Peristyle.

In the first place, the situation has implications for the internal chronology of the complex: the water pipe feeding both the workshop in room I as well as the *fullonica* was overbuilt by the furnace and the basin belonging to the former workshop, and the water pipe feeding the *fullonica* was – at least partially – covered by the tiles of the floor of room I. This more or less excludes the possibility that the *fullonica* antedated the workshop in room I and suggests that the two workshops were in fact contemporary; otherwise, the water pipe to the *fullonica* would probably have run along the wall as much as possible, and on top of the floor of room I instead of underneath it. Secondly, the provenance of the water pipe is highly significant. As it reached room I from the northwest, its only possible provenance is the peristyle of the adjacent Casa degli Amorini Dorati (VI 16, 7.38). Fortunately, this water pipe could also be traced: it ran along the east side of the peristyle garden of this house, bending west precisely at the height of room I (fig. 19)²². The workshop was thus provided with water from the house next door.

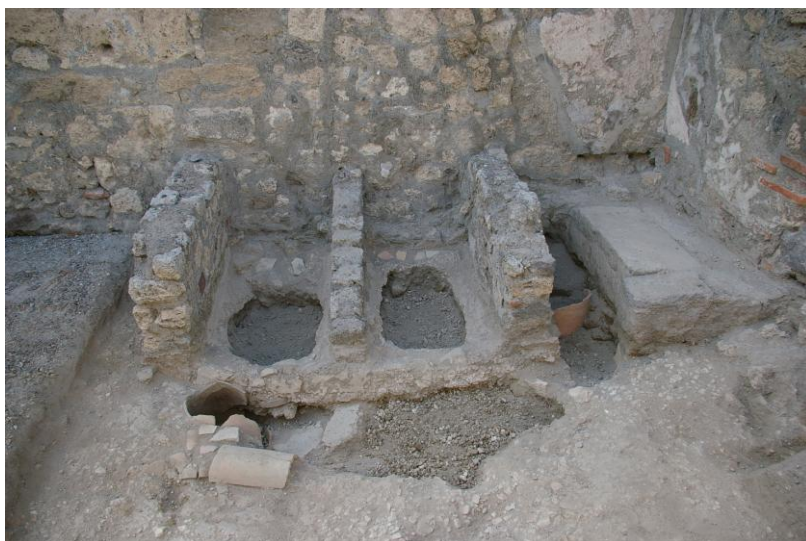
Fig. 21. Taberna I 4, 7: overview.

The picture that emerged was both significant and confusing. What was significant was that, as in most other *fullonicae* investigated during the project, evidence could be found for a work floor in front of the fulling installation: there were the remains of a rim in the form of an *imbrex* attached to the floor ca. 35 cm south of stall S1 (fig. 21). The rim was not parallel to the border of the fulling installation, but slightly angled towards the southeast, so that the work floor became slightly wider towards the back of the shop. Yet, what was strange, was that the floor remains between the rim and the fulling stalls were scarce, and appeared to have been broken off. Indeed, most of the area southeast of the fulling installation consisted of little more than *lapilli*, which, remarkably, even continued *underneath* the rim marking the entrance of stall S2. The holes left by the fulling tubs in both stalls also were filled with remains of the AD 79 eruption. This suggests that there had been structures of wood that had disappeared and subsequently had been filled up with *lapilli*, perhaps through the holes left by the fulling stalls.

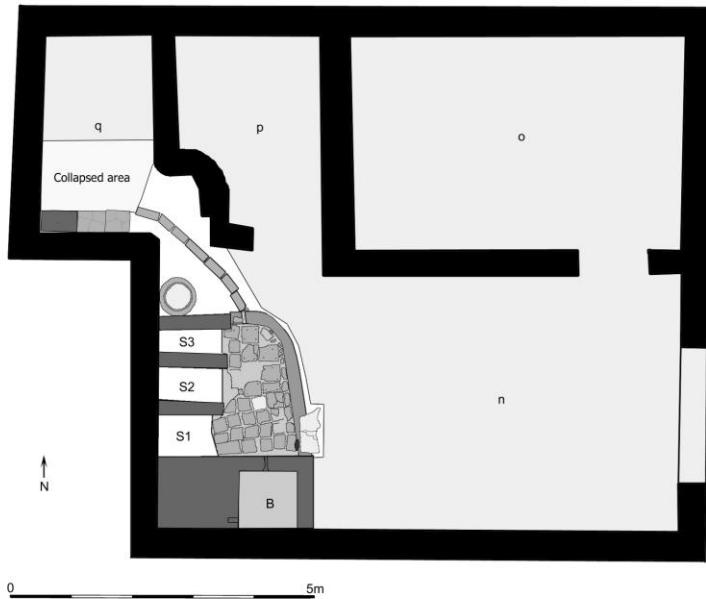
Fig. 22. Taberna VI 15, 3: map.

The main working installations of *taberna* VI 15, 3 were all investigated in 2006 (fig. 22). Yet, one of the most puzzling remains discovered then was a narrow drainage channel made of *imbrices* that ran from somewhere in room Q to the work floor in front of the fulling stalls in the main room.²⁷ Unfortunately, room Q was partially backfilled, and it was not possible to follow the channel further than the entrance of the room in 2006. Hence, it was necessary to go back and see to which facilities it was connected. During the 2008 campaign, the southern half of the room was cleared to, approximately, the height of the AD

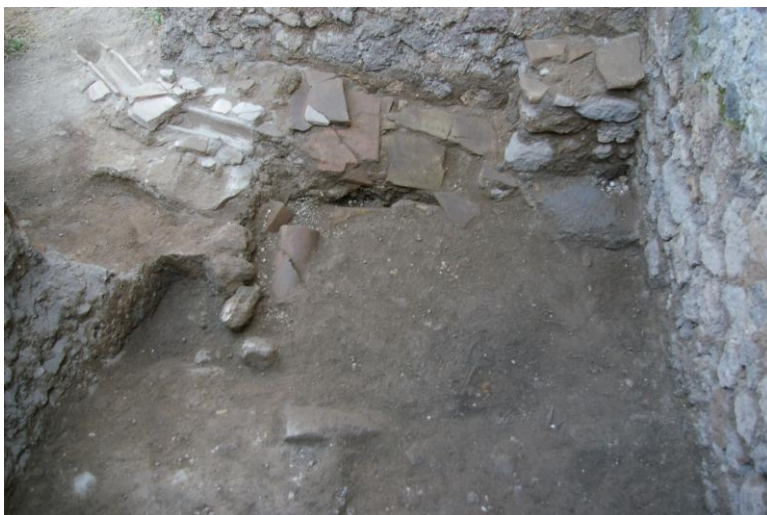
Fig. 23. Taberna VI 15, 3: overview of room Q.

79 pavement (fig. 23). Unfortunately, it turned out that traces of the floor and fixtures associated with it had only been preserved in a narrow strip of some 20cm along the south wall of the room: the rest of the remains that could reveal anything about the ancient use of the room had collapsed into a hole underneath it, which subsequently had filled up. As the size and the structural properties of the hole remained unclear, it was uncertain how much time it would cost to excavate it properly, and how safe this would be, especially considering the height of the walls surrounding the room. Since the remains found did not suggest that proceeding would return results that would significantly add to the project, it was decided not to proceed. The northern half of the room was cleared to a level of some 20cm above the floor level, to check whether there were any remains of larger installations, but this turned out not to be the case.

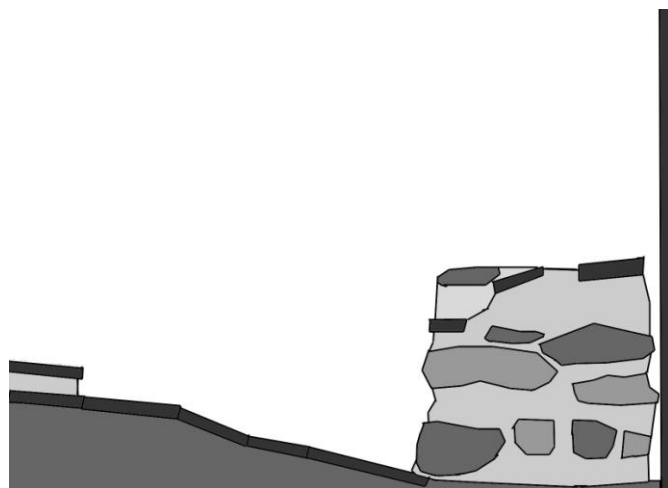
Fig. 24. Taberna VI 15, 3: drawing of remains in room Q.

The remains found along the south wall consisted of a low pillar, in the southwest corner of the room, which marked the end – and was partially placed on top – of a sloping floor of two tiles, which were all heavily damaged, and had partially disappeared in the collapse; notably, the pillar seemed to be completely preserved *in situ* (fig. 24). While it is hard to be completely sure because of the damage to the structure, what was found had all the properties of a small

toilet: Pompeian toilets generally had sloping floors in front of them, and they often had wooden seats resting on corresponding supports of stone, which surrounded the entrance to the cesspit or drain.²⁸ While the second, corresponding seat support here is lacking, it may easily have fallen into the hole when it collapsed. If the remains indeed were related to a toilet, it is attractive to suggest that what collapsed was the cesspit related to it.
